PRELIMINARY ROOST ASSESSMENT (PRA)

BISHOPS VIEW, ST MARY'S, ISLES OF SCILLY

Our reference: 25-6-6

Report date: 2nd July 2025

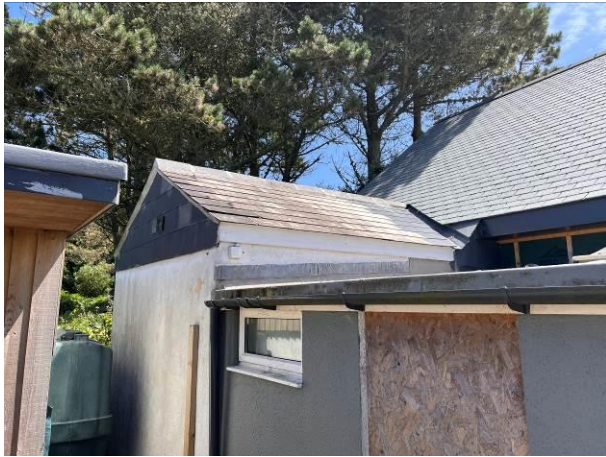
The roof is tiled with synthetic slate tiles with no gaps noted associated with the roof or ridge tiles. Minor lifted sections are superficial and do not offer suitable roosting features due to the nature and dimensions of the tiles. Hanging tiles on the upper gable appear to be similarly well-sealed.

Photograph 1: Showing the single-storey pitched roof section which would be extended to a second storey.

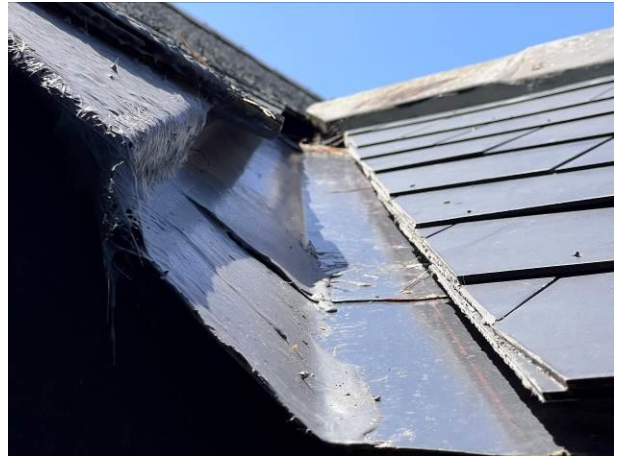
There is flashing at the valley where this pitched roof ties into the main roof – this was well-sealed and in good condition.

Photograph 2: Showing the well-sealed valley between the single-storey roof and the existing main pitched roof into which it is tied

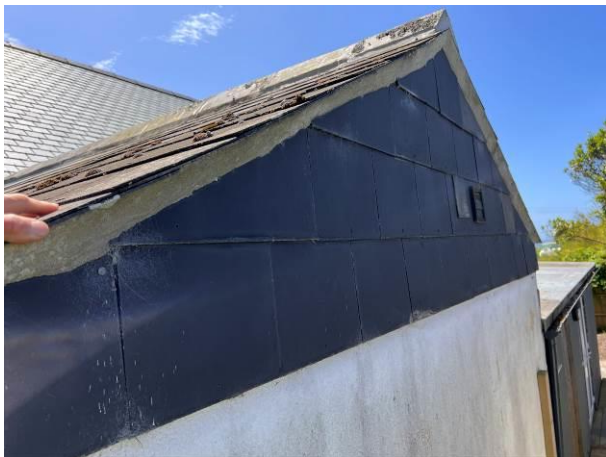
Photograph 3: Showing the hanging tiles on the upper gable of the single-storey section – these are well-sealed at the base

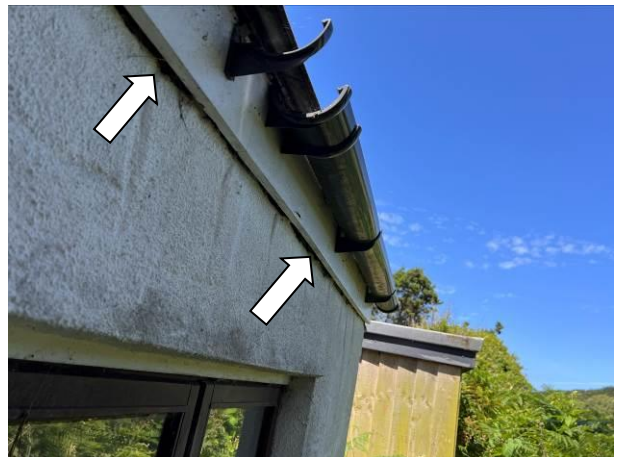
There is potential access for bats via gaps at the eaves of the building on the eastern aspect which are too wide to provide roosting features in their own right, and lack a terminal apex for a crevice-dwelling species such as common pipistrelle, but would provide potential access to roosting features associated with the loft space.

- Roosting opportunities associated with the roof structure which could be accessed via the gap behind the fascia on the eastern aspect of the single-storey building.

The single-storey component roof is considered to have **Low Potential** to support roosting bats – this takes into account:

Photograph 4: Showing the gaps behind the fascia on the eastern aspect of the single-storey section

In accordance with the criteria outlined in the Best Practice Guidance, one Presence/Absence Survey (PAS) would be required to provide an appropriate evidence-base upon which to support a planning application.

The PAS surveys should be led by Licensed Bat Worker(s) between May and September. The survey would require one surveyor in order to achieve a comprehensive view of the relevant features and should be supported by use of an infra-red or thermal imaging camera along the eastern aspect.

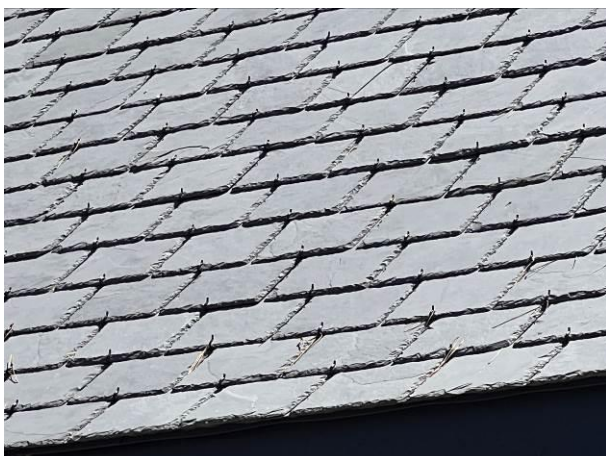
The main roof has been recently constructed with dry-laid slate tiles which are in excellent condition with no gaps or potential access points noted on this aspect.

The main roof is considered to have **Negligible Potential** to support roosting bats in the location where the new roof would tie in. The absence of a void would preclude the risk of an impact to this aspect of the roof having an indirect impact on a central roost which is accessed from another aspect as would be the case if a loft space were affected.

Photograph 5: Showing the tightly fitted dry-laid slate tiles of the main roof into which the new extension would be tied.

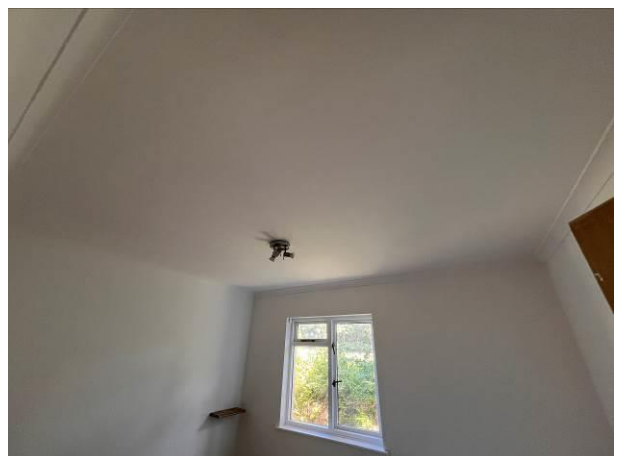
The loft void is sealed but was previously accessed during a PRA survey in 2023 prior to renovation works. At this time it was confirmed that the roof was built around a timber-truss framework - there is no ridge present and the roof is under-felted throughout in good condition. Rodent droppings were noted. No evidence of bats was identified, but the restrictions on access to the void represented a constraint to survey.

- The sealed void within the single-storey roof could not be accessed for inspection as it was sealed;

Photograph 6: Showing the interior room of the single-storey section – the sealed void is in the roof space above this.
