## PRELIMINARY ROOST ASSESSMENT (PRA)

LOWENVA,  
CHURCH ROAD, ST MARY'S, ISLES OF SCILLY

*Our reference: 26-2-2*

*Report date: 17<sup>th</sup> February 2026*

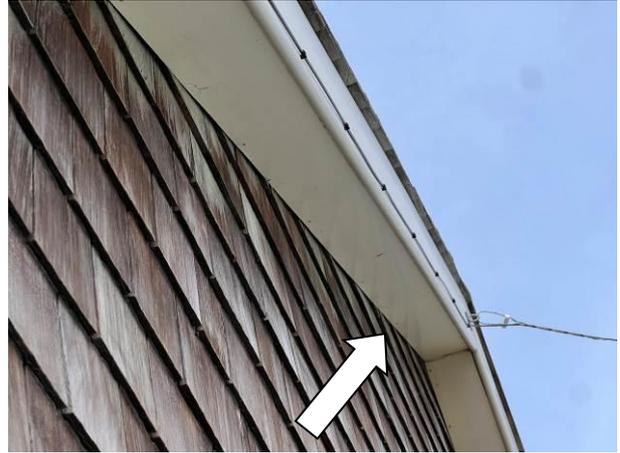
The boxed soffits on both the eaves and the gable have occasional gaps where they are imperfectly cut to the irregular blockwork of the wall. Larger gaps are present at the terminus of these soffits on the corners of the property. These gaps were inspected with a video endoscope and no evidence of bats was noted but there is potential for use by roosting bats either within the boxed soffit itself, or within features associated with the wall plate which are accessible through these access features. Guttering was attached to the eaves soffits only.

**Photograph 2:** Showing the shingles on the gable ends of the property – the boxed soffits with minor gaps can be seen

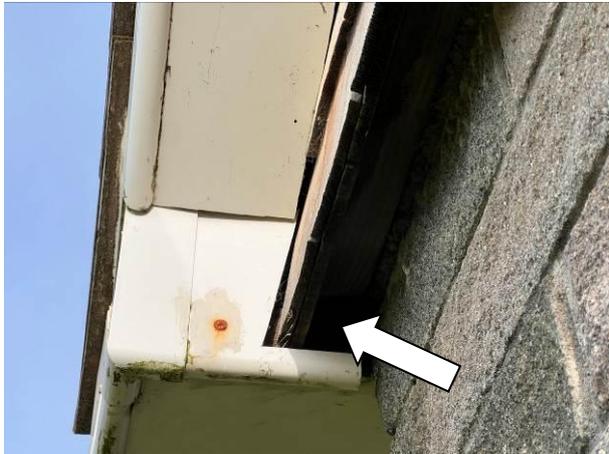
- Gaps behind the soffits at the gable and eaves which might provide roosting opportunities in their own right, or provide access to roosting opportunities associated with the wall plate.

**Photograph 3:** Showing the gap at the corner of the property providing access to the boxed soffit

- 1x Presence/Absence Survey (PAS).

If the recommended timing of works is not possible, then contractors should visually inspect the work area internally and externally before they are affected by the works, in order to confirm that no nests are present – specifically in the gaps within the soffits. In the event that a bird nest is present, it must be left undisturbed until chicks have fledged the nest, at which point works can proceed.

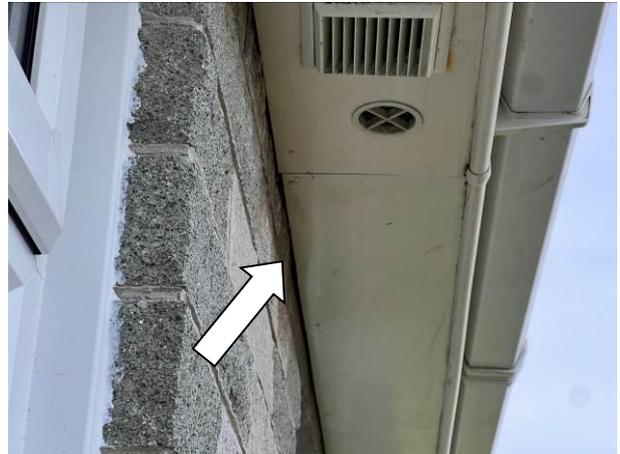
House sparrows have the potential to nest in features associated with the soffits of the property, although no evidence of historic nesting was identified at the time of survey. Additional minor opportunities may be found elsewhere on the structure, or within the associated garden.

**Photograph 4:** Showing an example of the minor gaps in the boxed soffits where they meet the wall.

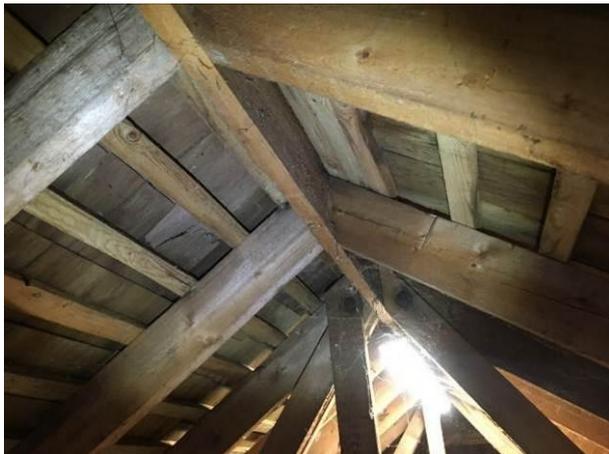
The roof itself is constructed around a timber truss framework with timber shingles attached directly to wooden battens with no insulation or underfelting. Despite the inherent suitability of the material for roosting bats, the characteristics of the shingles mean that there are no suitable cavities between them, nor beneath them. There are minor cavities created by the intersection of timbers at the gable walls within the loft space, but these were found to be relatively open and well cobwebbed at the time of survey indicating no current or recent occupation by bats. There is a timber ridge board present.

**Photograph 5:** Showing the roof structure with ridge board visible. The shingles are attached directly to the battens.

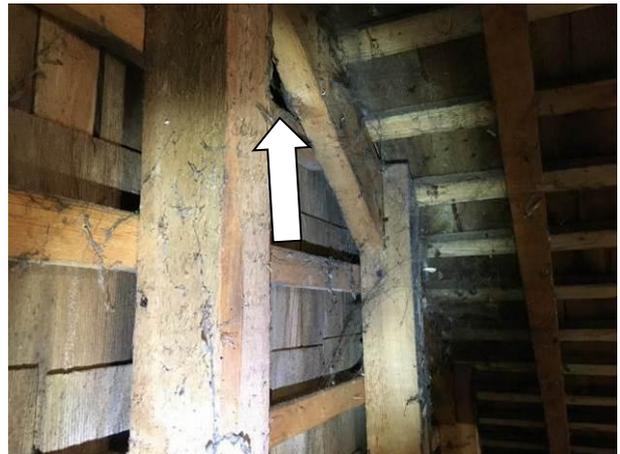
**Photograph 6:** Showing the apex of the interior gable – an example of the locations where minor gaps are present are indicated.
