## Newman House, TR21 0LS

Leslie Cornell Building Restoration Ltd  
Unit 13-14 St Austell Bay Business Park  
Par Moor Road  
St Austell  
Cornwall, PL25 3RF  
01726 337577  
[cornellcob@outlook.com](mailto:cornellcob@outlook.com)  
[www.cornellcob.co.uk](http://www.cornellcob.co.uk)

Leslie Cornell

November 2016

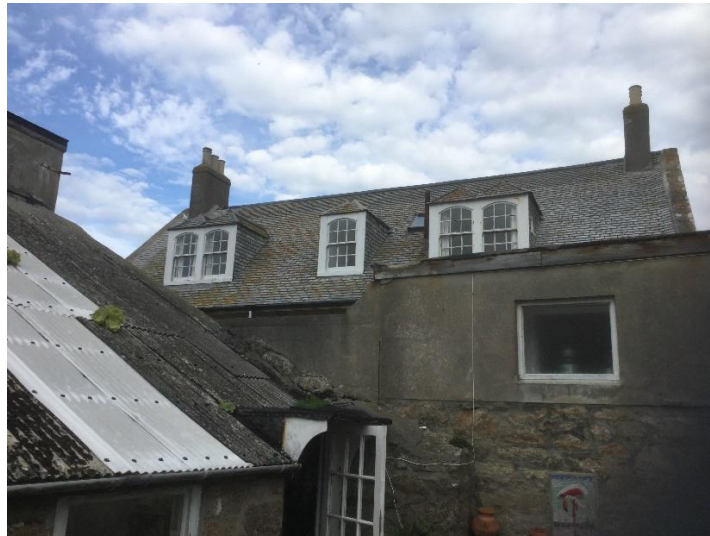
**NEWMAN HOUSE SOUTH ELEVATION**

*South Elevation* – Drawing Ref: NH/10516/COURTYARD-ELEVS/01 and ANNEXE-ELEVS/02

1.5 (as 1.1)

1.6 (as 1.2)

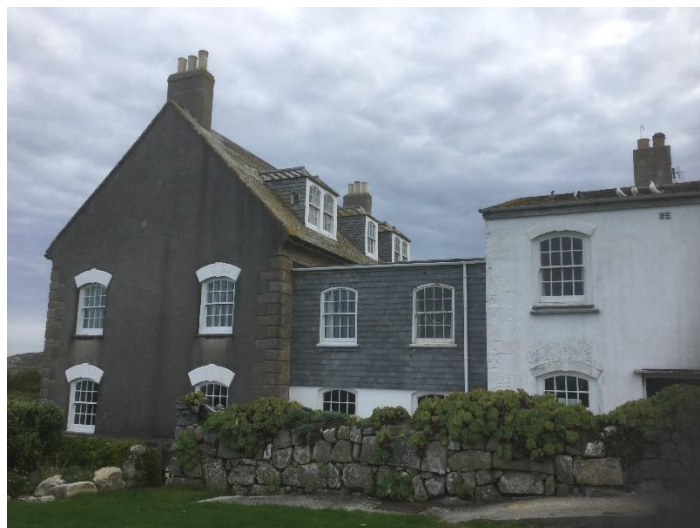
**NEWMAN HOUSE WEST ELEVATION**

*West Elevation* – Drawing Ref: NH/10516ELEV-WST/03 AND 04

- 1.7 Remove, using non-power tools, existing cementitious render application/s
- 1.8 Remove, using conservation approved methods and materials, existing paint surfacing/s to window arches and keystones
- 1.9a (as 1.2)
- 1.9b Using an appropriate Natural Lime/sand mortar, introduce a 'bag-rub' application\*
- 1.9c Using an appropriate Natural Lime/sand mortar, introduce a 3-coat render\*
- 1.10 Items 1.9a and 1.9b – Introduce a Mineral Paint System

- 1.7 Removal of existing cementitious render application/s should be achieved using hand-tools only ie hammer and (varying) chisels. Continue (as 1.1)

- 1.8 **Removal of existing painted surfacing/s to window arches and keystones.** Peelaway 7 is recommended as an approved paint removal process. Reason: Non-toxic, sympathetic to substrate/s and environmentally (in comparison) considerate. Test areas must be introduced prior to full application. As per manufacturers specifications

**1.9b Bag-rub** – A successful bag-rub application can be achieved using conventional plastering tools. This application should only be introduced if the stonework is of questionable appearance and/or friable. Reason: To ensure substrate stability without losing the [natural] aesthetic.

**1.9c Lime render** – To be introduced only if all other options have been dismissed. Reason: The aesthetic loss of Historic construction methods and materials.

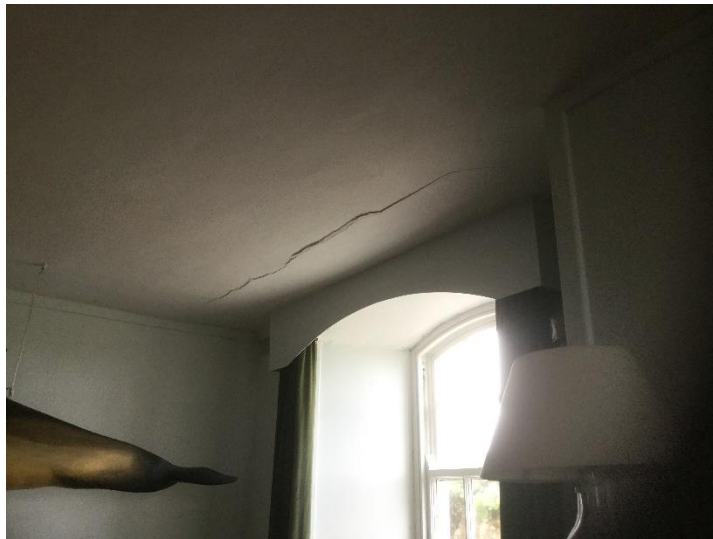
**NEWMAN HOUSE GROUND FLOOR DINING ROOM**

**8.0 Newman House Ground Floor** (Internal) Drawing Ref: NH/10516/PLAN-GRD/02

- 8.1 Dining Room – Item 1 – Remove localized failed/failing surface plaster/s to ceiling
- 8.1a Introduce an appropriate Natural Lime/sand base-coat plaster
- 8.1b Introduce an appropriate Natural Lime/sand top-coat plaster
- 8.1c Introduce an appropriate Natural paint
- 8.2 Dining Room – Item 2 – Remove localized failed/failing surface plaster/s to R/H window reveal.
- 8.3 (as 8.1a, b and c)

**Removal** of existing failed areas of plaster to be undertaken with hand-tools. Note; where 'patching-in' is required and/or unavoidable, use of a multi-tool may be necessary. Reason: Multi-tool can effectively remove a recognized area without disruption to surrounding, stable plaster/s. Care must be taken not to 'chase' too deep. Reason: To ensure underlying fabric and/or lathes are unaffected.

**Lime Applications** - Introduce an NHL 3.5+ medium coarse sand (with natural hair) base coat. After initial curing, comb-scratch. Scratch (or float coat) to be NHL 3.5 + fine/medium grit sand applied to moistened background. Finish coat to be NHL 2 + fine sand. Trowel to finish.

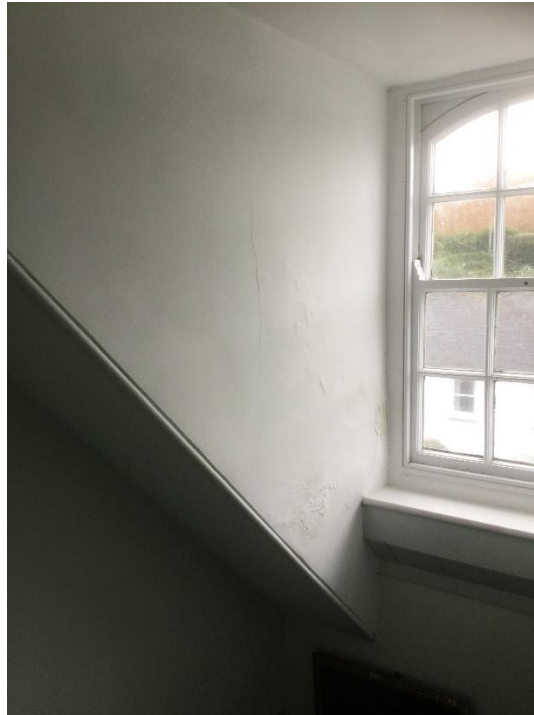
**NEWMAN HOUSE 2<sup>ND</sup> FLOOR  
DORMER REVEALS (TYP)**

**10.0 Newman House – 2<sup>nd</sup> Floor** (Internal) Drawing Ref: NH/10516/PLAN-1<sup>st</sup>/04

- 10.1 WC – Remove and replace existing wallpaper/s
- 10.2 D1 – D10 – Dormer reveals (all). Remove localized existing failed/failing surface plaster/s
- 10.3 (as 8.1a, b and c)
