Heritage Assessment

Newman House, TR21 0LS

November 2016

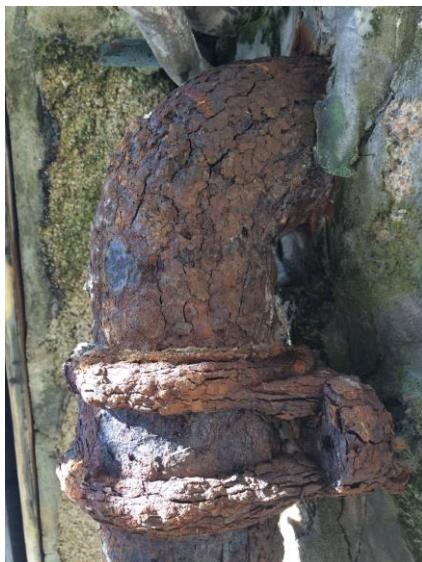
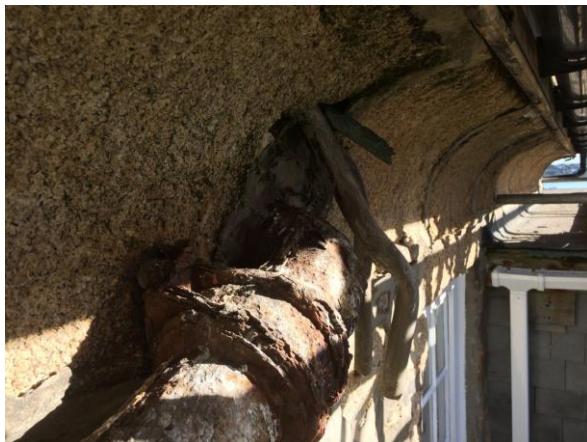
1. The introduction of a cast-iron replacement will require essential annual maintenance. Due to the location of the property, sea-salts are commonplace and we would expect accelerated corrosion if left unattended. Given the location [of the FWP] within the Courtyard, access is restricted at high-level. Safe-working (at height) could not be achieved with ladder/s and in addition, a glass-canopied roof, at 1st floor level, will impede full (required) access.
2. We do not propose and/or condone further usage of UPVC rainwater/FWP products within this, or any other phase of restoration. The existing, cast-iron, ogee profile guttering to additional elevations is in good condition, moreover, these elements can be accessed safely in accordance with Work at Height Regulations 2005.
3. Our proposed introduction of a UPVC replacement FWP would not, in our opinion, reflect

negatively to the historical importance of Newman House and/or impact upon the local environment. The location [of the FWP] is within a Courtyard accessed only by house-holder and maintenance personnel and is not visible from the public highway/footpath.

- 6.1 Remove existing failed/failing cast-iron Foul Waste Pipe (FWP) from ground-level to eaves
- 6.2 Introduce UPVC, cast-iron FWP replacement

- 6.1 **Courtyard –** Foul Waste Pipe (FWP) to be removed from the existing, low-level branch tee only. Items to be removed are: 1 x section of pipe, 1 x 45 degree bend, 1 x section of pipe and 1 x 45 degree bend. Reason: Deterioration. These items are to be removed by hand, potentially a small angle grinder may be required to assist with corroded fixing/s. Items removed to be replaced with like for like components. All [newly introduced] fixings to be stainless steel.

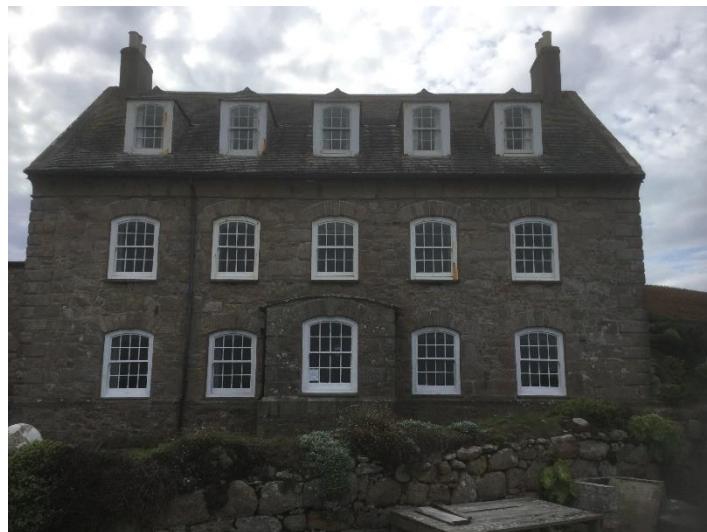
NEWMAN HOUSE NORTH ELEVATION

North Elevation (inc Porch) – Drawing Ref: NH/10516/ELEV-NTH/01

- 1.1 Remove, using non-power tools, existing cementitious pointing application/s (inc opening reveals).
- 1.2 Using an appropriate Natural Lime/sand mortar, repoint all exposed jointing/s

1.1 Removal of existing cementitious pointing applications should be achieved using hand tools only ie hammer and plugging chisel. The use of power tools for removal is not recommended...principal reason being that [potentially] irreversible damage to surrounding fabric/s may result. As good practice the depth of jointing should be 1 and a half times that of the jointing gap (guideline).

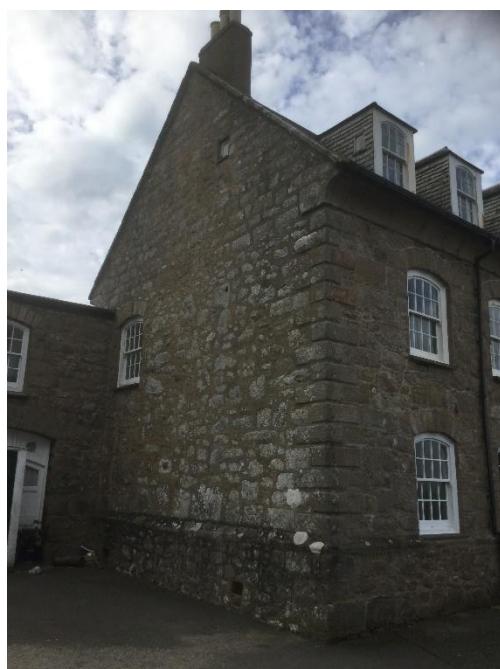
NEWMAN HOUSE EAST ELEVATION

East Elevation – Drawing Ref: NH/10516/ELEV-EST/02

- 1.3 (as 1.1)
- 1.4 (as 1.2)

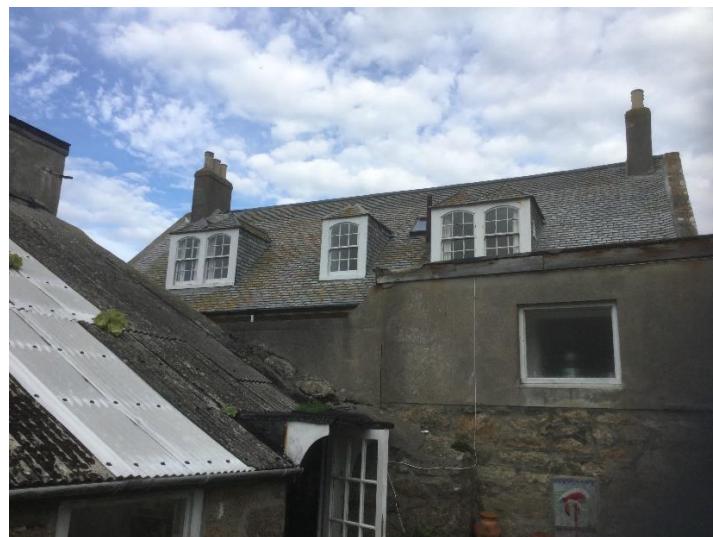
NEWMAN HOUSE SOUTH ELEVATION

South Elevation – Drawing Ref: NH/10516/COURTYARD-ELEVS/01 and ANNEXE-ELEVS/02

- 1.5 (as 1.1)
- 1.6 (as 1.2)

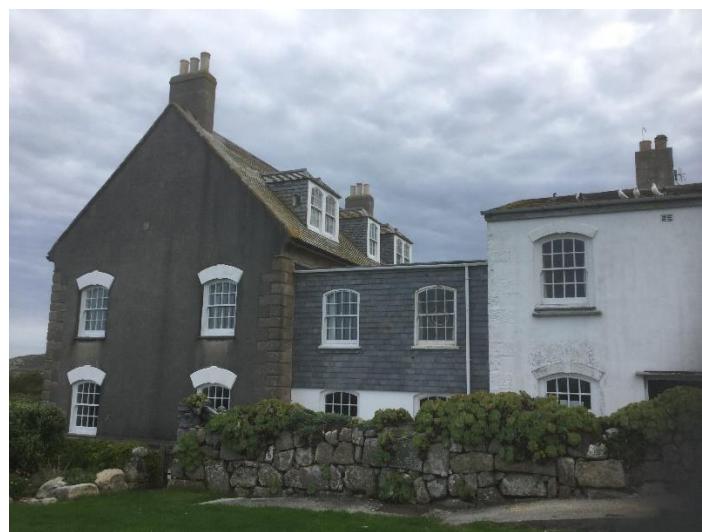
NEWMAN HOUSE WEST ELEVATION

West Elevation – Drawing Ref: NH/10516ELEV-WST/03 AND 04

- 1.7 Remove, using non-power tools, existing cementitious render application/s
- 1.8 Remove, using conservation approved methods and materials, existing paint surfacing/s to window arches and keystones
- 1.9a (as 1.2)
- 1.9b Using an appropriate Natural Lime/sand mortar, introduce a ‘bag-rub’ application*
- 1.9c Using an appropriate Natural Lime/sand mortar, introduce a 3-coat render*
- 1.10 Items 1.9a and 1.9b – Introduce a Mineral Paint System

1.7 Removal of existing cementitious render application/s should be achieved using hand-tools only ie hammer and (varying) chisels. Continue (as 1.1)

1.8 **Removal of existing painted surfacing/s to window arches and keystones.** Peelaway 7 is recommended as an approved paint removal process. Reason: Non-toxic, sympathetic to substrate/s and environmentally (in comparison) considerate. Test areas must be introduced prior to full application. As per manufacturers specifications

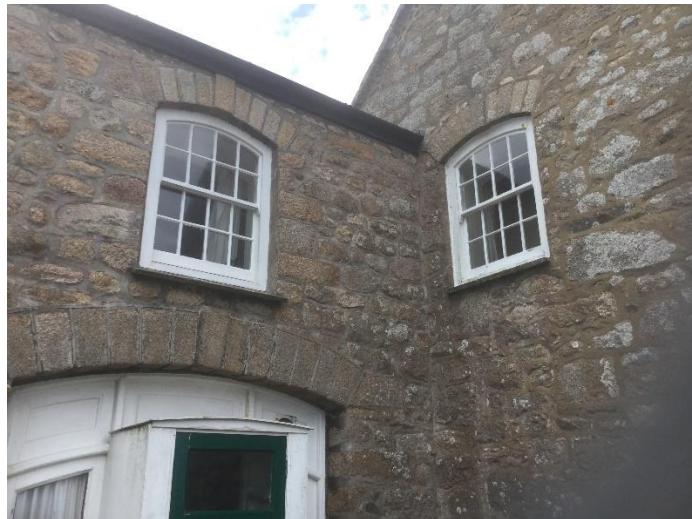
NEWMAN HOUSE ANNEXE NORTH ELEVATION

North Elevation

2.1 (as 1.1)

2.2 (as 1.2)

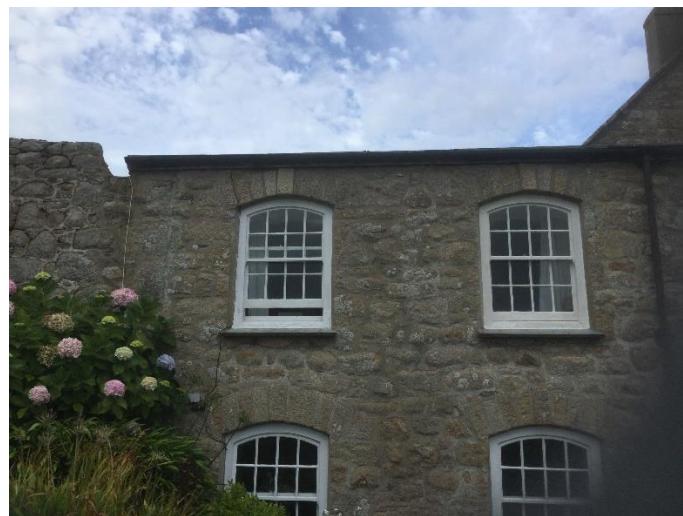
NEWMAN HOUSE ANNEXE EAST ELEVATION

East Elevation

2.3 (as 1.1)

2.4 (as 1.2)

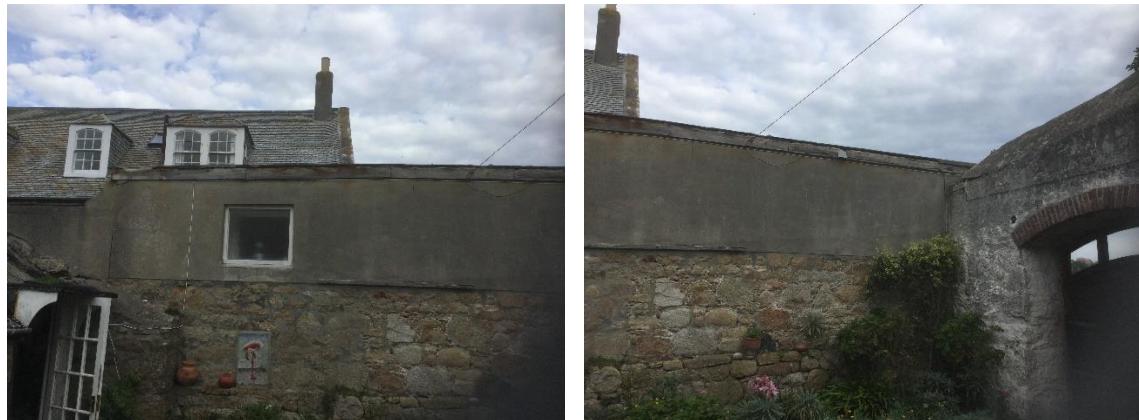
NEWMAN HOUSE ANNEXE SOUTH ELEVATION

South Elevation

- 2.5 (as 1.1)
- 2.6 (as 1.2)

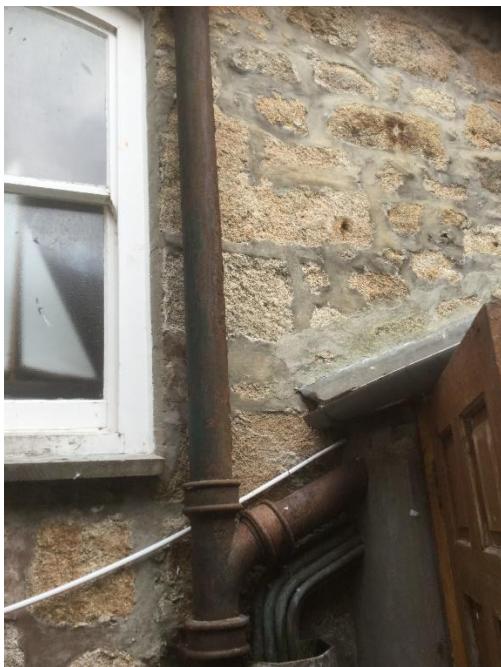
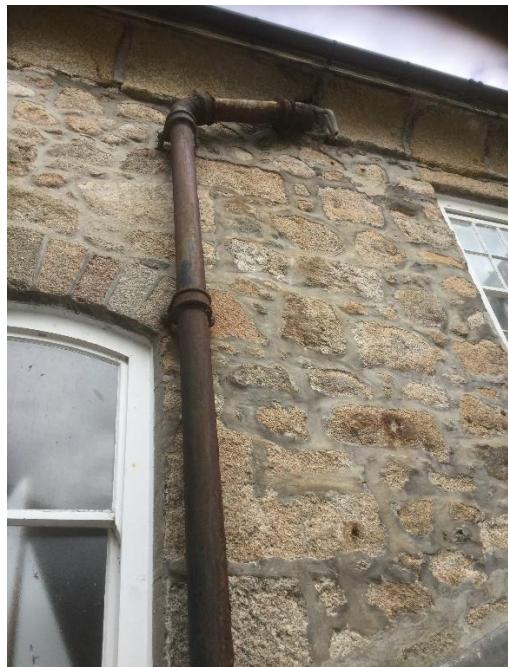
NEWMAN HOUSE COURTYARD FWP

6.0 Courtyard Drawing Ref: NH/10516/COURTYARD-ELEVS/01

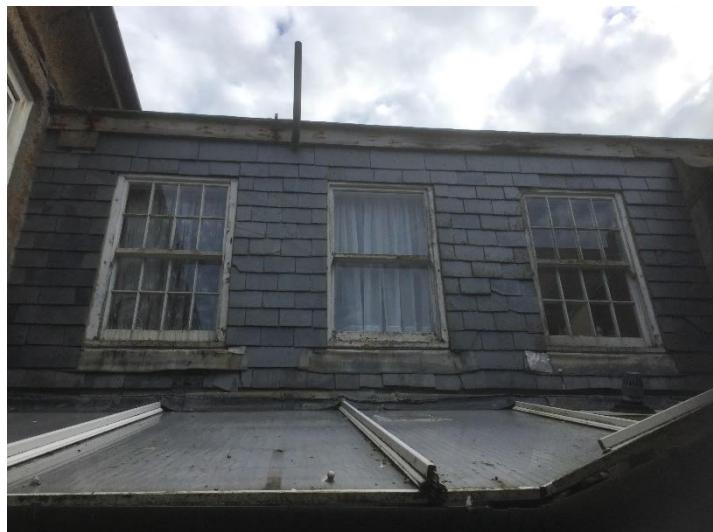
NEWMAN HOUSE STUDIO WEST ELEVATION

- 6.3 West Elevation (Studio) – Replace and/or reinstate all missing, broken, failed natural slate to 1st floor covering/s.

- 6.4 West Elevation (Studio) – Introduce treated 150mmx25mm timber fascia board, rainwater gutter and downpipe
- 6.5 In-situ restoration to: W27, W28 and W29

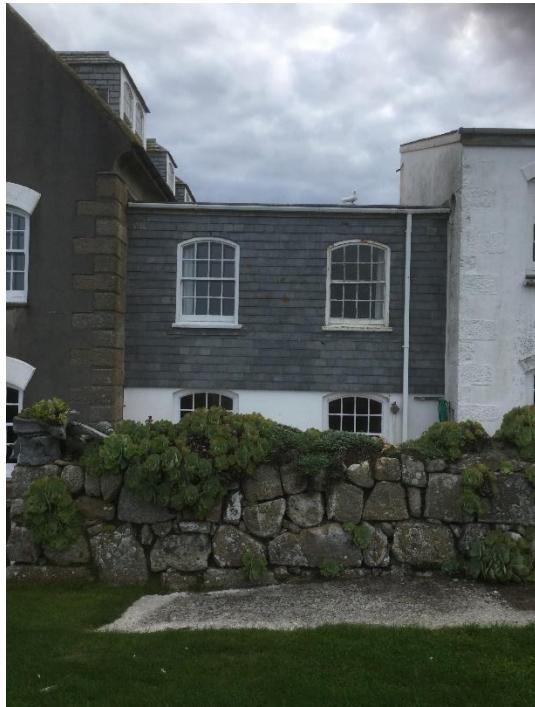
NEWMAN HOUSE POTTERY WEST ELEVATION

7.0 West Elevation (Pottery) Drawing Ref: NH/10516/ELEV-WST/03 and 04

- 7.1 Remove existing natural slate (to be re-used for Item 6.3)
- 7.2 Introduce an appropriate render to exposed substrate/s (substrate unknown at present)
- 7.3 Introduce 4x natural slate window cills
- 7.4 Introduce a Mineral Paint System (as detailed for Item 1.10) to Ground and 1st Floors
- 7.5 In-situ restoration to: W15, W16, W17 and W18

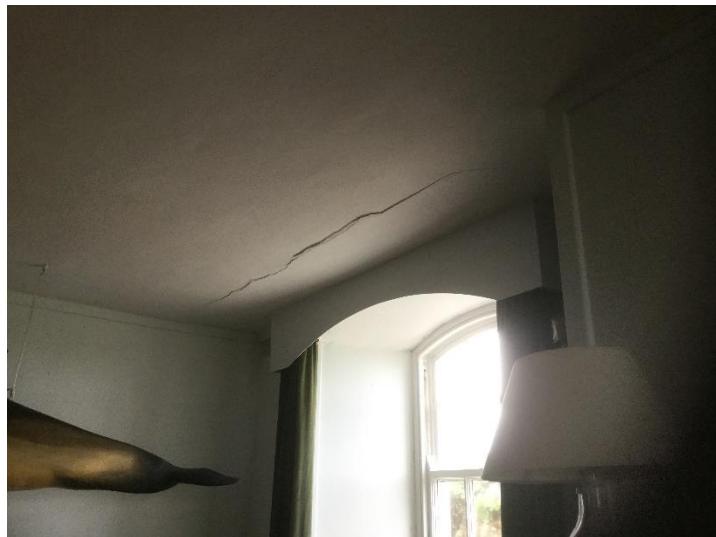
NEWMAN HOUSE GROUND FLOOR DINING ROOM

8.0 Newman House Ground Floor (Internal) Drawing Ref: NH/10516/PLAN-GRD/02

- 8.1 Dining Room – Item 1 – Remove localized failed/failing surface plaster/s to ceiling
- 8.1a Introduce an appropriate Natural Lime/sand base-coat plaster
- 8.1b Introduce an appropriate Natural Lime/sand top-coat plaster
- 8.1c Introduce an appropriate Natural paint
- 8.2 Dining Room – Item 2 – Remove localized failed/failing surface plaster/s to R/H window reveal.
- 8.3 (as 8.1a, b and c)

Removal of existing failed areas of plaster to be undertaken with hand-tools. Note; where ‘patching-in’ is required and/or unavoidable, use of a multi-tool may be necessary. Reason: Multi-tool can effectively remove a recognized area without disruption to surrounding, stable plaster/s. Care must be taken not to ‘chase’ too deep. Reason: To ensure underlying fabric and/or lathes are unaffected.

Lime Applications - Introduce an NHL 3.5+ medium coarse sand (with natural hair) base coat. After initial curing, comb-scratch. Scratch (or float coat) to be NHL 3.5 + fine/medium grit sand applied to moistened background. Finish coat to be NHL 2 + fine sand. Trowel to finish.

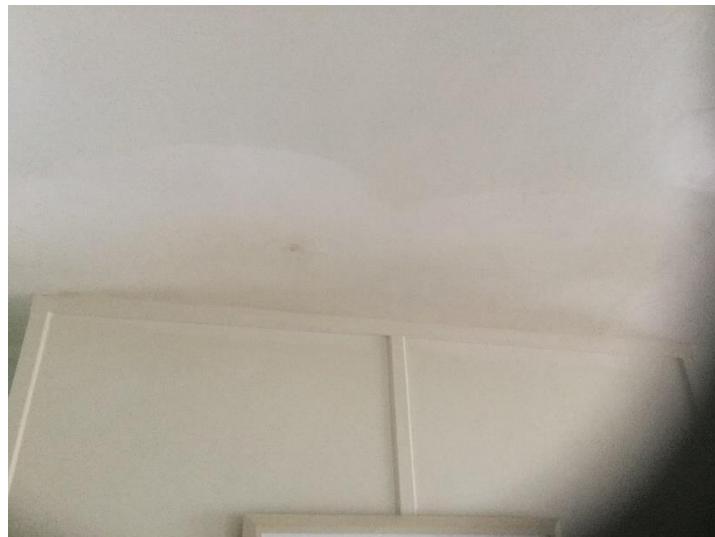
NEWMAN HOUSE 1ST FLOOR MASTER BEDROOM

9.0 Newman House – 1st Floor (Internal) Drawing Ref: NH/10516/PLAN-1st/03

- 9.1 Sitting Room – Item 1 – (as 8.1, 8.1a, b and c)
- 9.2 Sitting Room – Item 2 – (as 8.2, 8.2a, b and c)
- 9.3 Landing Wall – Item 3 – Remove existing failed wallpaper and replace
- 9.4 Master Bedroom – Item 4 – Remove existing wallpaper/s to ceiling and replace

- 9.3 Wallpaper (all)** – Removal of existing failed/failing wallpapers must NOT be undertaken using steam operated systems. Reason: High risk of separating underlying, natural plaster/s from fabric/s. We recommend that controlled ‘saturation’, using warm water, sponges and upvc (round-edged) scrapers.

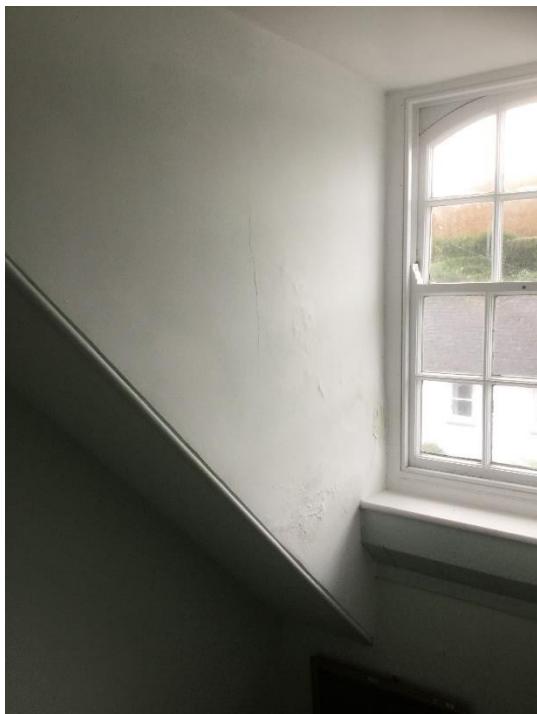
**NEWMAN HOUSE 2ND FLOOR
DORMER REVEALS (TYP)**

10.0 Newman House – 2nd Floor (Internal) Drawing Ref: NH/10516/PLAN-1st/04

- 10.1 WC – Remove and replace existing wallpaper/s
- 10.2 D1 – D10 – Dormer reveals (all). Remove localized existing failed/failing surface plaster/s
- 10.3 (as 8.1a, b and c)
