# PRELIMINARY ECOLOGICAL APPRAISAL & PRELIMINARY BAT ROOST ASSESSMENT OF:

2 MATTHEWS FIELD  
CHURCH ROAD  
HUGH TOWN  
ST MARY'S  
TR21 0NA

*Our reference: BS2-2018*

*Report date: 8<sup>th</sup> October 2018*

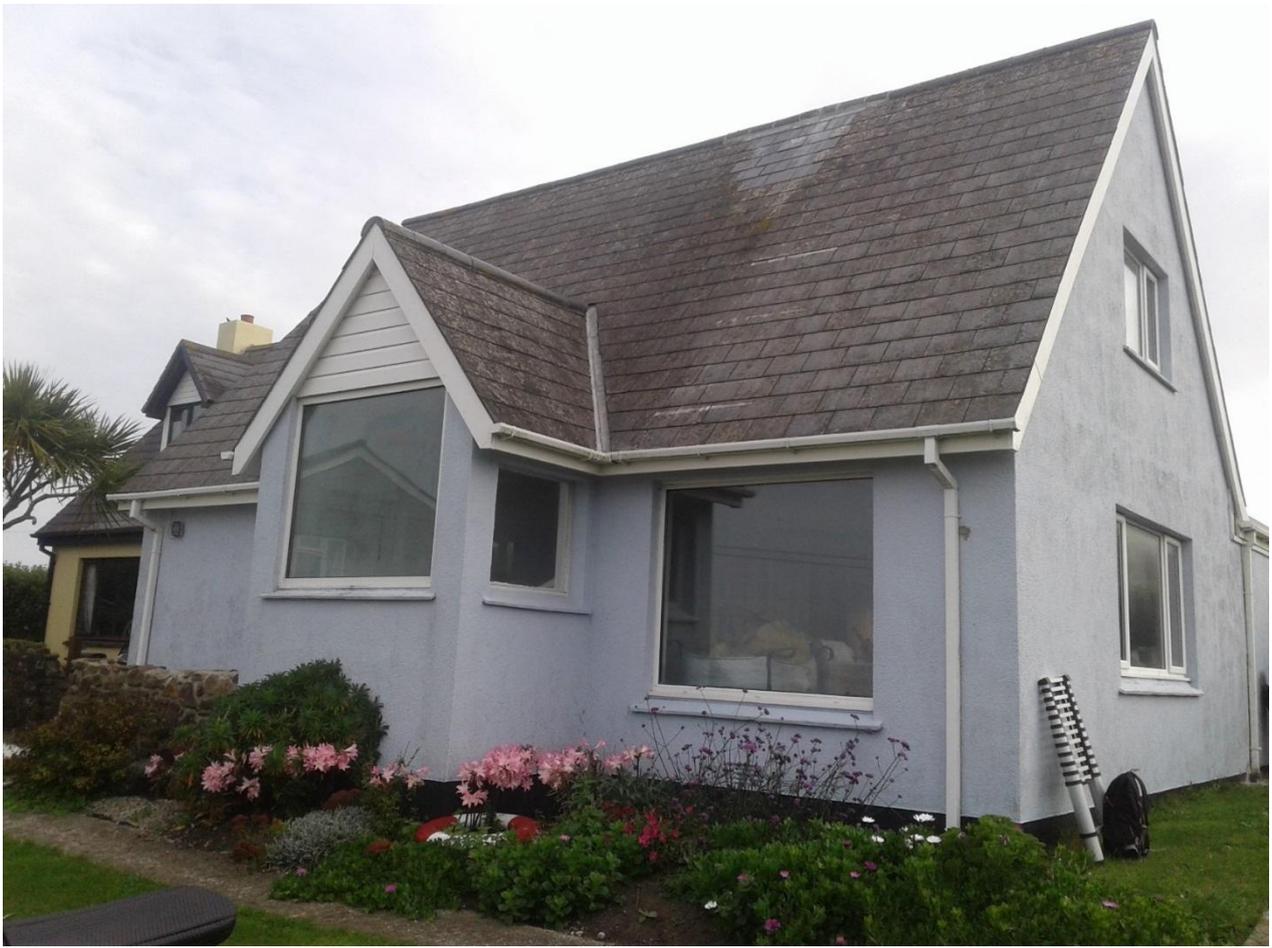
*Photo 1. West elevation of 2 Matthews Field*

The house is located off Church Road, St Mary's (National Grid Reference SV9078810464, Figure 1.). The application site comprises of a chalet style semi-detached house with a flat roofed extension to the rear (Photo 2), with a pitched roofed porch to the front (Photo 1). The total area of the application site is approximately 580m<sup>2</sup> (red area, Figure 1).

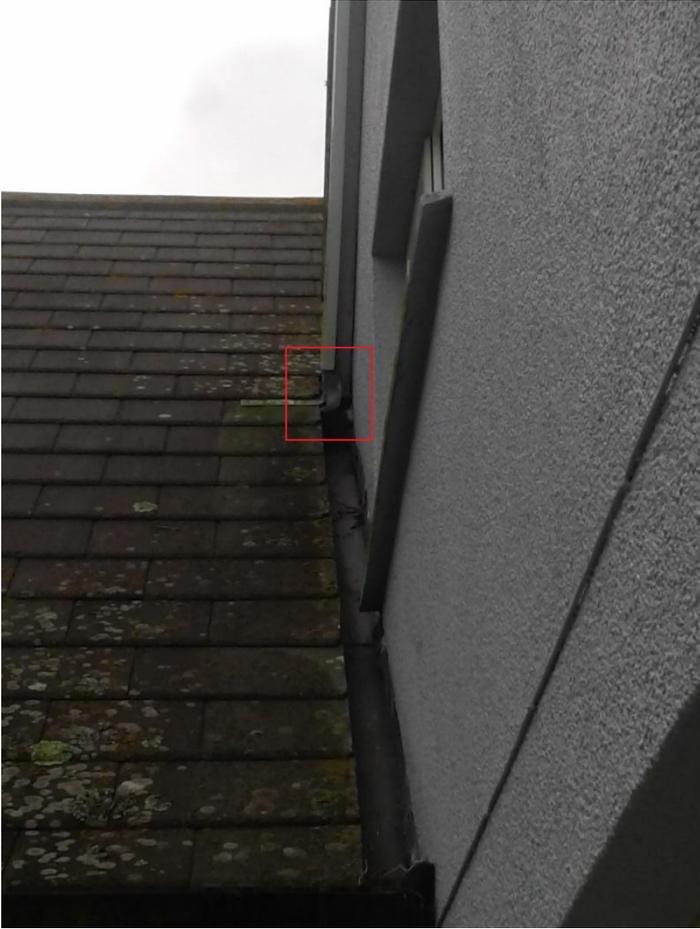
*Photo 1. Gap in flashing and under soffit*

- At the northern gable end where the roof terminates and ties into the neighbouring property there is a gap under the flashing and soffit (see photo 1).

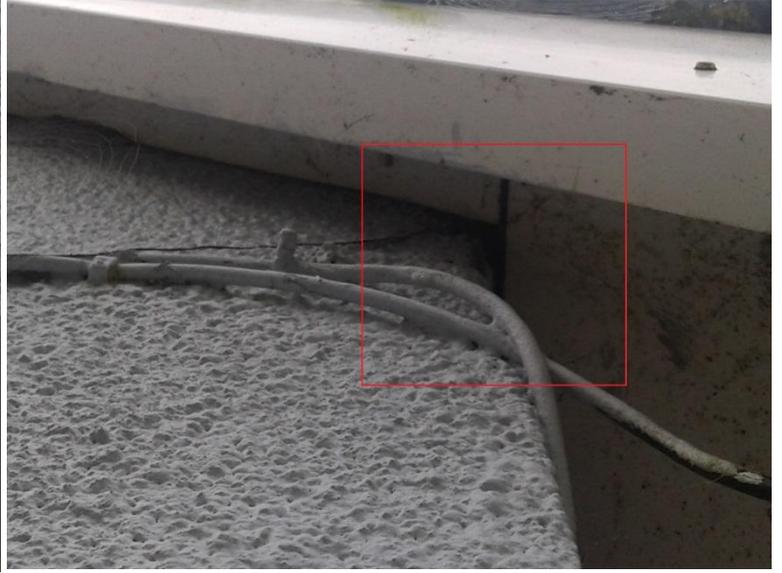
*Photo 2. Gap at North western corner*

- At the north-western corner there is a gap behind the soffit junction (see photo 2).
- Where the cable for the artificial light, at the north-western corner, runs behind the soffit, there is a gap (see photo 3).

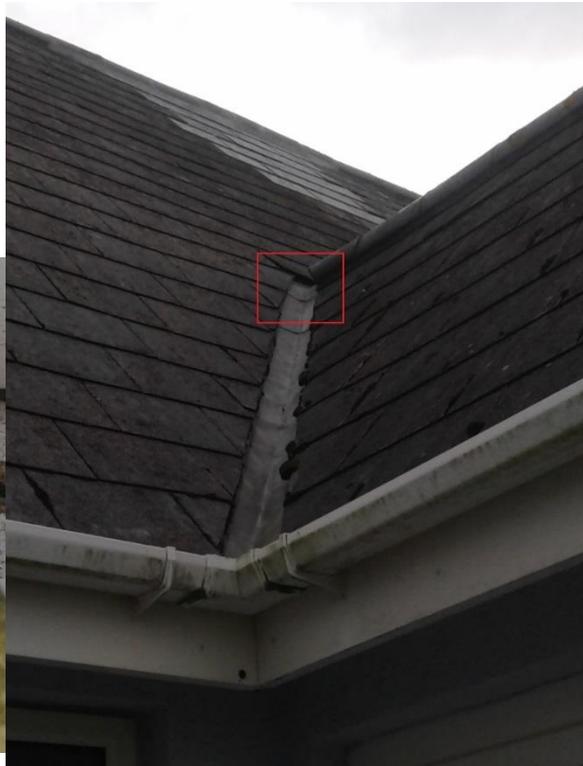
*Photo 4a. Gaps under tiles overhanging valley.*

- There is a gap underneath the roof tiles overhanging the valley between the porch and the main roof (see photo 4a & 4b). Also gap under final ridge tile of southern aspect of porch (see photo 4b).

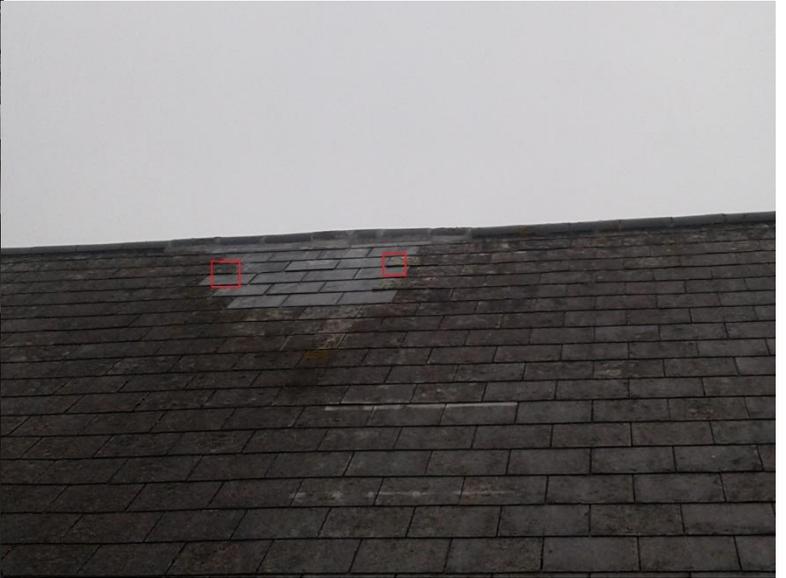
Photo 5. Raised roof tiles on main roof (western aspect)

- There are gaps under two lifted tiles around an area of new tiles on the main roof, where the new tiles tie into the old (see photo 5).
- There is a gap under the terminal ridge tile, where the mortar is missing, on the southern gable end (see photo 6.)

- The presence of small mammal droppings which are similar in size and shape to a pipistrelle species of bat.
- Several of the potential roost features that were unable to be inspected would be directly affected by the works, these being; The gaps under two lifted tiles, around an area of new tiles on main roof, where the new tiles tie into the old (see photo 5) would be compromised by the installation of the roof-lights; the gap under the terminal ridge tile, where the mortar is missing, on the southern gable end (see photo 6) would be compromised by the proposed roof works and eaves extension and the gap under the flashing where the neighbours roof ties into the eastern aspect of the main roof (see photo 9) would also be compromised by the elevation of the roof on the eastern aspect.

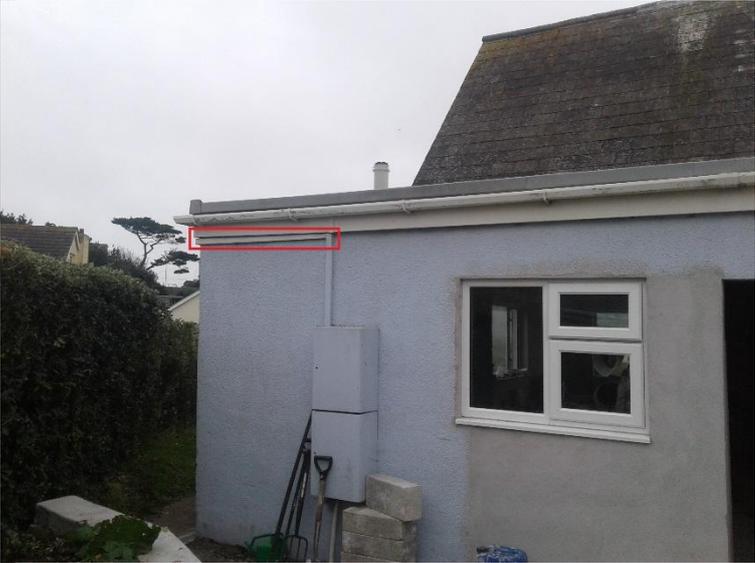
Photo 7. Gaps behind fascias

- There are gaps behind the fascias on the eastern aspect of the flat roofed extension towards the south eastern corner (see photo 7).
- A void has been created where the battens do not meet at the north east corner (see photo 8) of the flat roofed extension.

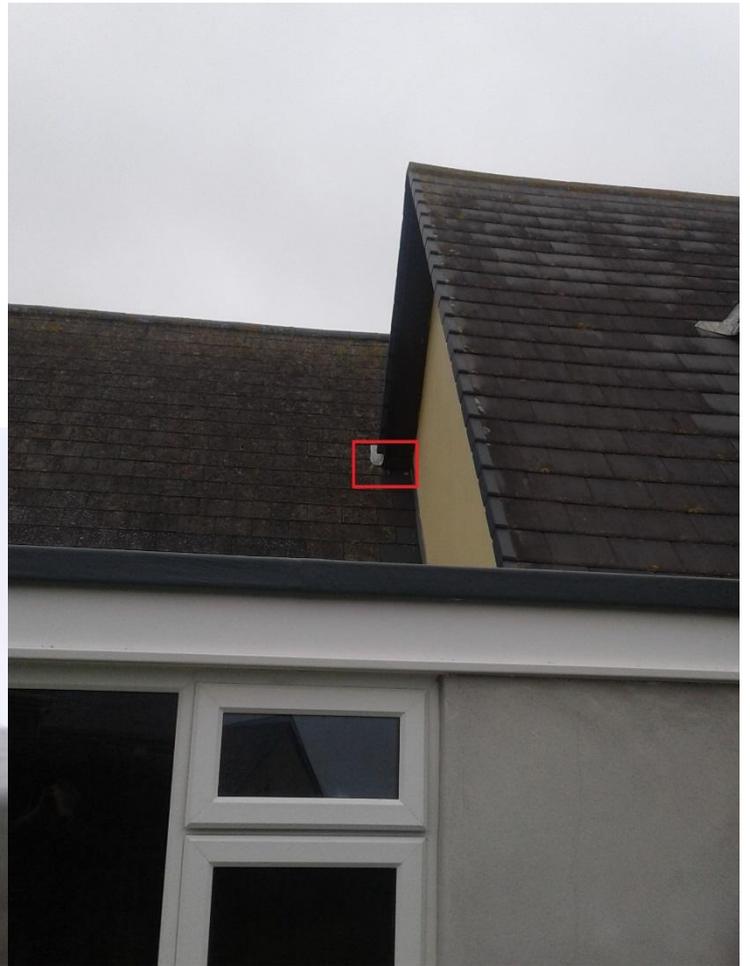
Photo 9. Gap in flashing

- There is a gap under the flashing where the neighbours roof ties into eastern aspect of main roof (see photo 9).

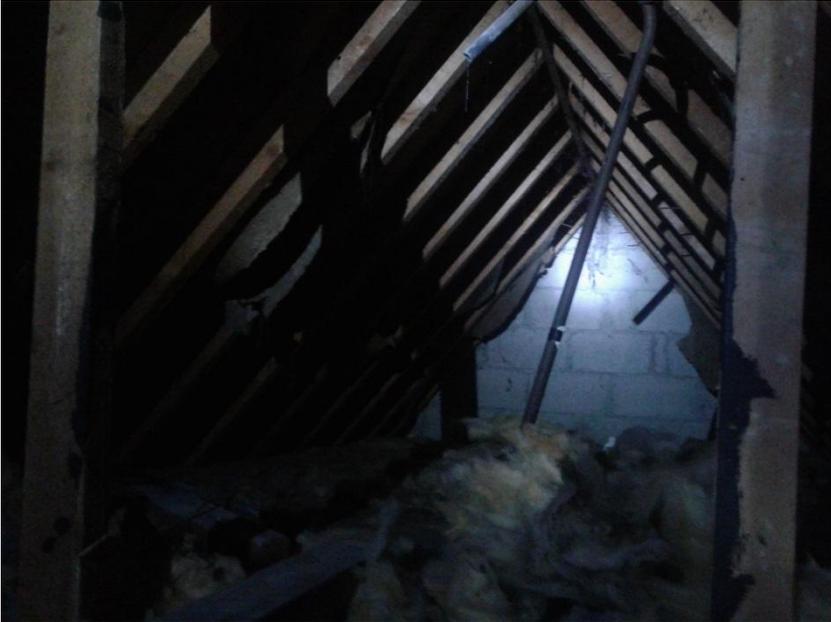
Photo 10. Loft space showing wooden rafters.

2 Matthews Field has one main loft space encompassing the pitched roof space only. The roof is a timber closed coupled roof (see photo 10). The roof is still lined with the original fibre/felt which has many tears in it. The loft was sparsely boarded, but access was gained across the beams. The loft had insulation between the beams but not the rafters and there were a lot of thick cobwebs with accumulated dust. The loft was extensively searched and mammal droppings were found on a beam and board near the loft hatch entrance (see photo 11a & 11b).

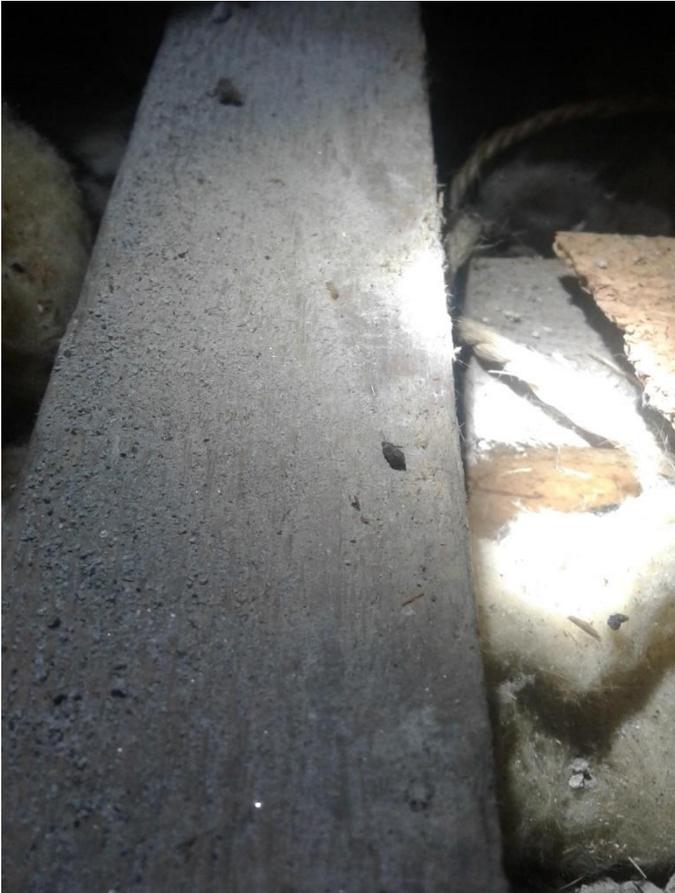
Photo 11a. Mammal dropping.

- The loft was extensively searched where droppings were found on a beam and on a board. Analysis revealed that the shape and size of the droppings were similar to a pipistrelle species of bat, but could not be conclusively proved.

Therefore, to confirm whether or not the house hosts roosting bats, further survey visits (see section 5.3 below) would need to be undertaken during the bat active season.
