Tregarthens Hotel
St Mary's, Isles of Scilly

Ecological Appraisal
and Bat Surveys

Ref:
BE255

Date:
21st July 2015

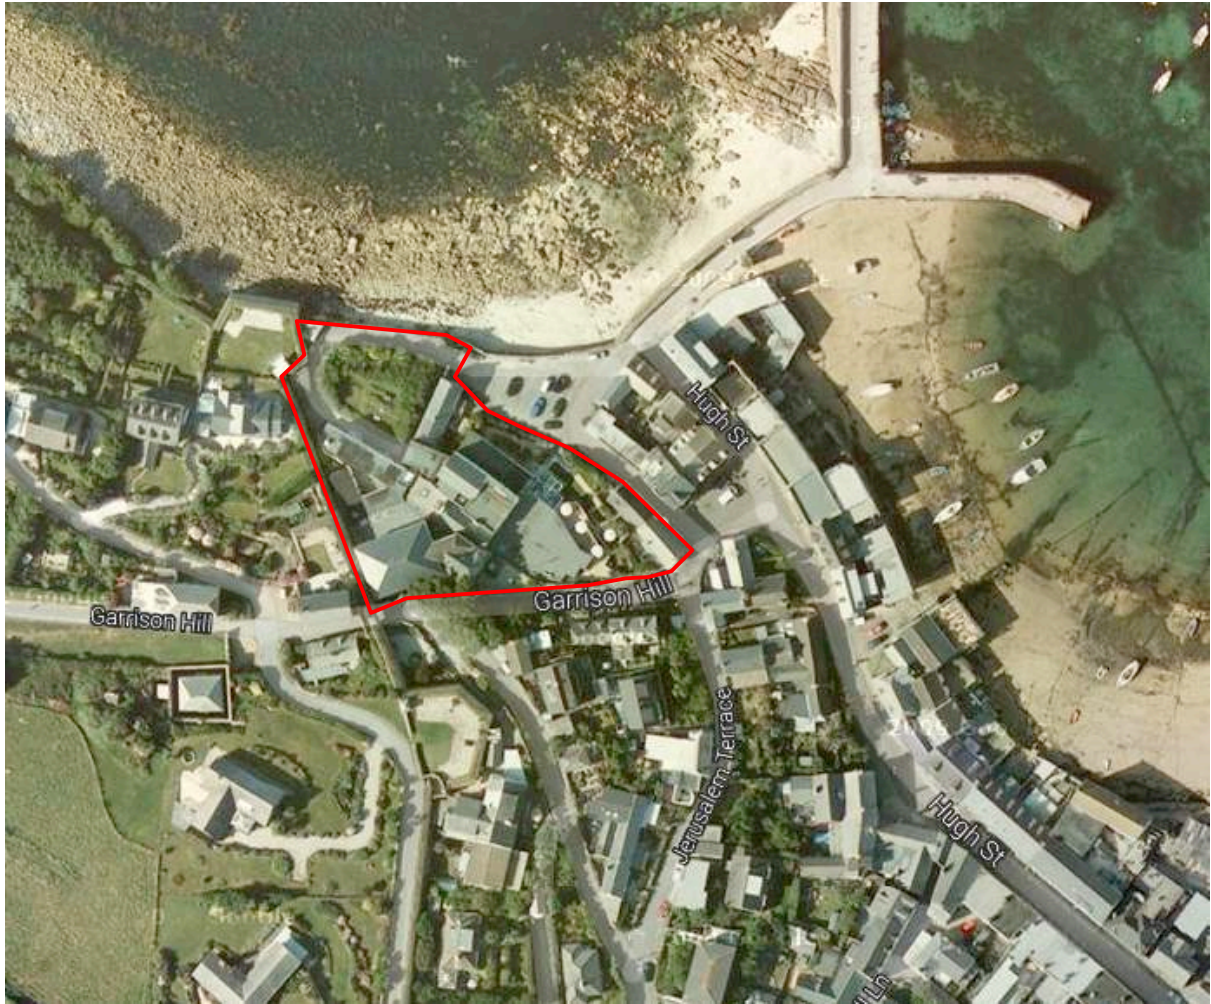
Figure 1. Aerial photograph (from Google maps 2015) showing survey area (location of the site is shown on Map 1 at the end of this report).

The site does not contain any semi-natural habitats. Most of the site is built environment of buildings with concrete/tarmac between. Green landscape is limited to small areas of lawn and garden borders (see Figure 1).

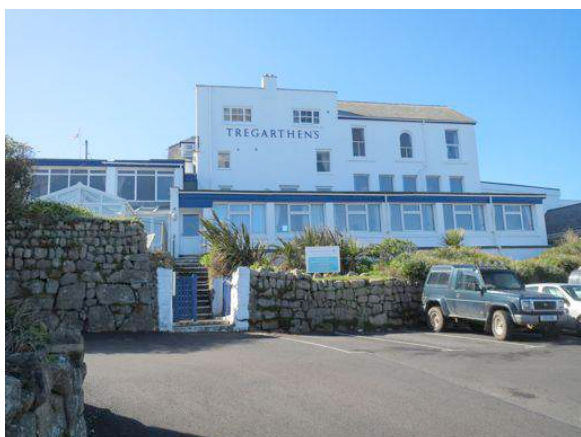
Photograph 1. Front (north) elevation of Tregarthens Hotel

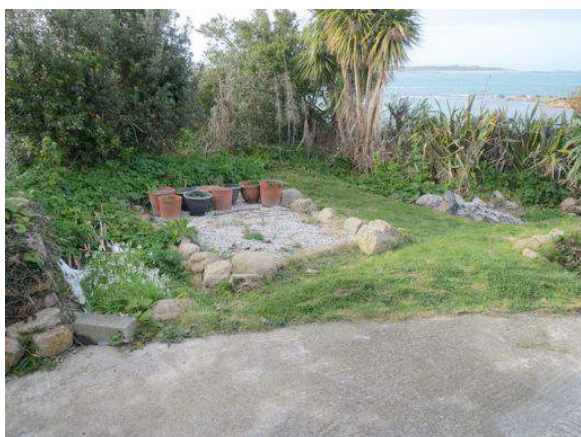
Photograph 2. Kitchen garden

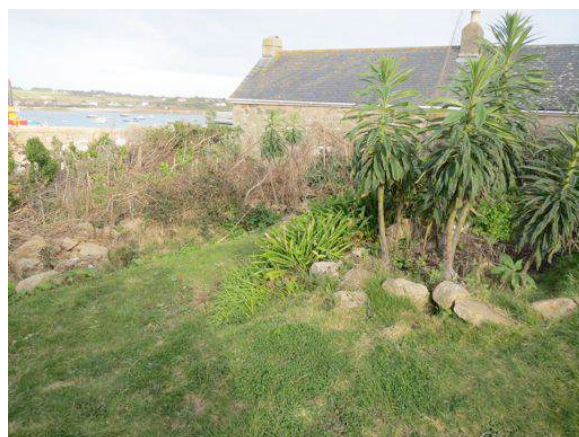
The garden areas associated with the hotel are very small in extent. There are areas of lawn with perennial ryegrass, common bent grass, cock's-foot, daisy, white clover, common cat's-ear and ribwort plantain. The borders and flowerbeds support kitchen herbs and garden plants that are mostly non-native and common in the residential gardens of the island, including *Phormia* sp., *Agapanthus*, *Echium* sp. and acaves. Native species include alexander's and butterbur. No plant species of biodiversity value were observed within the gardens. The garden areas of the hotel are not considered to have notable biodiversity value.

Photograph 3. Lawn and gardens

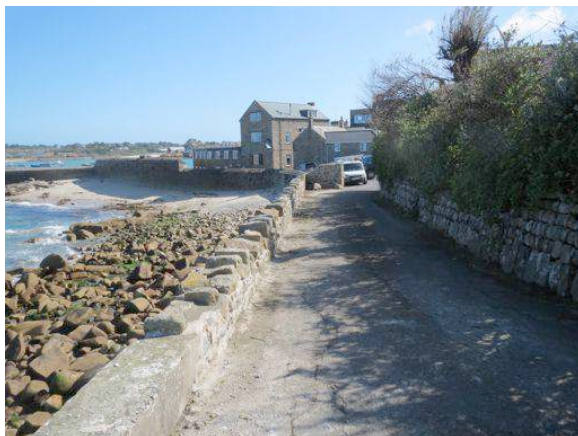
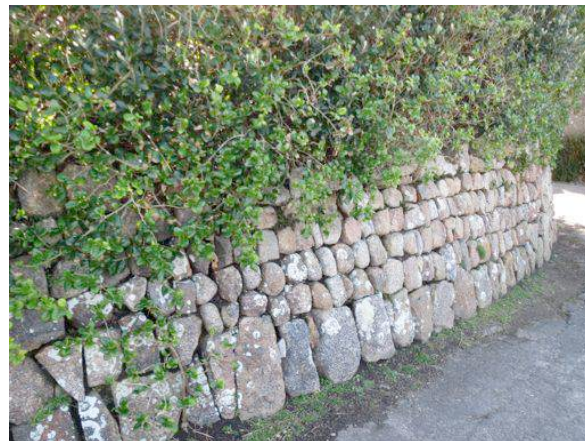
The western boundary is marked by a tall granite Garrison Wall, there is a stone wall along the road known as Garrison Hill and a stone retaining wall is present between the access road and the seashore on the northern boundary (Photographs 4 & 5). The joints between these stones have tight cement mortar and there is little plant cover. *Aeonium* sp. were observed in the Garrison wall. There is also a stonewall with an earth core and without cement mortar between the northern access road and the kitchen garden (shown on Photograph 5). Sea spleenwort was noted here.

Due to a lack of earth and/or little/sparse vegetation cover the walls cannot be described as hedgerows and therefore would not be protected by the Hedgerow Regulations 1997 nor do they qualify as Biodiversity Action Plan (BAP) priority habitat. The Isles of Scilly Biodiversity Audit 2008 (Lewis *et al.*, 2008) states that there are virtually no true native hedgerows in the Isles of Scilly. Lewis *et al.* (2008) states that 'hedges' come in three main types, dry-stone walling (single leaved), 'Cornish hedges' (double leaved) and granite masonry (such as the Garrison walls). All three types are present within/along the boundaries of Tregarthens Hotel. Such boundary features can play a role in enabling species to move through the landscape by connecting semi-natural habitats. However those within the site are present within an urban setting and do not have connections with semi-natural habitat. The wall with the earth core shown on Photograph 5 may provide a refuge for invertebrates and small mammals. The walls may also support notable lichen populations. They are likely to be of value at the level of the site.

Photographs 4 & 5. Stone walls either side of access road on northern boundary

The lesser white-toothed shrew (otherwise known as the 'Scilly shrew') is absent from mainland Britain but is found on the Isles of Scilly. It is mostly associated with the seashore and feeds on a variety of invertebrates including small crustaceans that live amongst rocks on the seashore. The desk study identified 29 records for lesser white-toothed shrew on St Mary's. One of the records was from Garrison Hill, which borders the site. The Scilly shrew is protected from being killed or taken by certain methods under Schedule 6 of the Wildlife and Countryside Act and is a Cornwall Red Data book species. They nest under logs, between boulders or in abandoned mouse burrows. It is therefore possible that the Scilly shrew is present in the stonewall with an earth core without cement mortar between the northern access road and the kitchen garden (shown on Photograph 5).

- The stones from the wall will be carefully dismantled by hand and stored in a fashion that replicates their existing orientation so that any notable lichens present will remain undisturbed.
- The earth core from this stonewall will be carefully raked out by hand, stored and re-used in the replacement wall.
- The stones will be re-used in the scheme. Cement mortar will not be used to avoid contamination of the potential lichen flora. Care will be taken to ensure original orientation of the stones is restored.

Garden clearance and potential clearance of the stone wall will the earth core has the potential to disturb hibernating hedgehogs or cause injury to hedgehogs and lesser white-toothed shrew (Scilly shrew). To avoid these impacts once invasive weeds have been removed or treated the remaining garden foilage will be cleared to ground level by hand at least three days prior to earth movements. The cut material will be removed from the construction zone. The areas are small so this is achievable. This will degrade the habitat and allow hedgehog and lesser white-toothed shrew to move away from the site on their own. The stone wall will be dismantled by hand as detailed in section 5.3 to avoid impacts to shrews. If hedgehog and shrews do not move to safety on their own accord they may be transferred to a neighbouring garden.
