BAT PRESENCE/ABSENCE SURVEYS OF:

TRELAWNEY
CHURCHTOWN
ST MARTIN'S
ISLES OF SCILLY
TR21 0JQ

Our reference: BS4-2018PAS

Report date: 13th September 2018

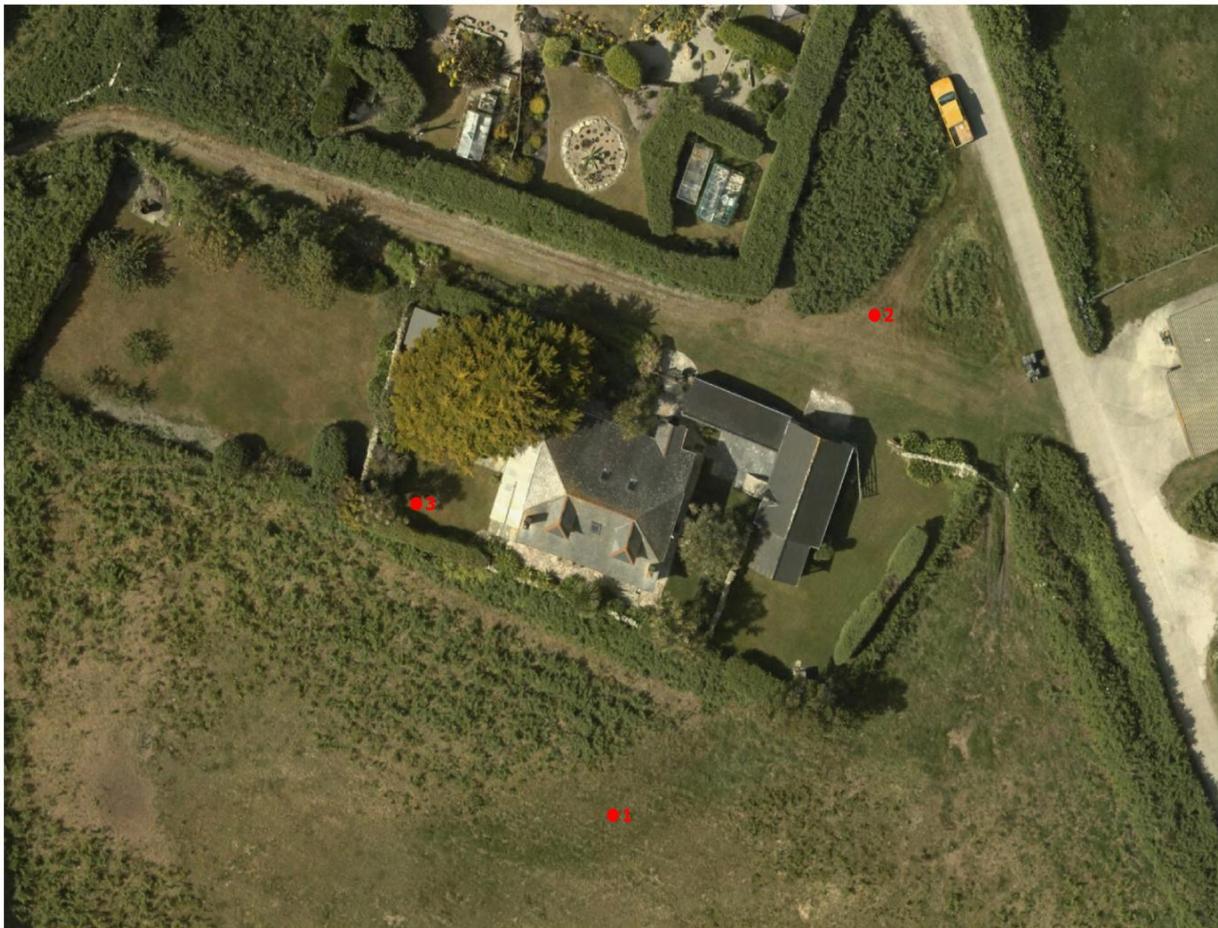
Figure 1. Location of surveyors during the dusk emergence and dawn re-entry survey

- Starting the survey 15 minutes before sunset and continuing for approximately 1.5-2hours after¹;
- Identification of bat species primarily through the use of ultrasound characteristics. To aid identification flight and habitat characteristics were also noted (where possible) in order to determine the species;
- Identifying exit locations of bats by standing at different vantage points around the building that offered visual contact with any potential exit point previously recorded. Surveyors stood no more than 50m apart, or away from the building (see Fig 1 for location of surveyors).

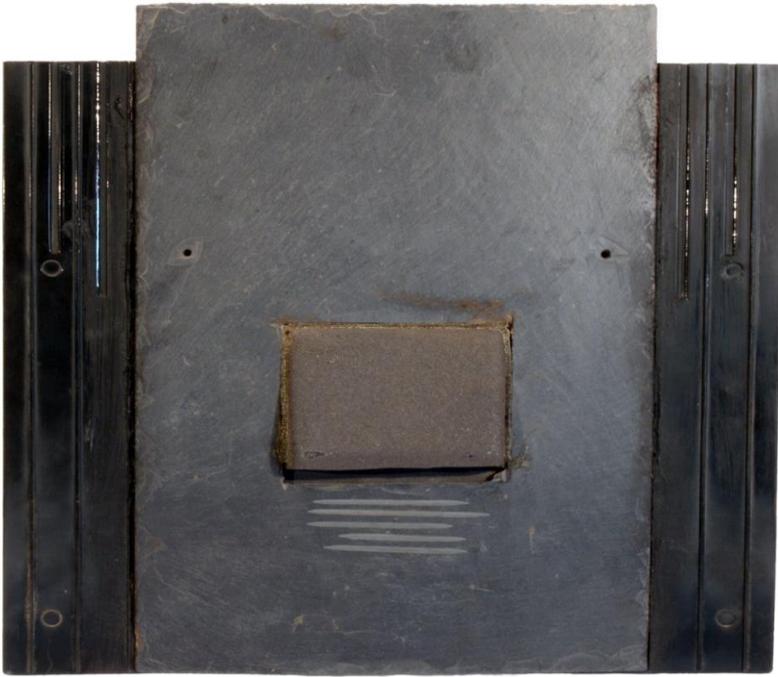
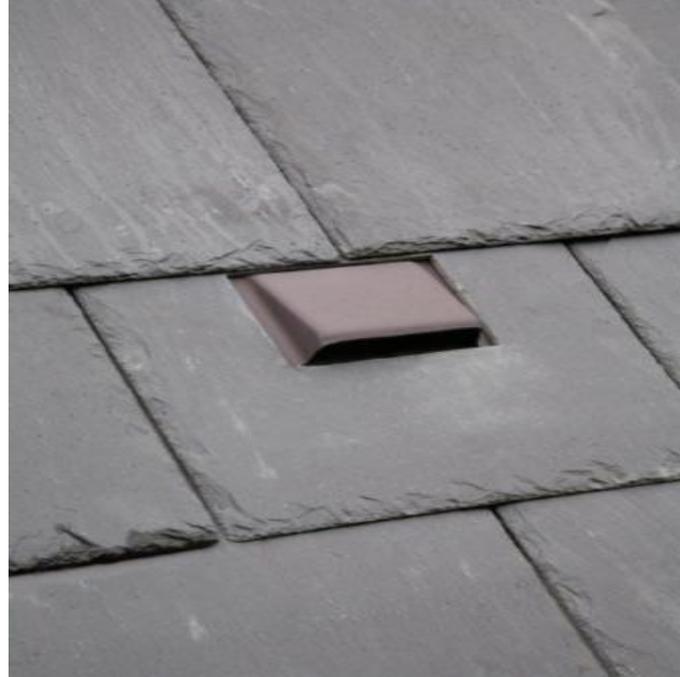
Figures 2 and 2a. Example of an in-line roof tile (tailored to your roof material style and its placement within the roof)

- i. All new roofing felt laid to be traditional Type 2 bitumen felt, as modern breathable membranes have been shown to kill bats¹⁰.
- ii. Roosting provision in the new building to be provided as long term replacement for the loss of roosts for crevice dwelling species. This should be in the form of 2 roof line access tiles, one for each aspect (north and south) (see Figures 2 and 2a for examples and Appendix D for supplier details).

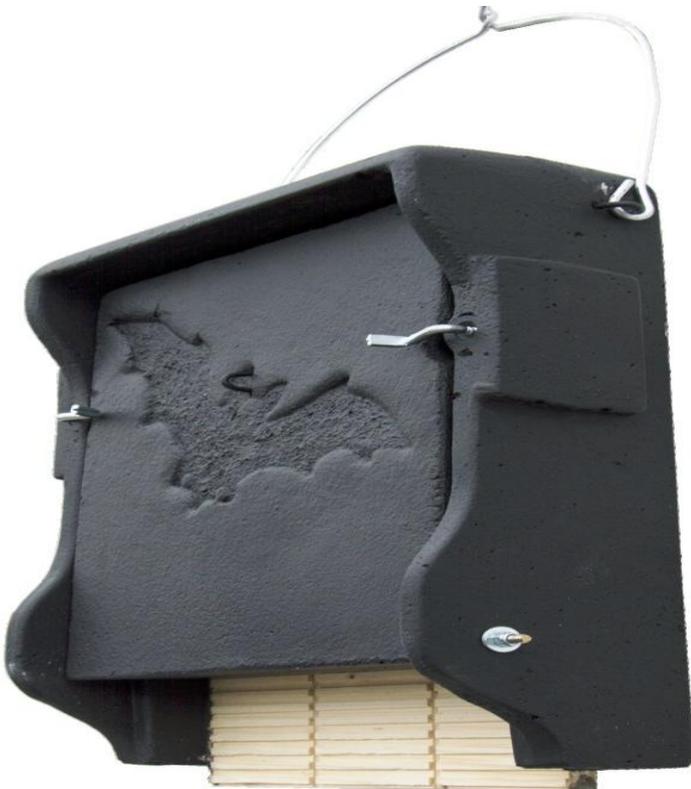
Figure 4. free-standing bat box example

- iv. Alternative to the roof in-line roof tiles the erection of 3 free-standing bat boxes developed for crevice-dwelling species (see figure 4 for example and Appendix D for supplier details). Erect these on three aspects (north, south and west) of the Monterey Cypress to the west of the house at a height of 4 -6m

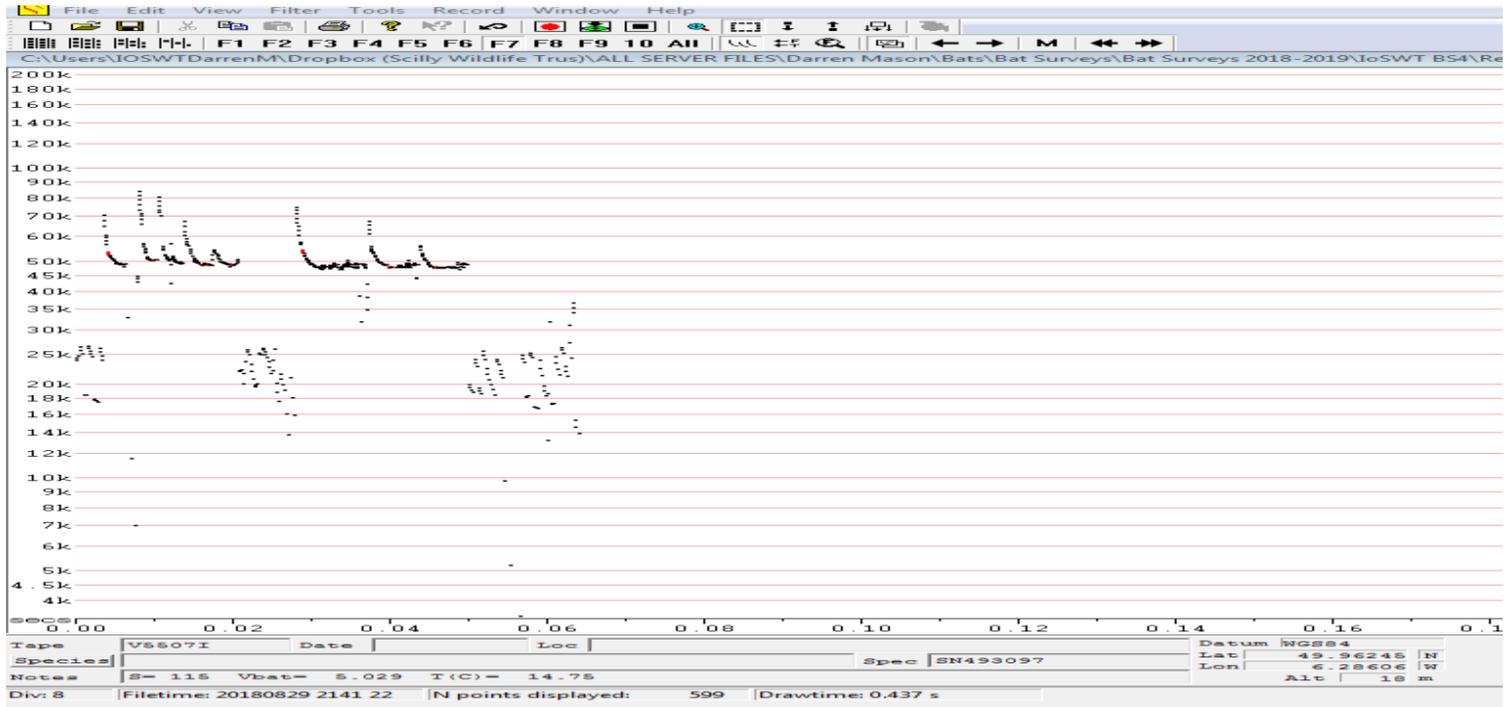
Sample sonogram from 21:41 with social calls

Species recorded active onsite during the dusk emergence survey included Common pipistrelle (*Pipistrellus pipistrellus*) (see Appendix B for sample sonogram examples). Activity was deemed low with most activity related to commuting from east to west, recorded at the location of surveyor 1 (see Appendix A for recorded bat contacts). The first bat contact came at 25 minutes after sunset (surveyor 1) at a lux light level of 2, from what appeared to be the east-facing roof of the garage. It has been shown that *pipistrellus* sp. typically emerge 30 minutes after sunset to avoid predation^{5,6}. The proximity of the first contact to around this time after sunset may indicate that a roost(s) of this species very nearby. Both commuting and foraging activity were recorded (as seen from sonograms) intermittently throughout the survey period. In total 11 bat contacts were recorded, the last at 21:47. No bats were seen to emerge from the proposed development.

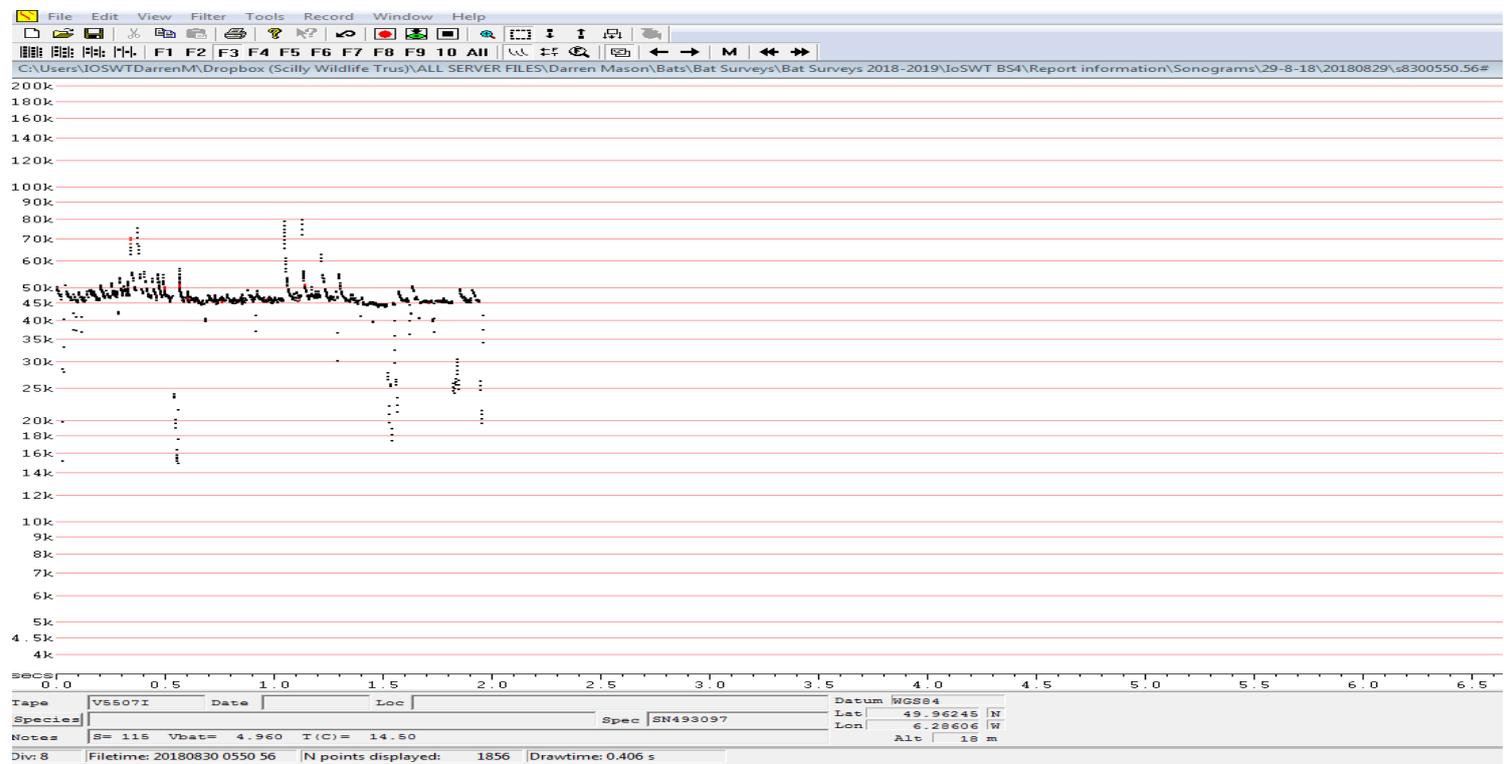
Sample sonogram from 05:50
