PRELIMINARY BAT ROOST ASSESSMENT OF:

JEDI
McFarlands Down
St Mary's
Isles of Scilly
TR21 0NS

Our reference: BS6-2018

Report date: 24th August 2018

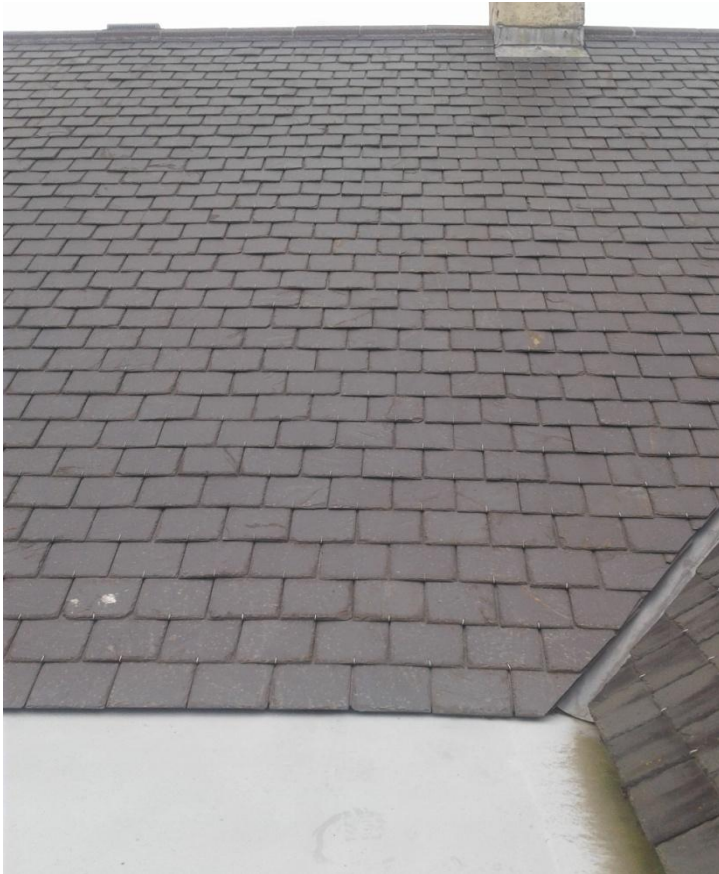
For the installation of one rooflight to the west facing roof slope to provide light source for the upstairs corridor and means of fire escape (see photo 1 for location).

Photo. 1 West facing roof and site of the rooflight window.

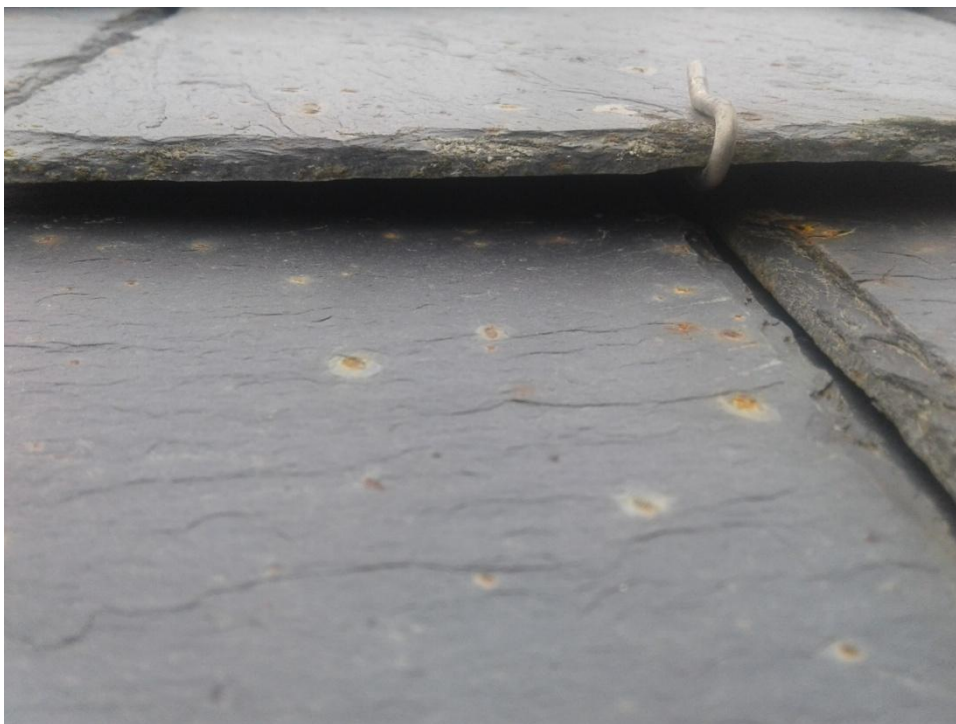
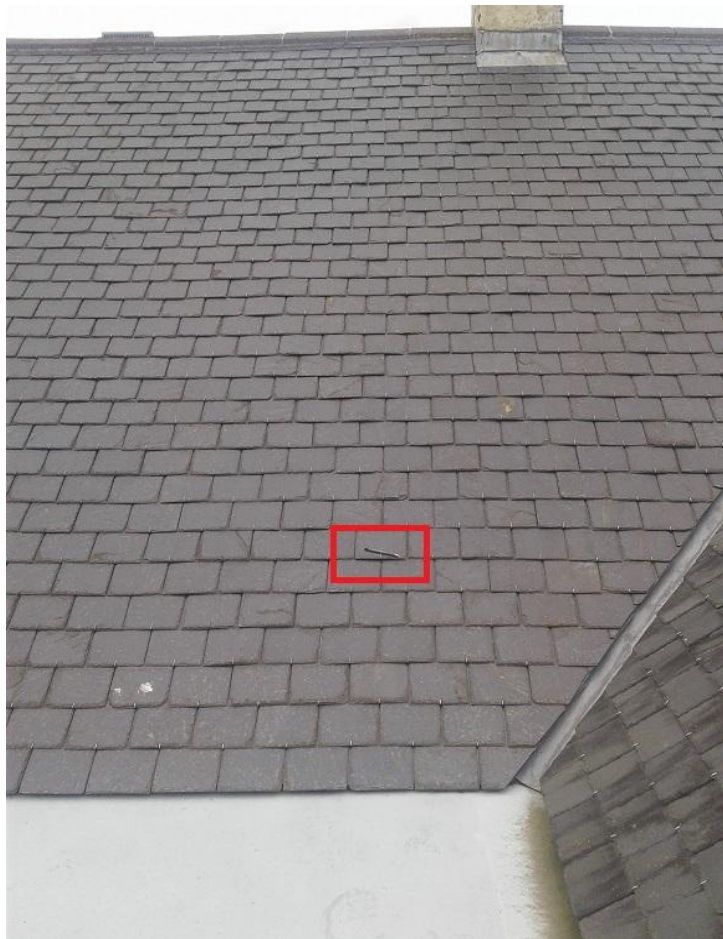
- A raised roof tile within the proposed development site (see photo 2 & 2b).
- A vent within the tiled roof (see photo 3).

Photo 2

Photo. 2b

The value of the house for bats is considered to be 'low' (see Table 1). This assessment is based on the occurrence of the following features within or immediately adjacent to the site:

The Bat Conservation Trust's Bat Survey Guidelines¹ (referred to by Natural England in their advice to planning officers) state that buildings with 'low' bat suitability require one dusk emergence or dawn re-entry survey between May and September. In this case, as evidence of bats has not been recorded it is recommended to carry-out one dusk emergence survey.
