# PRELIMINARY ECOLOGICAL APPRAISAL & PRIMARY BAT ROOST ASSESSMENT OF:

LONGSTONE LODGE  
LONGSTONE  
ST MARY'S  
ISLES OF SCILLY  
TR21 0NW

Report Date: 15<sup>th</sup> July 2019

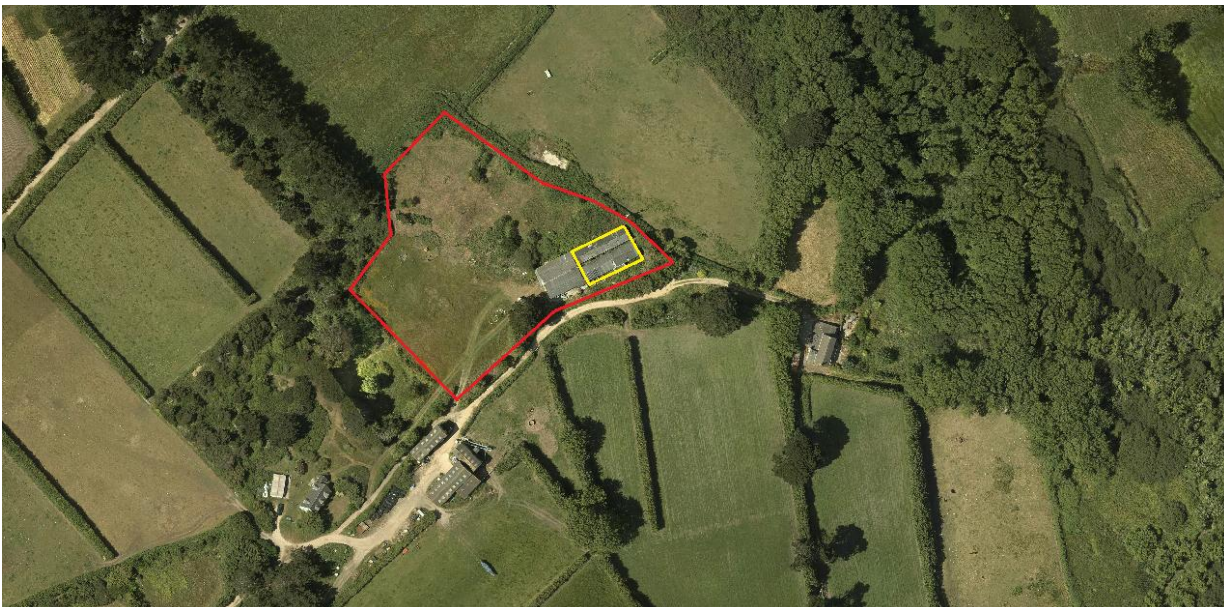
Figure 1. Location of Longstone Lodge.

The Lodge is located in Longstone, St Mary's (National Grid Reference SV91881 11330, Figure 1.). The sites total footprint is approximately 7599 m<sup>2</sup> (red area, see Figure 1). The location of the proposed development within the site is approximately 354 m<sup>2</sup> (yellow area, see Figure 1).

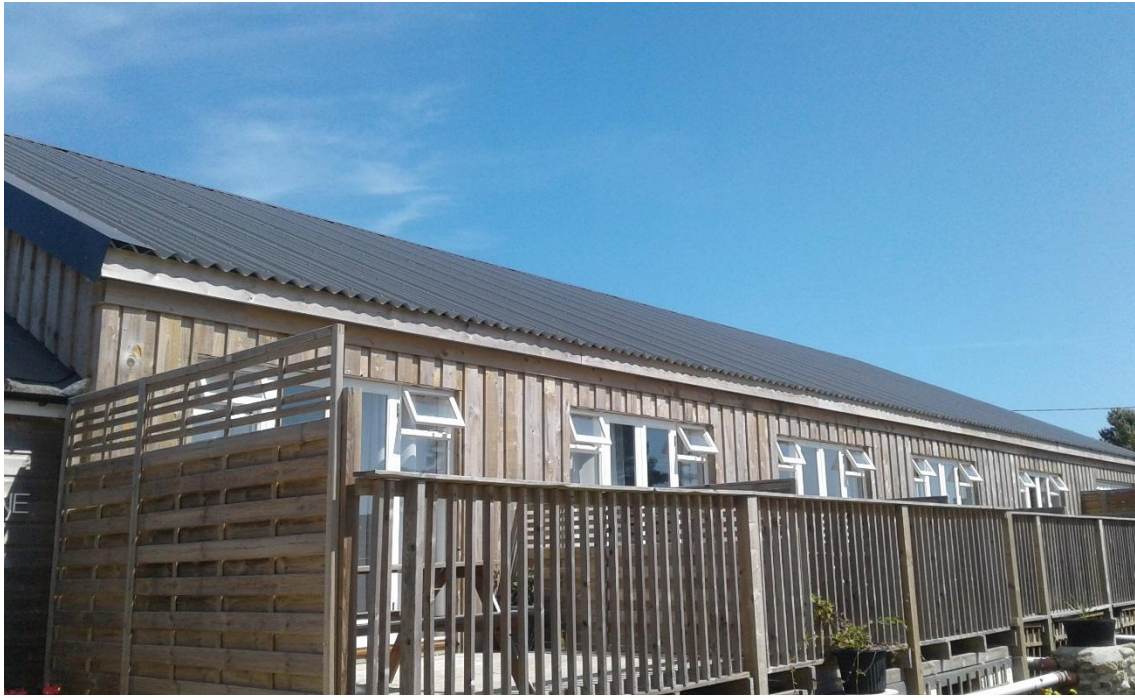
*Photo 1. Longstone Lodge (south aspect)*

Longstone Lodge is a single storey timber frame building with a simple gable roof with a pitch of 20°. The building is finished with hit and miss rough sawn timber cladding. The roof is finished with corrugated metal sheets, ridge capping and bargeboard flashing all finished with a coat of polyester paint (see photos 1 & 2). The downpipes and guttering are all plastic and the windows and doors are UPVc. On the eastern aspect there is a timber porch with a mono-pitched roof and UPVc windows and door. The building has a number of features potentially suitable for roosting bats, including:

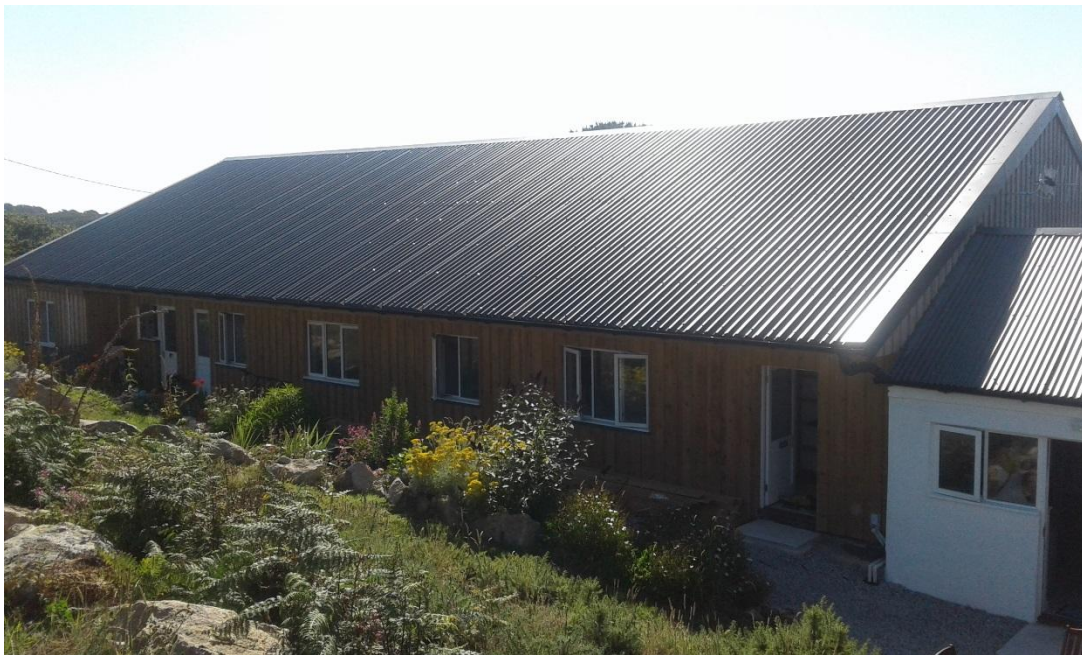
*Photo 2. Longstone Lodge (north aspect).*

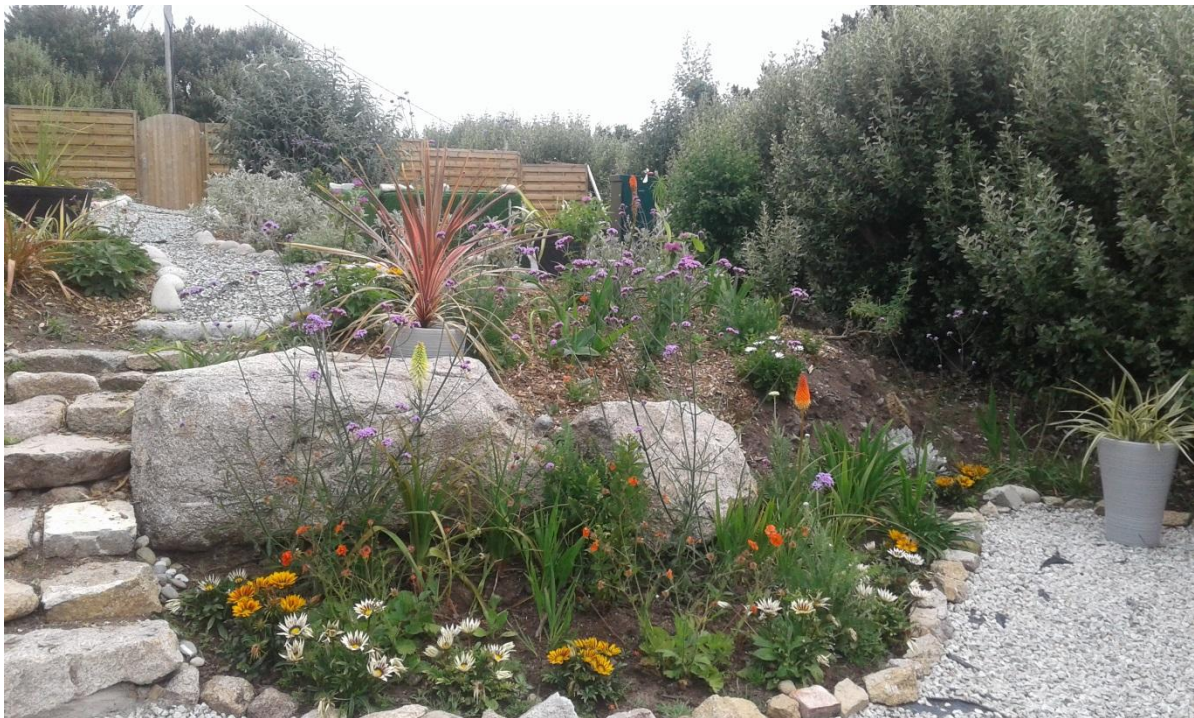
There is a communal garden in front of the southern aspect that runs the full length of the Lodge, with a clipped hedge, also running the full length of the garden, providing shelter from the track on the other side (see photo 3). The hedge comprises species including Escallonia (*Escallonia macrantha*), Olearia spp, Hebe spp and Tree Bedstraw (*Caprosma repens*). There is a very wide variety of flowering plants within the flower beds including, Buddleia (*Buddleja spp*), Lupin (*Lupinus spp*), Poppy spp, Cat's ear (*Hypochaeris radicata*), Red-hot-poker (*Kniphofia uvaria*), Viburnum spp, Argentinian vervain (*Verbena bonariensis*), Tree echium (*Echium pininana*), Red Valerian (*Centranthus ruber*) and a multitude of species of the Asteracea (Daisy) family.

Photo 3. Communal garden on the southern side.

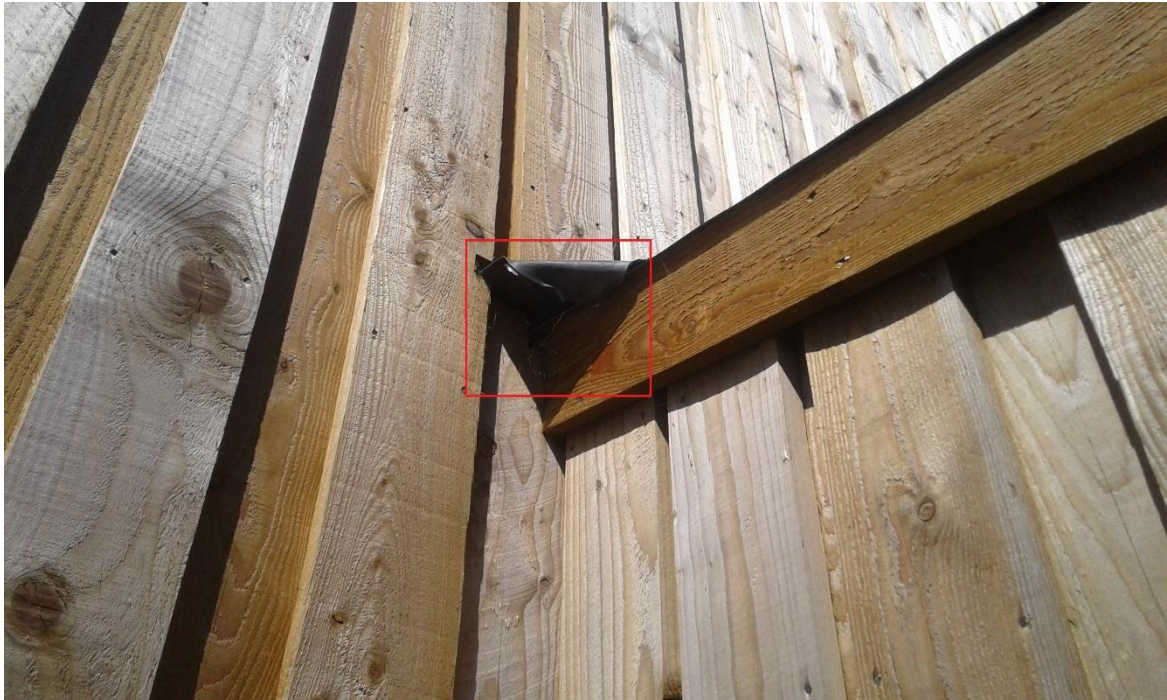
- At the north-west corner the hit and miss timber has left gaps and access into the roof space from below (see photo 4).
- There are gaps under the lead flashing where the porch roof ties into the main building on the east elevation, on both sides of the porch north and south (see photos 5 & 6).
- A small gap at the south east corner at the top of the timber towards the roof (see photo 7).
- At the south west corner there's a gap into the roof space where the barge flashing fits over the roofing sheets (see photo 8).
- There are voids created by the hit and miss timber on the western aspect that are accessible from below (see photo 9).

*Photo 6. Porch on east aspect aspect – gap under lead flashing.*

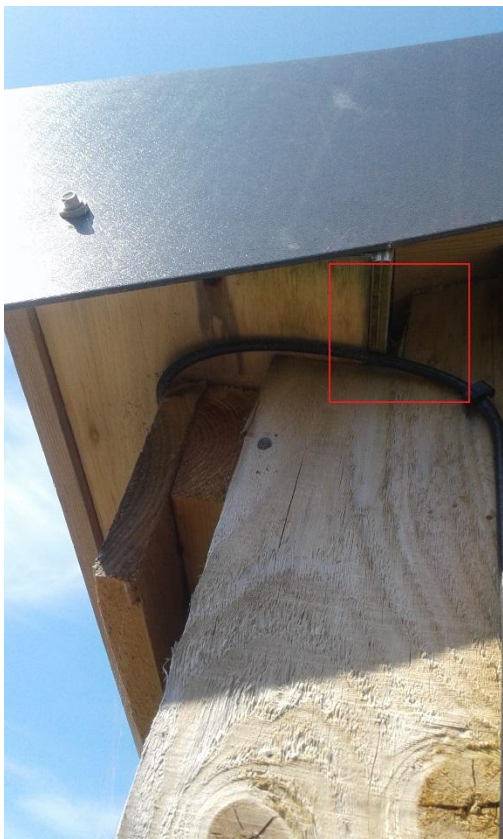
*Photo 7. South east corner – gap at the top of timber.*

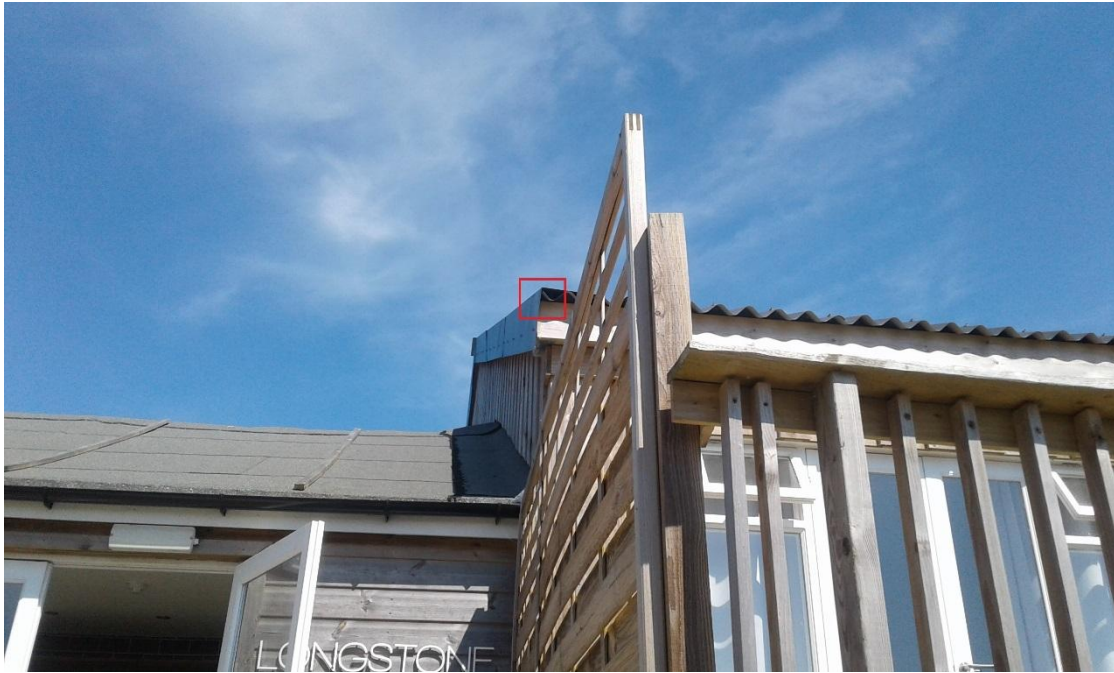
*Photo 8. South west corner – void created where the barge flashing fits over the roofing sheet.*

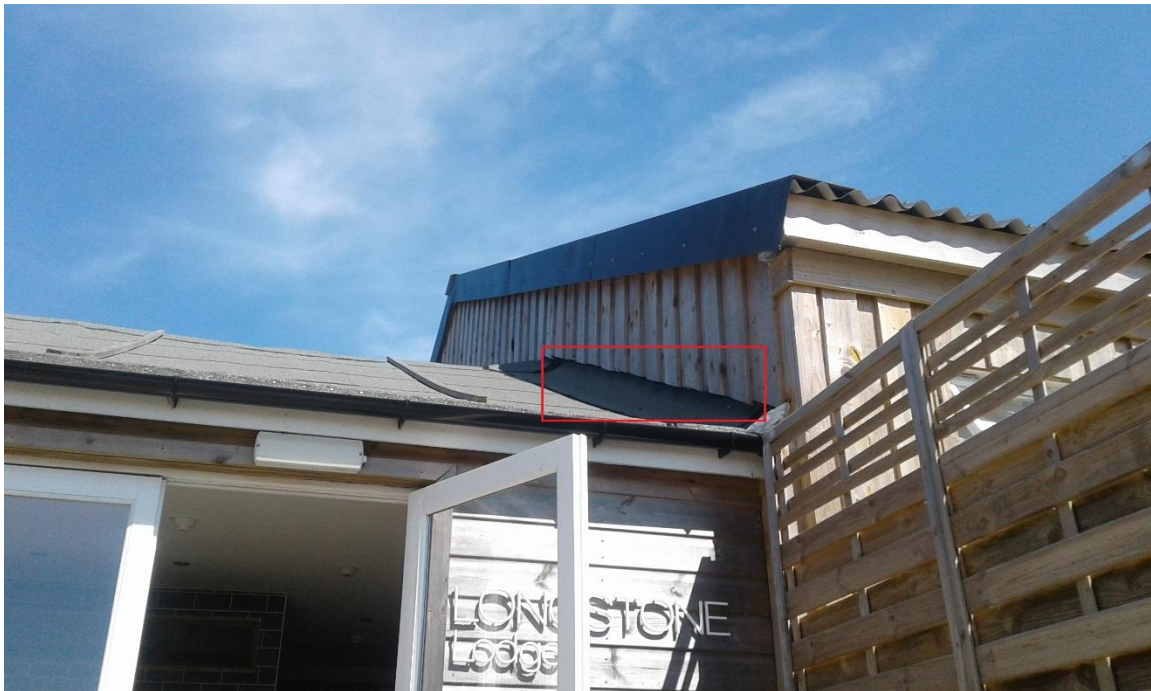
*Photo 9. The hit and miss timber arrangement creates voids with access below.*

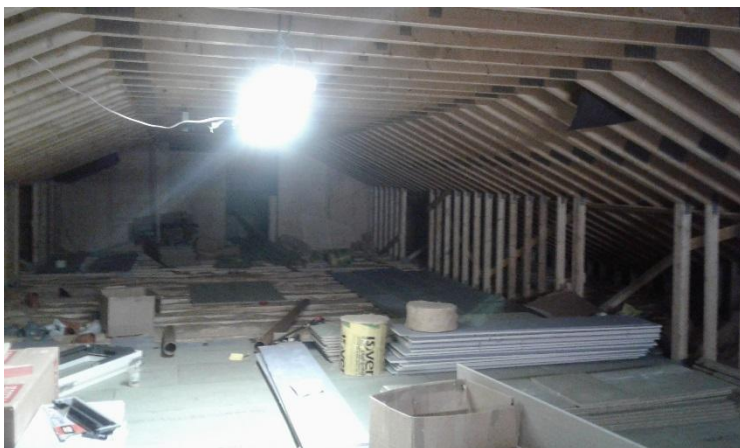
*Photo 10. The loft space.*

The loft space of the Lodge runs the entire length of the building (see photo 10). It is almost one entire open space, apart from at the eastern end where there's a partially boarded-off section. The timber roof is a variation of a Queen post roof, with collar beams and queen posts which the purlins sit behind. The roof is lined with a breathable roof membrane which is in good condition. The loft

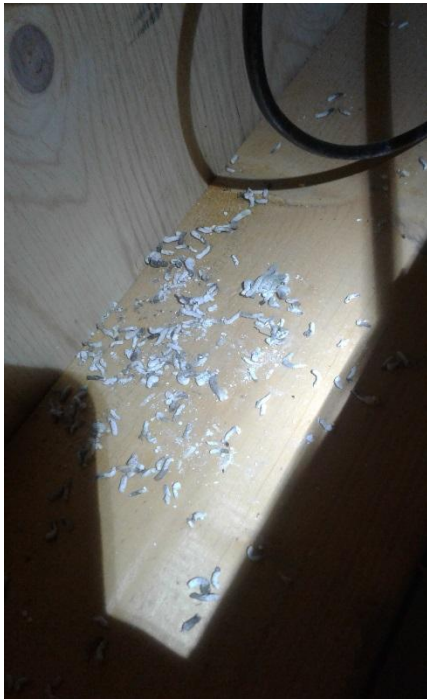
is part boarded and works seem to be ongoing to board the entire space. The loft is insulated between the tie beams. Inspection of the top of the boxes, the floor, insulation and materials in the loft space revealed no evidence of bat droppings. Inspection of the loft did reveal evidence of bird droppings (see photo 11). There weren't many cobwebs, this may well be due to the fact that it is presently being utilised as a working area.

*Photo 11. Bird dropping in loft.*

During the survey bird droppings were found internally, therefore it is likely that the site hosts birds (see photo 11). To check that the site is not being used by breeding birds a thorough search of the structure should be made prior to the start of any demolition works taking place during the

breeding season (March 1<sup>st</sup> to August 31<sup>st</sup>). If breeding birds are found works that would disturb the nest must be postponed until all young have fledged the nest and it is no longer in use.

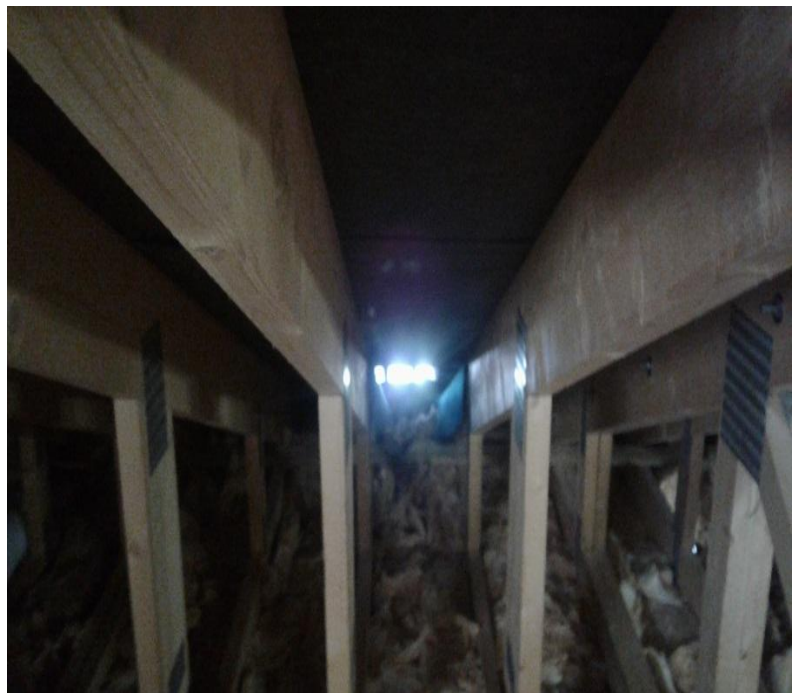
With the lights off there was natural light entering the loft space from under the eaves from both the north and the south aspects (see photo 12). This could permit the access of bats and birds into the loft space. The entire loft space was searched and no signs of bats were found including no grease and scratch marks or droppings.

*Photo 12. Natural light entering loft space.*
