PERMISSION FOR DEVELOPMENT

P/19/086/FUL

Bank Cottage South'ard Bryher Isles of Scilly TR23 0PR

Alteration and extension of the main house to provide two bedroom house. Renovation and extension of the Cottage to improve ancillary accommodation.

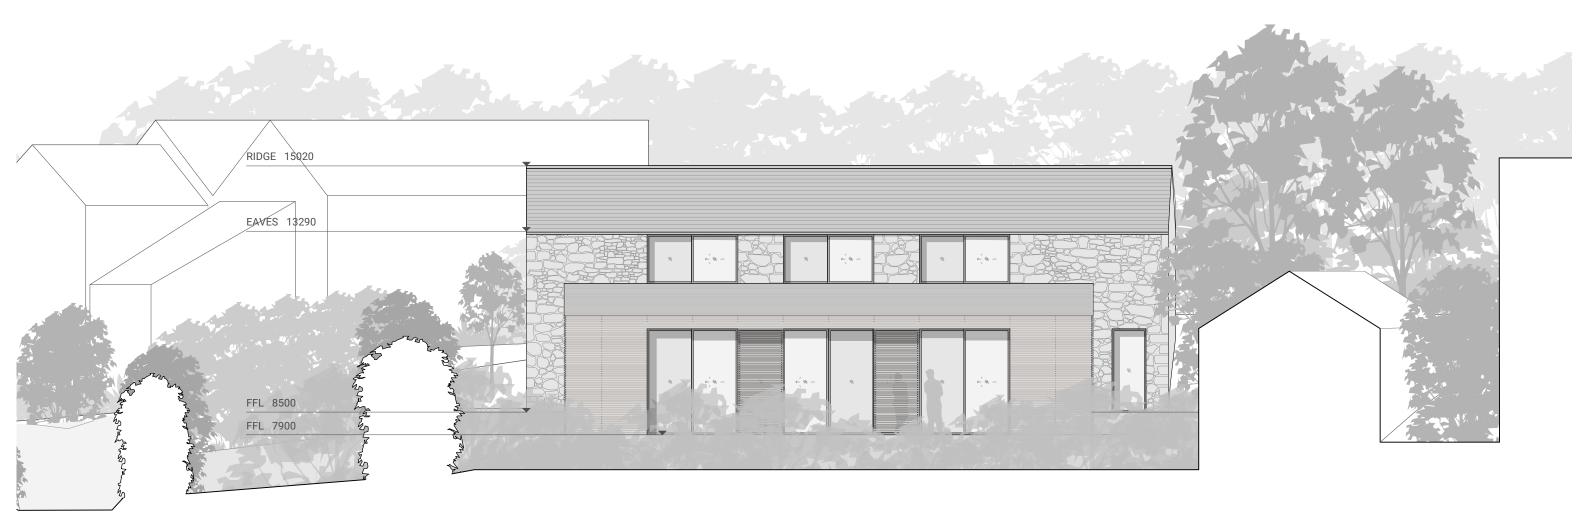
Windows + Doors:

Metal-clad, timber framed, double-glazed.

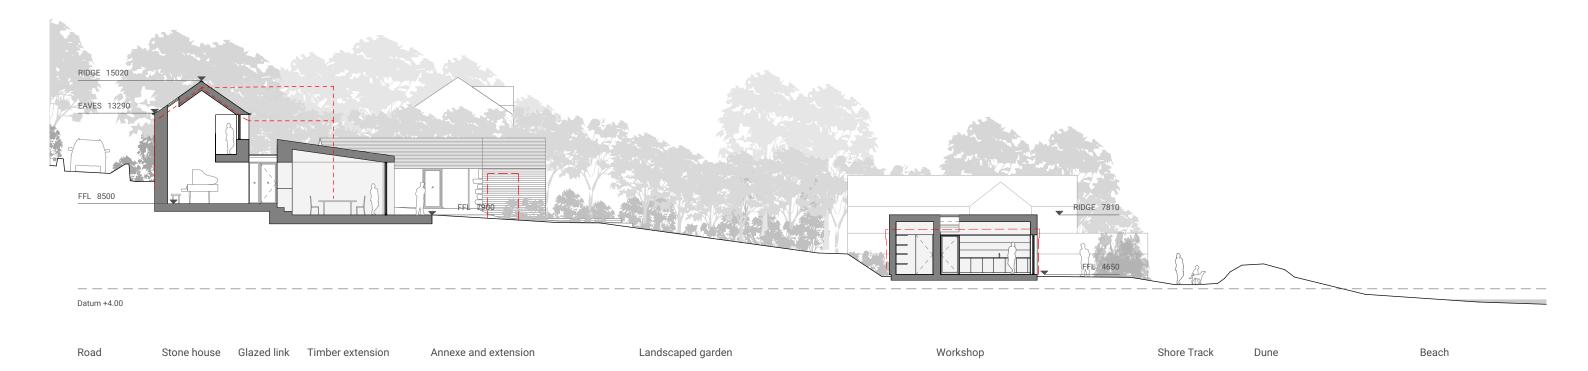
Ridge raised by 470mm. New stonework to match existing.

Red dashed line - Indicates position of existing buildings

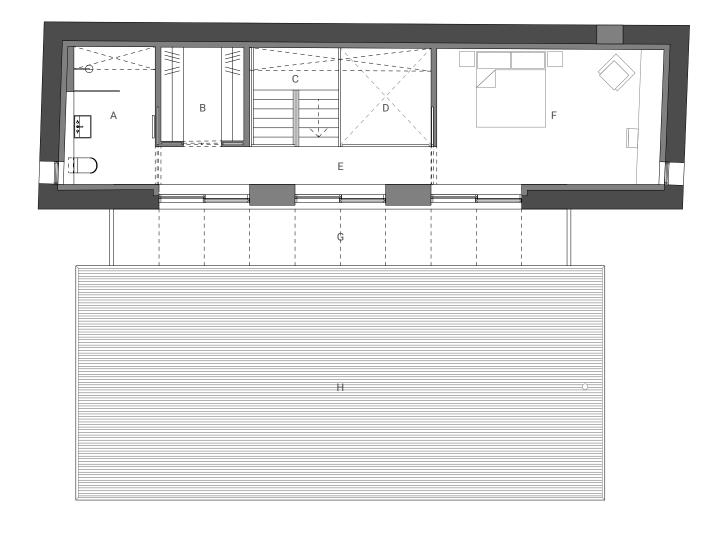
- A Shower room
- B Dressing room
- C Stair from ground floor D Void over hall (top lit) E Hall

- F Master bedroom
- G Glazed link
- H Timber-clad roof

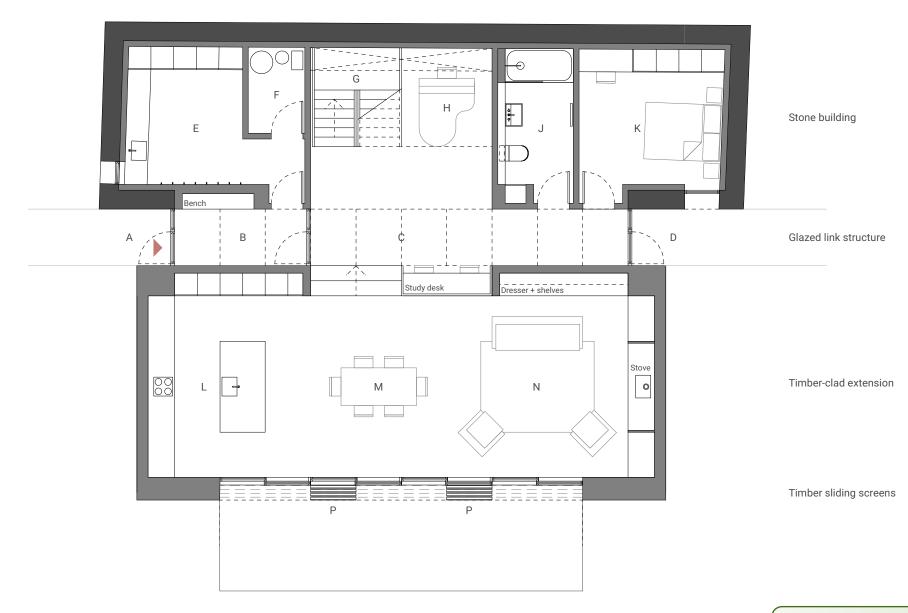
GROUND FLOOR KEY:

- A Main entrance
- B Lobby
- C Hall (top lit) D Rear entrance
- E Utility
- F Plant
- G Stair to first floor
- H Piano (top lit)
- J Shower room
- K Second bedroom / study
- L Kitchen
- M Dining N Living
- P Sliding timber screens

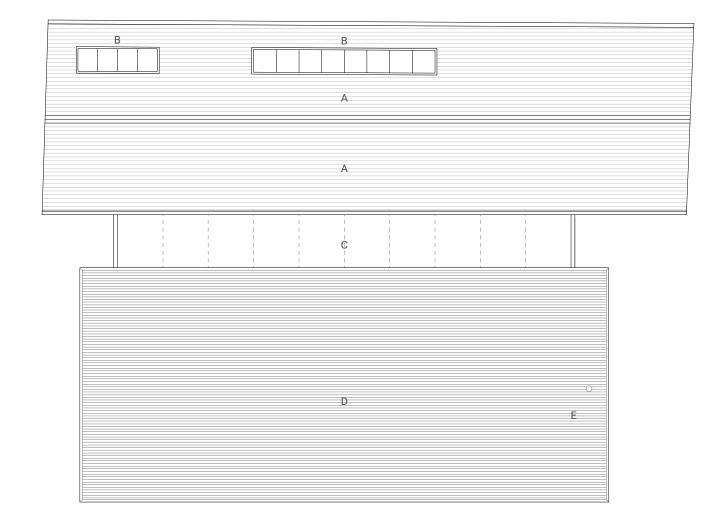
ROOF KEY:

- A Slate roof
- B Flush rooflight
- C Glazed link roof
- D Timber-clad roof E - Stove flue outlet
- F Timber canopy

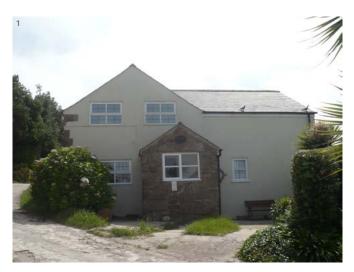
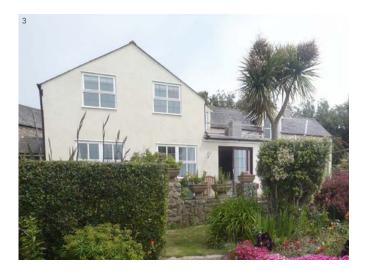
The existing fabric including the UPVC windows requires upgrading and there are numerous locations of severe water ingress - including water flowing down internal walls. Internally the head height on the ground floor is very low and not adequate for modern living.

- Existing house gable, extensions and porch
 Stone rear elevation / stone work retains evidence of previous openings / boat service timetable board displayed on stone wall at the end
 Existing house form within the garden

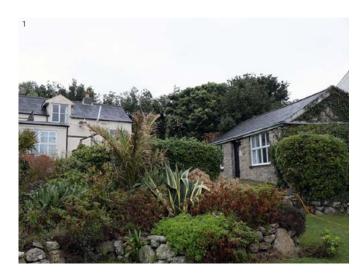
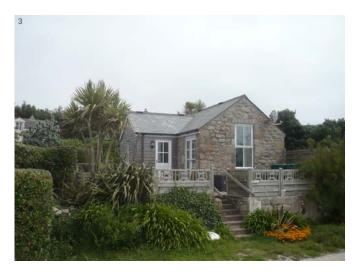
At the foot of the garden facing on the path that runs along the edge of the beach, the workshop is a timberframed, timber-clad structure. It was built originally to house a boat, for direct access to the beach, but there have been numerous ad-hoc additions including garden storage, and a lean-to greenhouse.

Currently it is only suitable for storage and is not insulated or heated. It is in a poor condition and needs significant work to make it watertight and stable, for example the electrical supply is faulty due to water ingress.

- Stone Annexe to the right of the house, viewed from the garden Timber workshop at the foot of the garden The Moorings, accessed form the beach path

It has not weathered well in recent times, evidenced by its current poor condition and obvious signs of wind and water ingress. In addition the electrical and water services need to be replaced and the interior needs to be properly insulated.

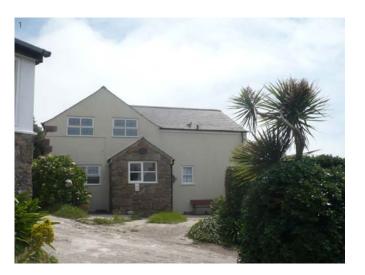
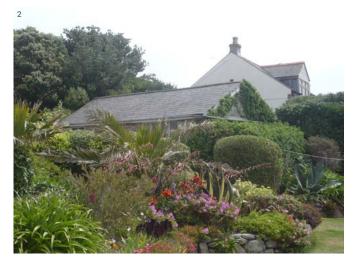
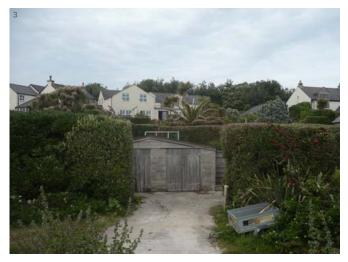
- Existing house and entrance porch on approach Existing annexe in the foreground, within the mature garden Existing workshop in the foreground, at the foot of the garden, facing the beach lane.

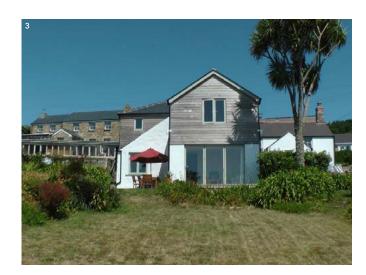
Careful treatment of fenestration is required to allow the altered buildings to sit harmoniously within their context. Larger areas of glazing have been limited to the southwest elevation, facing the garden. These areas of glazing have been broken up into elements with vertical emphasis, avoiding large planar expanses. There are many recent examples in Scilly of glazing of this arrangement working successfully.

- Section through House and proposed extension.
 Southwest elevation showing new glazing screens with vertical elements
 Pine Trees, Town Lane, Bryher, recent example of glazed screen with vertical elements

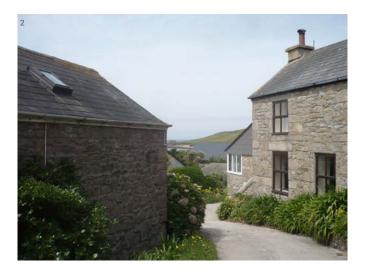
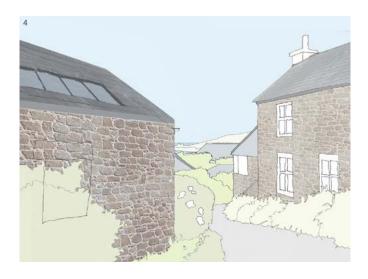
- The new house extension, workshop and alterations to the Annexe, sit unobtrusively within the garden of the property.
- The view from the lane to the rear is maintained. The character of the existing building to the lane is maintained, with the modest height rise, being achieved with new stonework to match the existing.
- The view from the junction of lanes at the entrance is improved with a stone gable with well-proportioned windows and a low extension to the garden, in place of the large gabled extension.

- View across Great Par beach to proposed House, within the context of the settlement Lane to the north, with Bank Cottage to the left and Atlanta to the right Existing mass of Bank Cottage with increase in height shaded dark shown to scale Proposed rear elevation of Bank Cottage with new stonework and rooflight

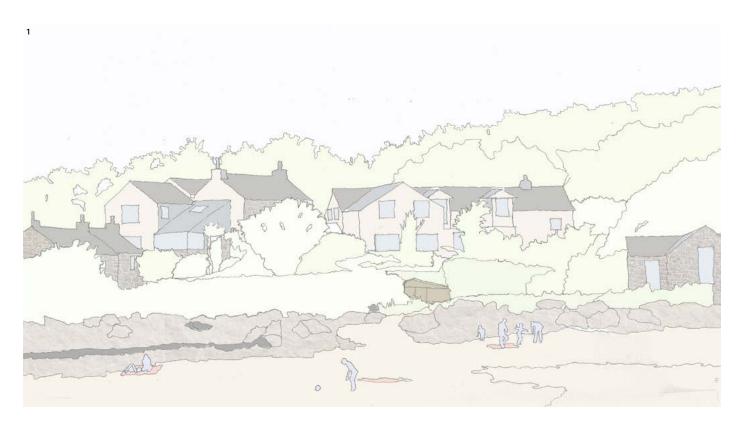
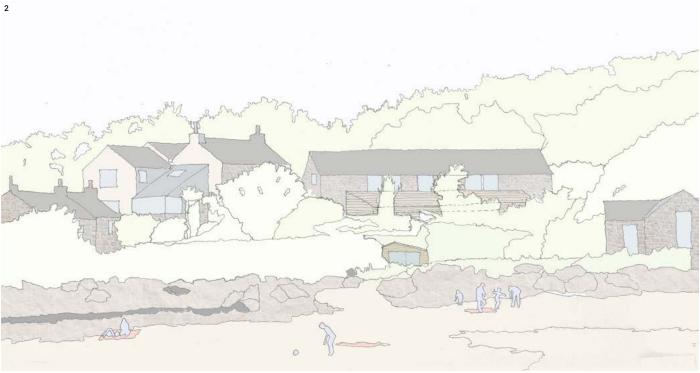
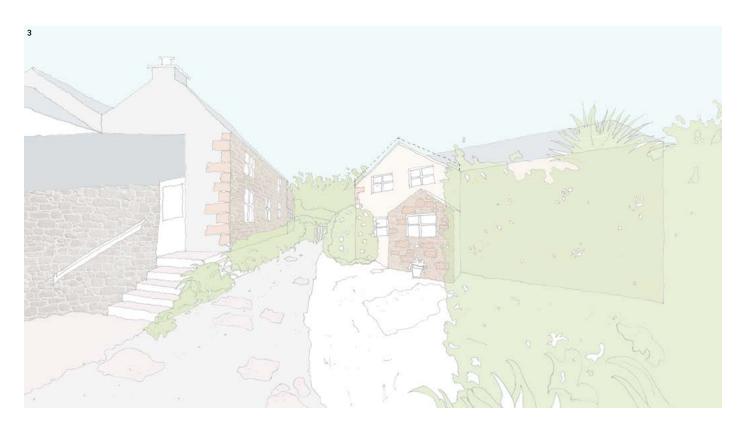
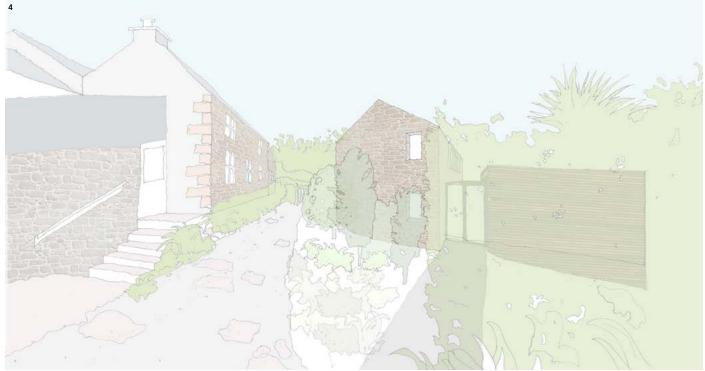
The adjacent images illustrate the proposals within the context of the wider settlement. The intention is to show the minimal impact that the proposals have on the character of the buildings and place:

- Existing House from across the shore Proposed House from across the shore Existing House from the lane entrance Proposed House from the lane entrance

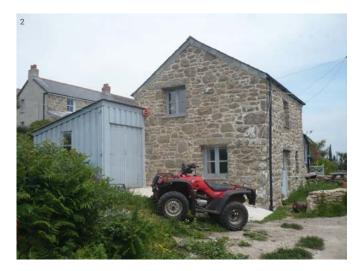
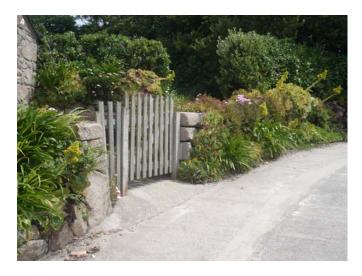
For the extensions and the workshop, the aspiration is to achieve simple detailing, avoiding unnecessary complexity. They are to be clad in delicately detailed horizontal timber. This will be untreated and allowed to weather naturally. There will be no overhangs and projections, allowing the timber to weather evenly.

- Slate roofing, timber cladding and mono-pitch outbuildings on adjacent site Nearby restored granite building with tall gable, small windows and a timber outbuilding Existing workshop with weathered timber Granite wall, weathered timber gate and native planting, in the lanes of Bryher

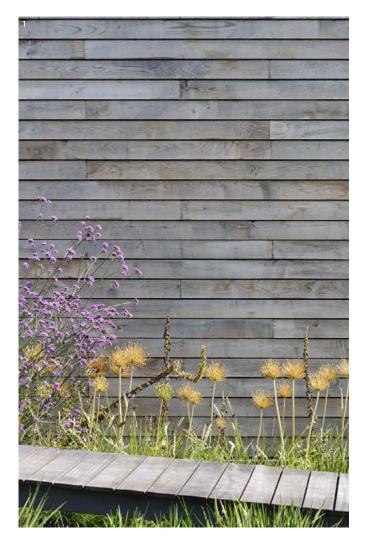
A planting scheme will be developed to reflect the rich variety of Scilly plants, whilst characteristics such as existing stone steps, embedded within the existing garden landscape, will be also be retained

Naturalistic planting against the back-drop of simply detailed, untreated timber cladding
 Existing stone steps embedded into the garden landscape

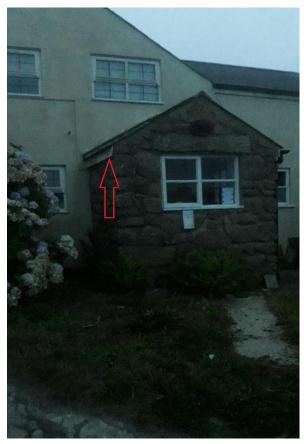
Location of bat roost at Bank Cottage

location also entering the roost. The species confirmed at this location was Common Pipistrelle. Examination of the floor and surrounding vegetation immediately below the roost entrance revealed very few droppings.
