# PRELIMINARY ECOLOGICAL APPRAISAL & PRIMARY BAT ROOST ASSESSMENT OF:

BANK COTTAGE  
SOUTH'ARD  
BRYHER  
ISLES OF SCILLY  
TR23 0PR

Our reference: BS10-2018

Report Date: 13<sup>th</sup> November 2018

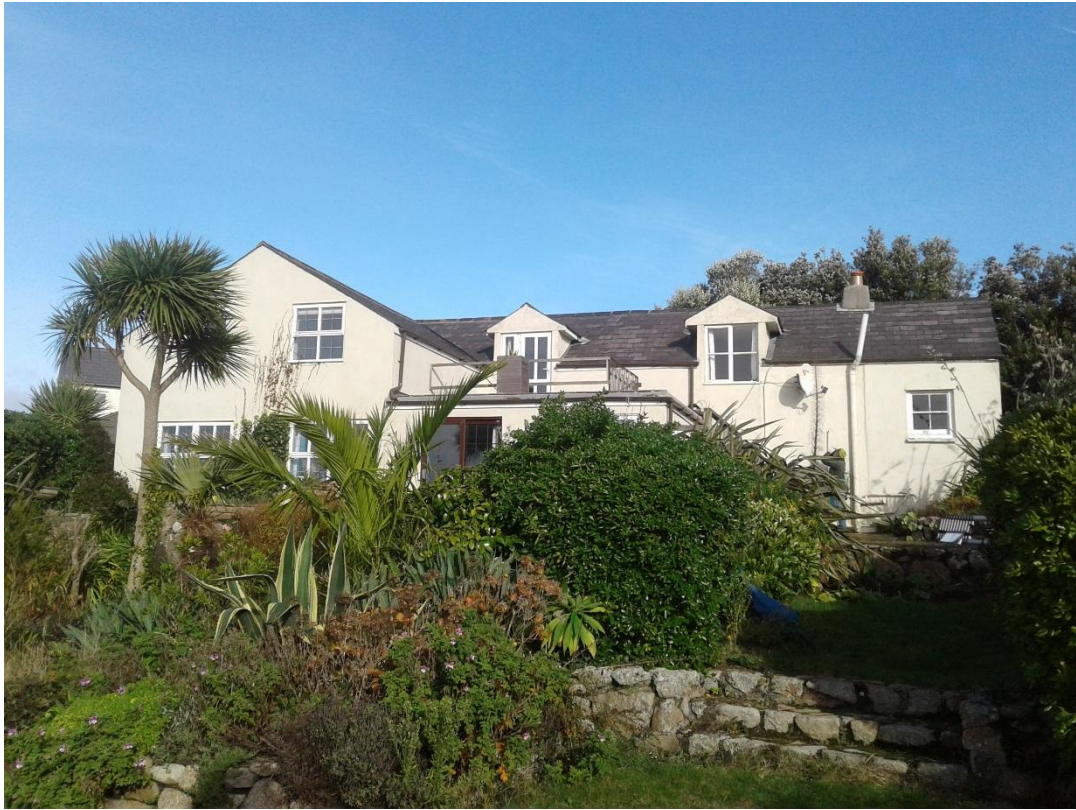
Photo 1 - The main house (south-west aspect).

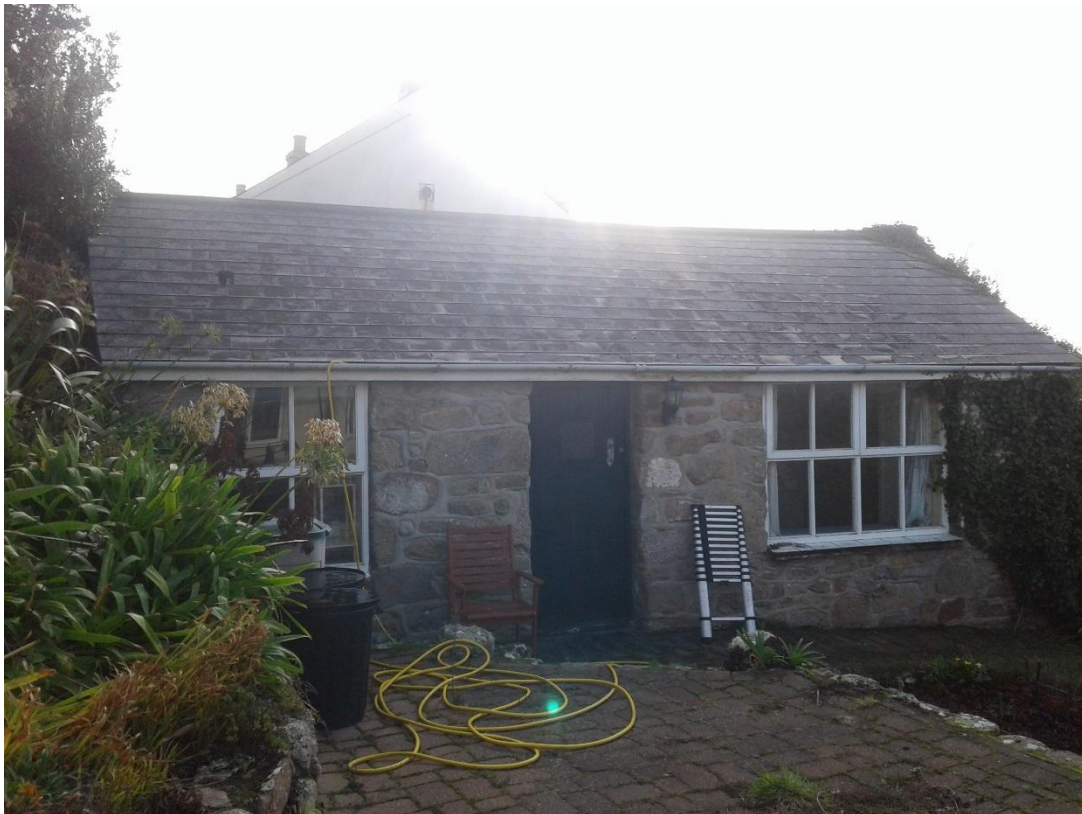
Photo 2 - The cottage (north-west aspect).

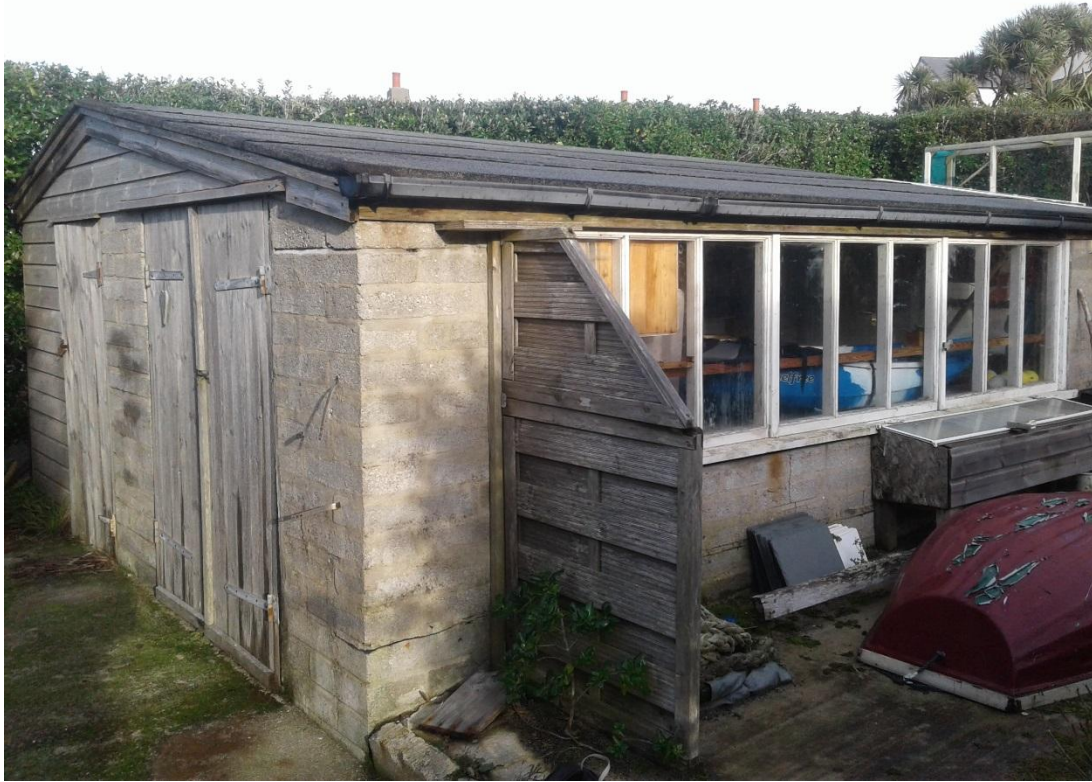
Photo 3 - Shed (south-east and south-west aspects)

The **Shed** is a cement block single storey structure with some wooden cladding. The roof is wooden framed and has a pitch of 9° and is finished with bitumen felt (see photo 3). There is a clear plastic extension on the north-east aspect.

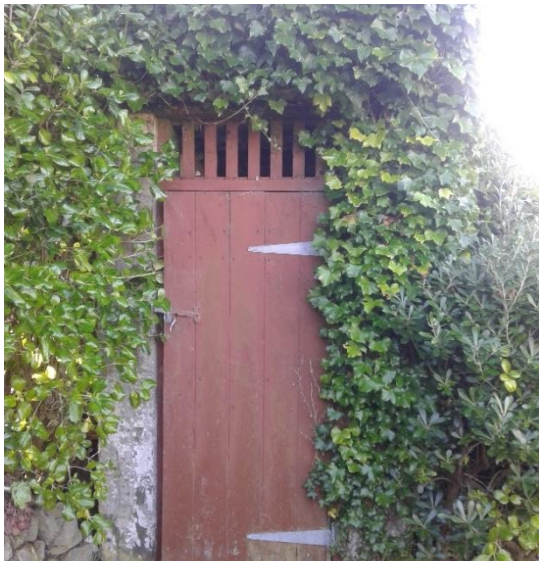
Photo 4 - Small standalone shed (north-east aspect).

The **small standalone shed** (see photo 4) standing south-west of the cottage was also surveyed. The outside of the building was covered in Atlantic ivy so much so that it hindered the ability to see what was underneath, this limiting feature is potentially obscuring any real or potential roosting features (see photo 4). The building itself appeared to be concrete in structure with a corrugated fibre cement roof. Currently it is serving as a small storage shed.

The **small standalone shed** has obvious access to the interior of the structure through the wooden slats above the door (see photo 4). Small mammal droppings were found inside the shed thought to be Scilly shrew (*Crocidura suaveolens*) (see 29).

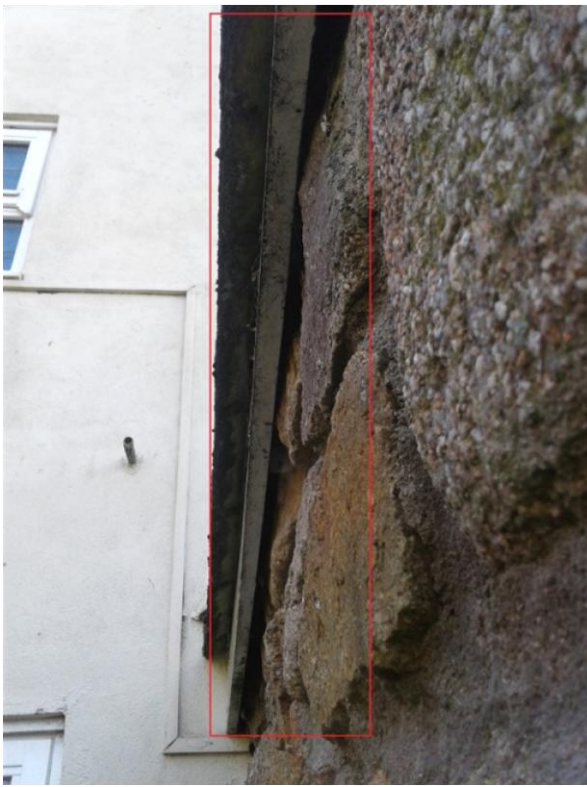
- Gaps behind the soffit board and the granite on the porch's northern and western sides (see photo 5). It should be noted that bird nesting material was found behind the soffit board on the western corner.

Photo 5 - Gapping behind the soffit on the porch.

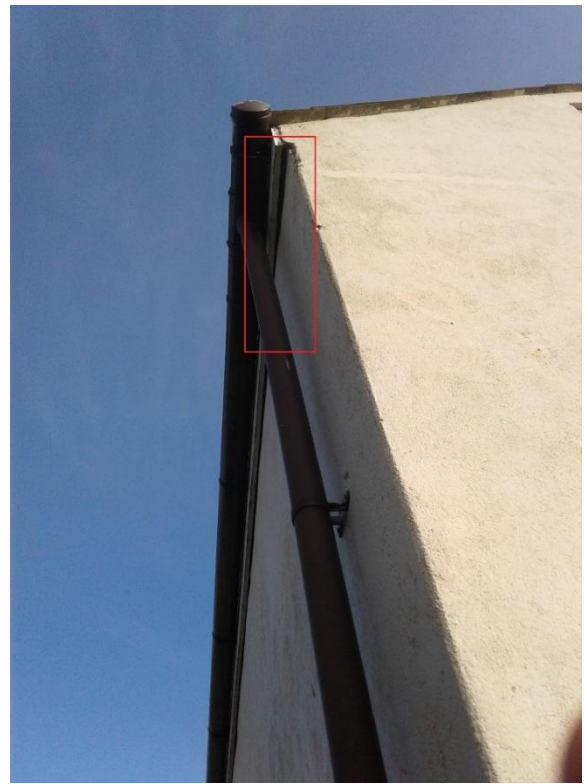
- Several gaps behind the soffit boards on the gabled extension north-west aspect, particularly at the western corner (see photo 6).
- Several gaps behind the soffit boards on the north-east aspect of the original building, particularly on the northern corner (see photo 7).

Photo 6 - Gaps behind the soffit at corner of extension.

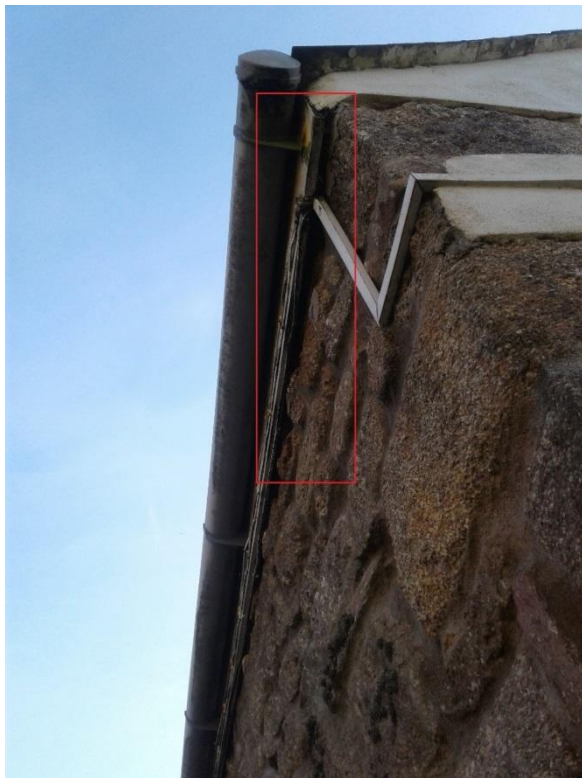
Photo 7 - Gaps behind the soffit.

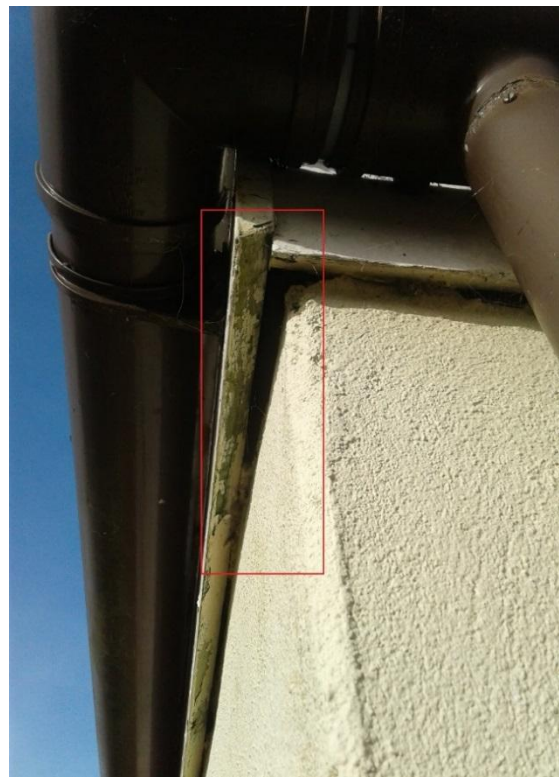
Photo 8 - Gap behind soffits.

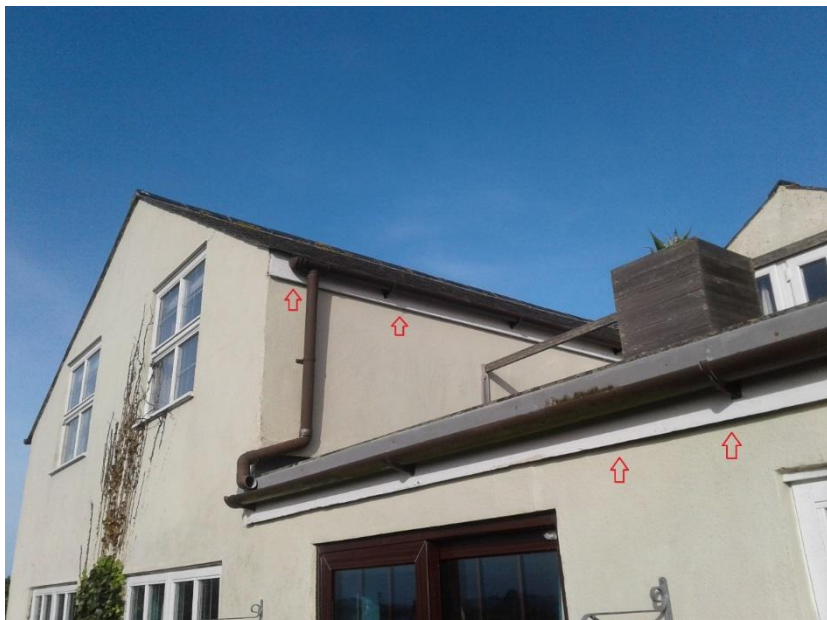
- South-west aspect - the gaps are numerous behind the soffit boards on the south eastern aspect of the gabled extension and on the south-west aspect of the flat roofed extension (see photos 8 & 9). Although not continuous they do run the length of the boards.

Photo 9 - Gaps behind the length of the soffit boards.

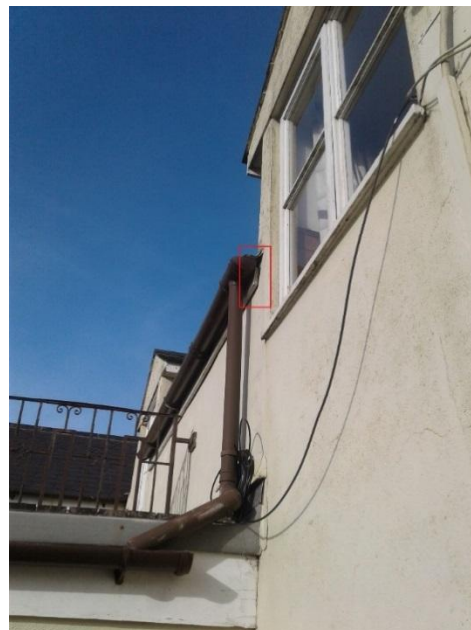
- South-west aspect gap behind the soffit and flashing beyond the down pipe and before the dormer (see photo 10).
- South-western aspect – Gaps under the flashings on the left hand side of both dormers (see photos 11 & 12)

Photo 10 - Gap behind the soffit & flashing.

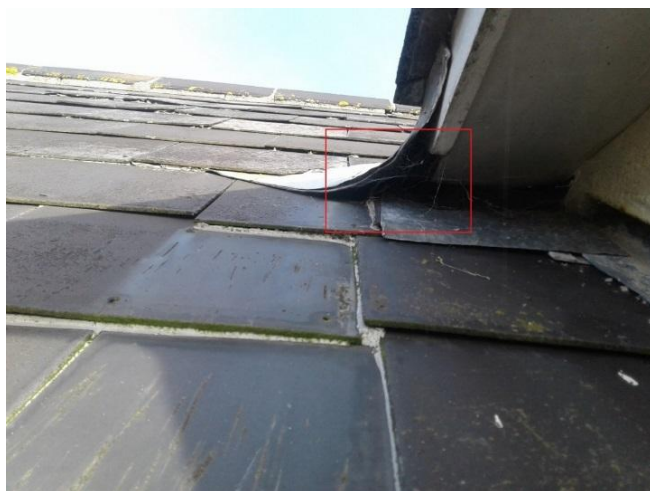
Photo 12 - Gap under flashing of the east dormer.

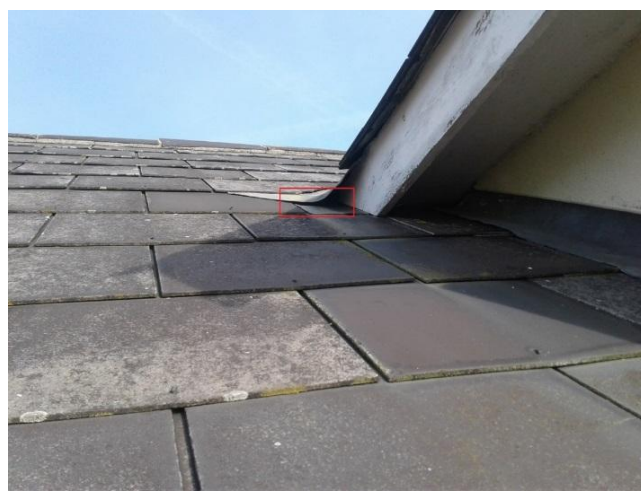
Photo 11 - Gap under flashing of the west dormer.

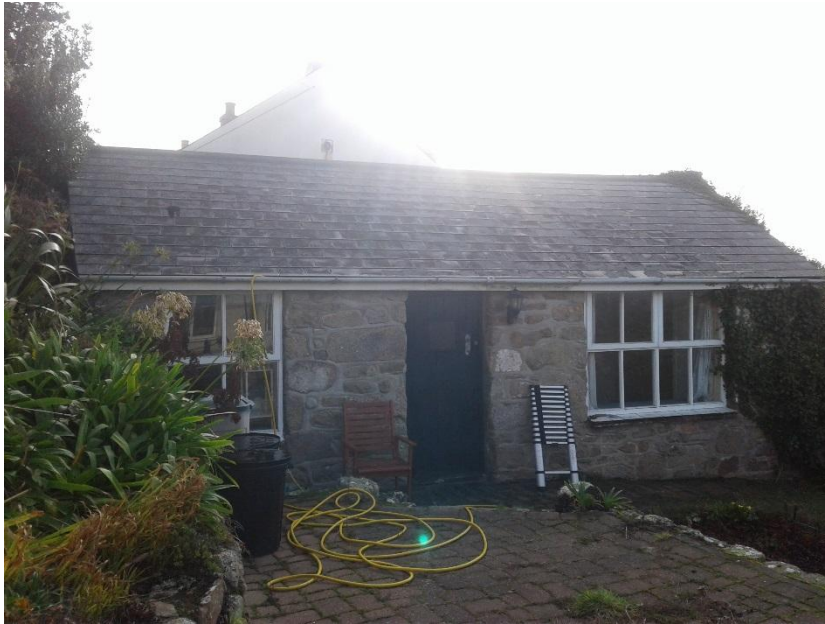
**The Cottage** is a single storey gabled granite outbuilding, with a slate roof and concrete ridge tiles. The roof has a pitch of 25°. There are two wooden framed windows on the north-west aspect with a wooden door and the soffit boards are also all wooden (see photo 13).

Photo 13 - The granite cottage.

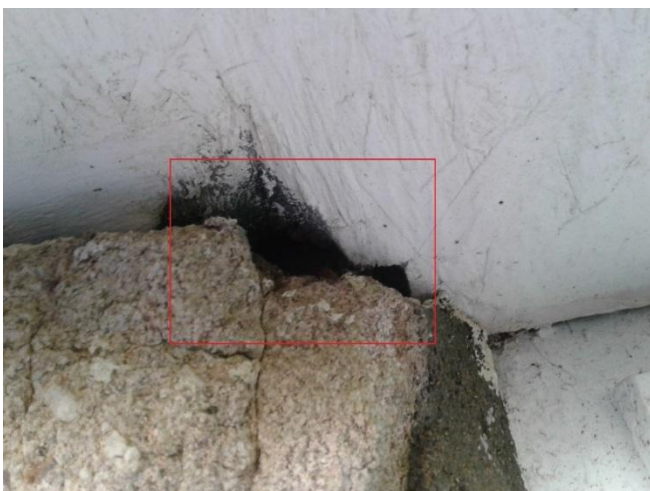
- North-west aspect – gap in soffit left of right hand side window (see photo 14).
- North-west aspect – gap in soffit where cable enters soffit. Small mammal dropping visible but not retrievable (see photo 15).
- North corner of north-west aspect – Cavity under and behind the fascia board appears to enter the roof space. Bird nesting material present (see photo 16).
- North-east aspect – gaping between the bargeboard and the granite towards the apex (see photo 17).

Photo 14 - Gap in soffit above granite.

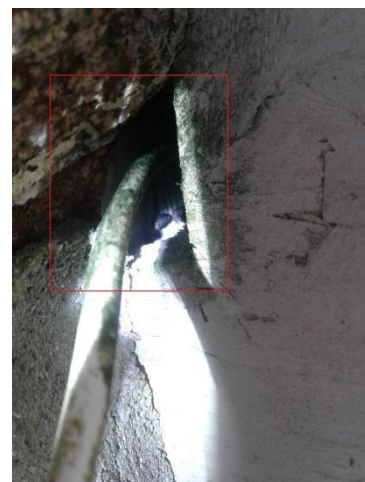
Photo 15 - Gap in soffit.

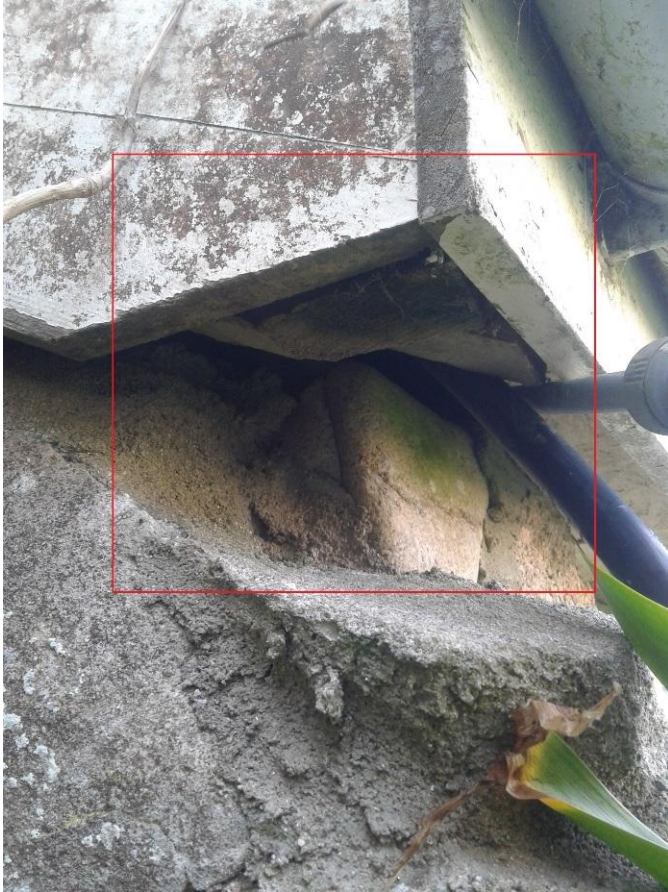
Photo 16 - Cavity behind the fascia boards.

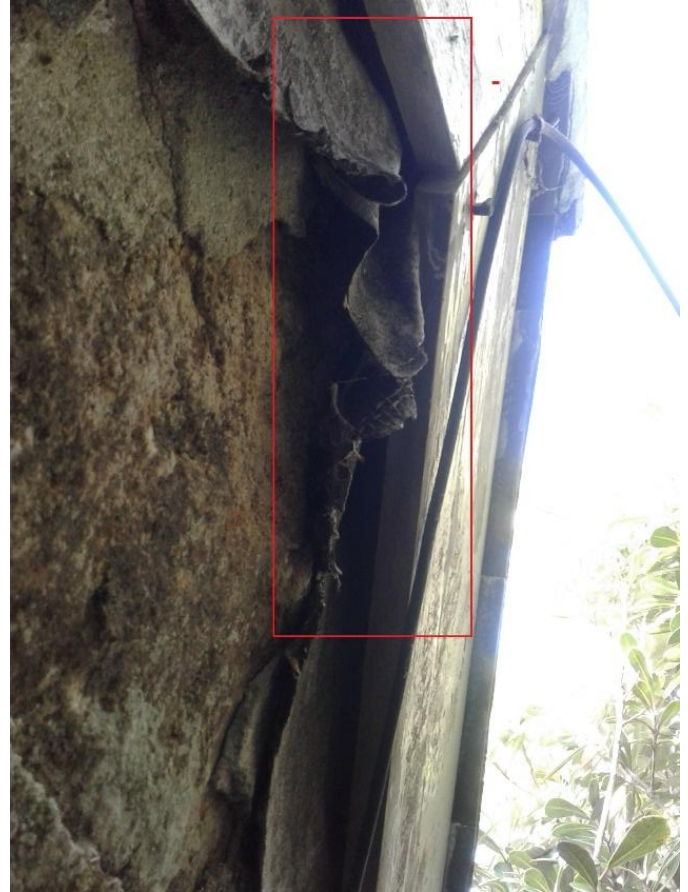
Photo 17 - Gaping between the bargeboard and the granite.

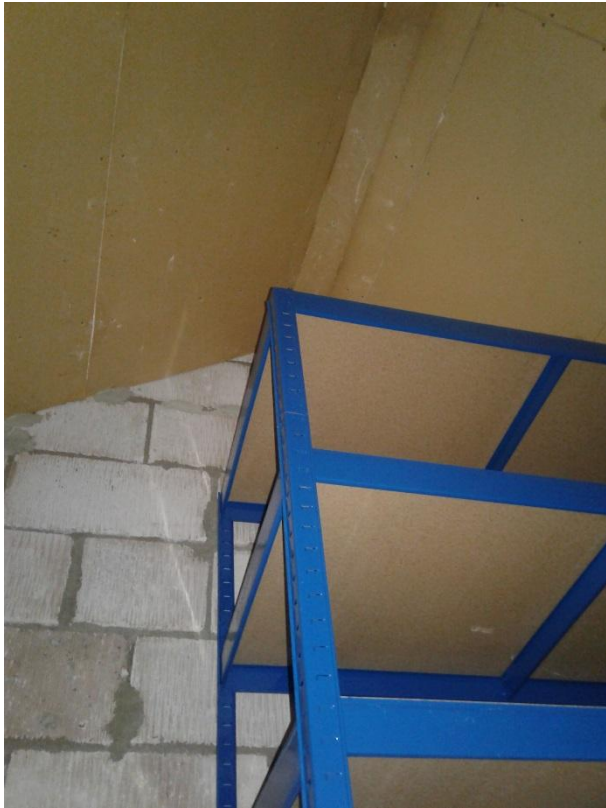
Inside the **main house** there were two loft spaces that were examined. The first of which was in the south-east part of the original building. This small loft space was well boarded with no gapping between the cement blocks and the boards affording no points of access (see photo 18).

Photo 18 – Loft space in south-east end of main house.

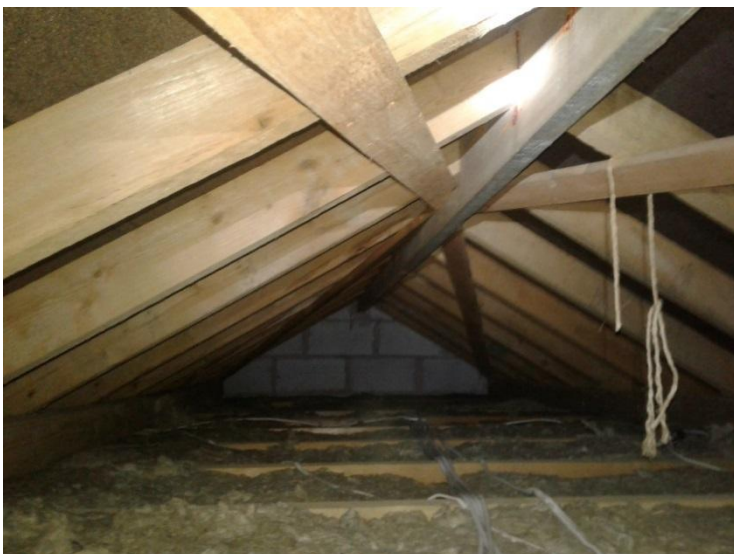
The second loft is in the north-west end of the house, within the roof space of the gabled extension. The loft has a closed-coupled roof with wooden beams and rafters (see photo 19). The roof membrane looked to be fibre felt. The cobwebs were minimal. There were no boards which meant searching for bats and bat sign could only be undertaken from the hatch with a torch. One end of the loft could not be viewed successfully due to it being partially partitioned off (see photo 22).

Photo 19 – Loft of gabled extension.

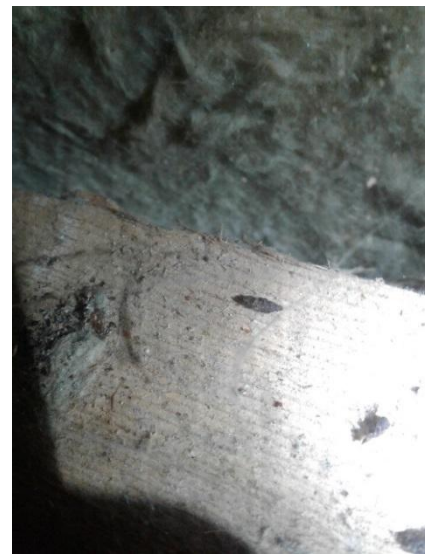
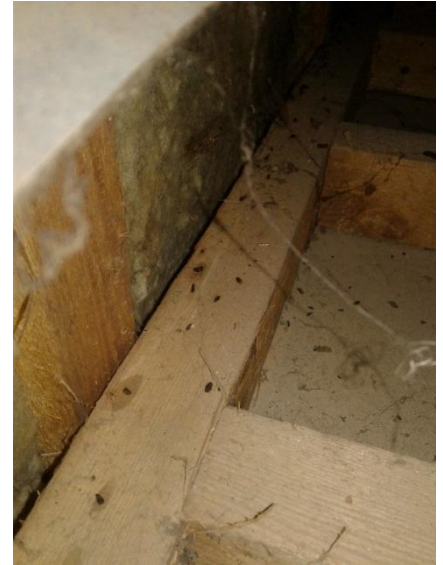
Four samples of mall mammal droppings were found (see photos 20 & 21). Three were within the measurement guidelines given for Common pipistrelle (*Pipistrellus pipistrellus*) species of bat.

Photo 20 – Dropping on beam.

Photo 21 – Droppings on beam.

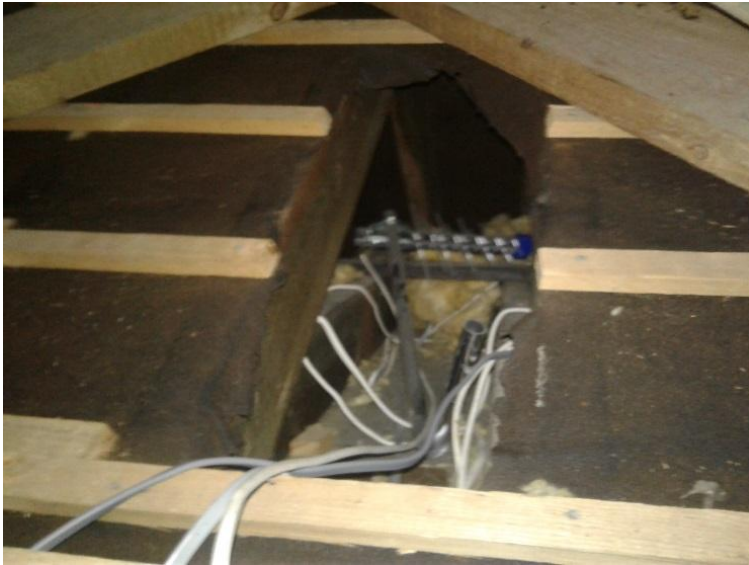
Photo 22 – End of the loft partially partitioned off.

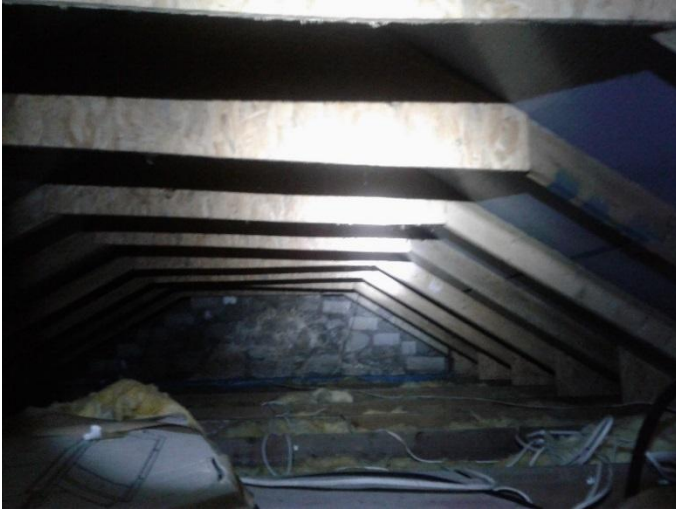
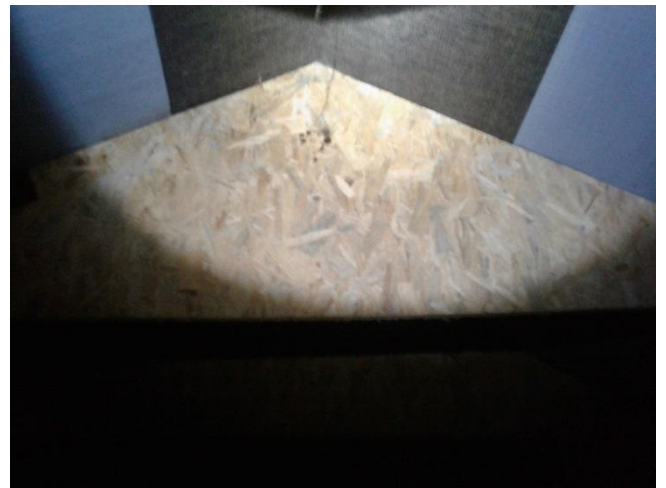
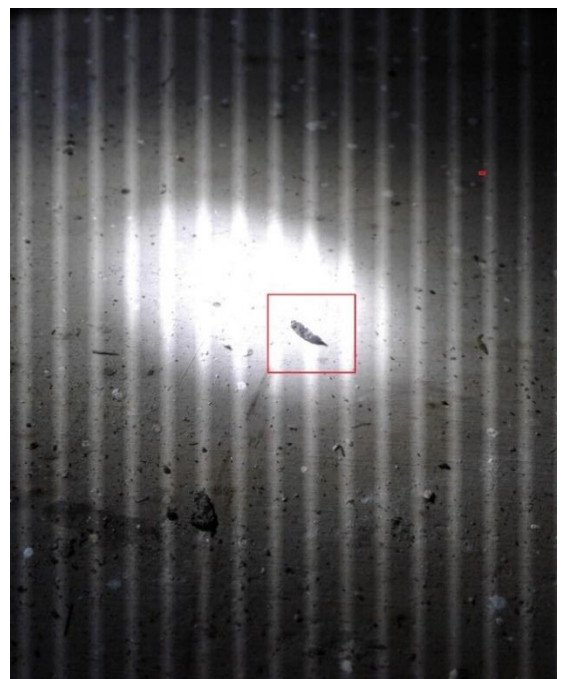
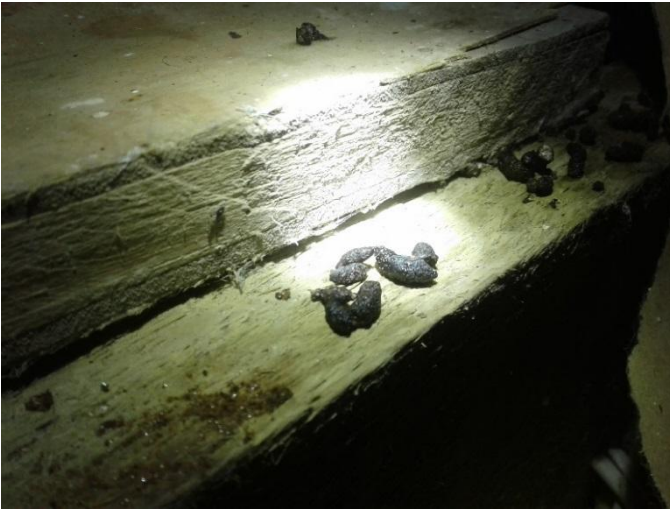
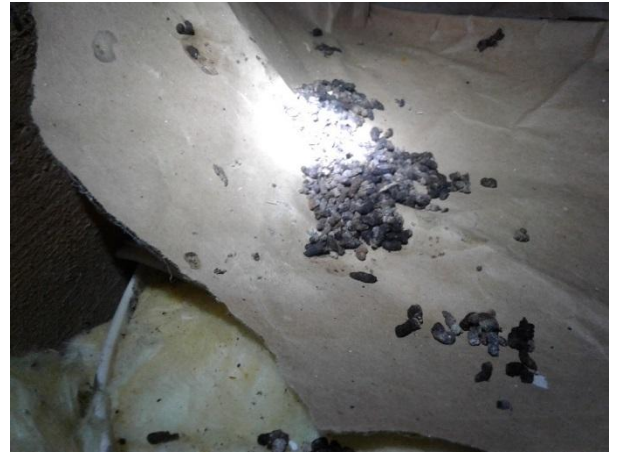
The loft space within the **cottage** has a collar beam roof (see photo 23) with chip-board above the collar beams to the apex (see photo 24). The collar beams, rafters and tie beam are all timber. Due to lack of boarding the survey was carried out from the hatch with a torch. The roof membrane is a patch work of breathable and original fibre felt. The fibre glass insulation was between the tie beams and few cobwebs were seen. With the lights off access points into the loft space from the south-east aspect (see photo 25) could be seen. Small mammal droppings were found and of the four samples taken, two were within the measurement guidelines given for Common pipistrelle (*Pipistrellus pipistrellus*) (see photo 26). There were other mammalian dropping in the shed thought to be Scilly shrew (*Crocidura suaveolens*) and Brown rat (*Rattus norvegicus*) (see photos 27 and 28).

Photo 23 – Cottage loft space.

Photo 24 – Chipboard above collar beam.

Photo 25 – Access points into loft space.

Photo 26 – Probable Common pipistrelle dropping.

Photo 27 – Small mammal droppings.

Photo 28 – Small mammal droppings.

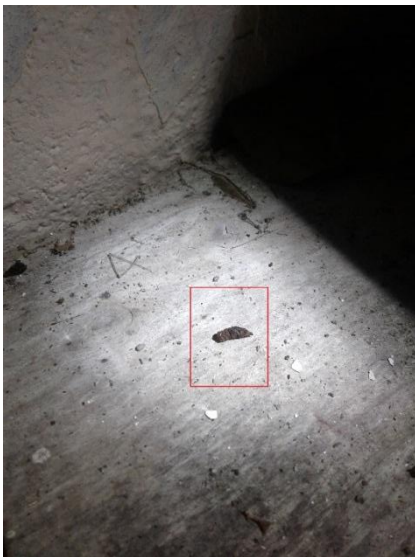
Photo 29 - Small mammal droppings.

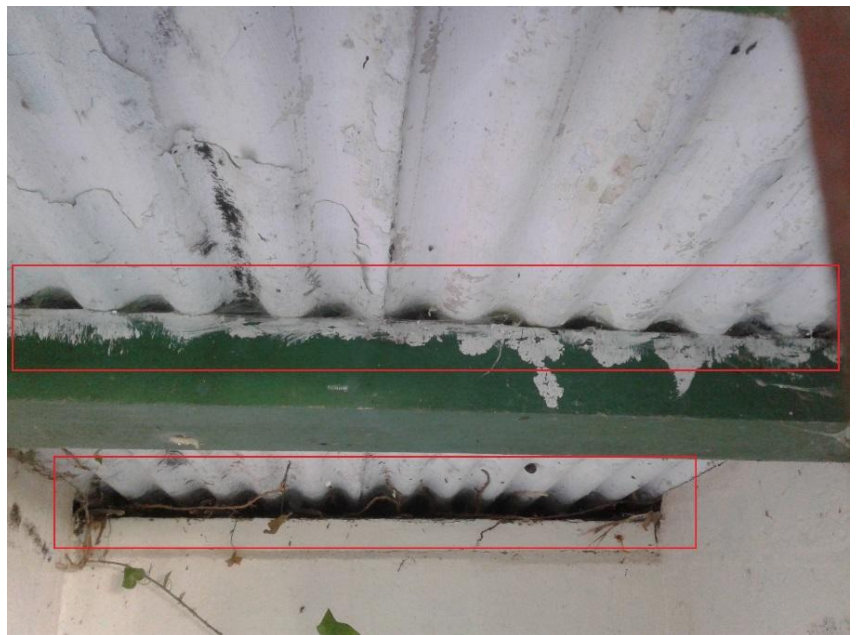
- Gaps below the cement fibre roof sheets and the back wall (see photo 30).
- Gaps above lintel in the roof (see photo 30).

Photo 30 - Inside the small standalone shed.

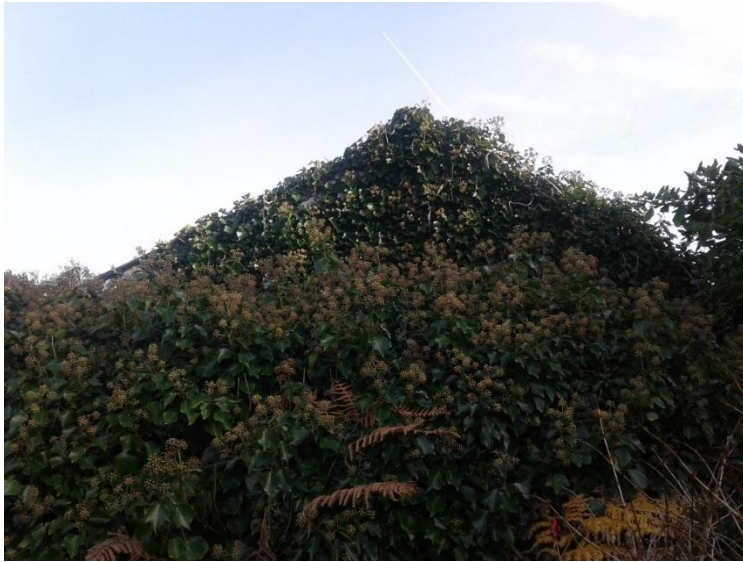
The survey was undertaken at a suitable time of year for carrying out preliminary roost assessments. However, there were a number of areas where vegetation growing on structures hindered the ability to see what was underneath, potentially obscuring any real or potential roosting features. On the south-west aspect of the cottage (see photo 31) and on the Standalone small shed, a thick cover of Atlantic ivy is present obscuring the view of any potential roost features (see photo 4). Access was not possible at the south-east aspect of the cottage. Parts of the loft-space in the cottage and the loft in the gabled extension of the main house could not be surveyed for safety reasons (insufficient boarding). Part of the loft in the north-west end of the house, within the roof space of the gabled extension, was partitioned off and no access was possible (see photo 22). These limitations have been taken into consideration in the assessment and recommendations given below.

Photo 31 – Vegetation on south-west aspect.
