PERMISSION FOR DEVELOPMENT

Application No:	P/20/047/HH	Date Application Registered:	24th July 2020
Applicant:	Adam Dorrien-Smith Stonar Bell Lane Poulton GL7 5ST	Agent:	Mr Nicholas Lowe Llewellyn Harker Lowe Architects Home Farm East Pennard Shepton Mallet BA4 6TT
Site address:	Dolphin House Dolphin Row Dolphin Town Tresco Isles of Scilly		
Proposal:	Internal alterations to the original house, a two storey rear extension to replace a C20th service tower, and the enlargement of the existing south eastern wing. (Listed Building) (Amended Plans)

Bat Survey Report

DESIGN, ACCESS, & HERITAGE STATEMENT

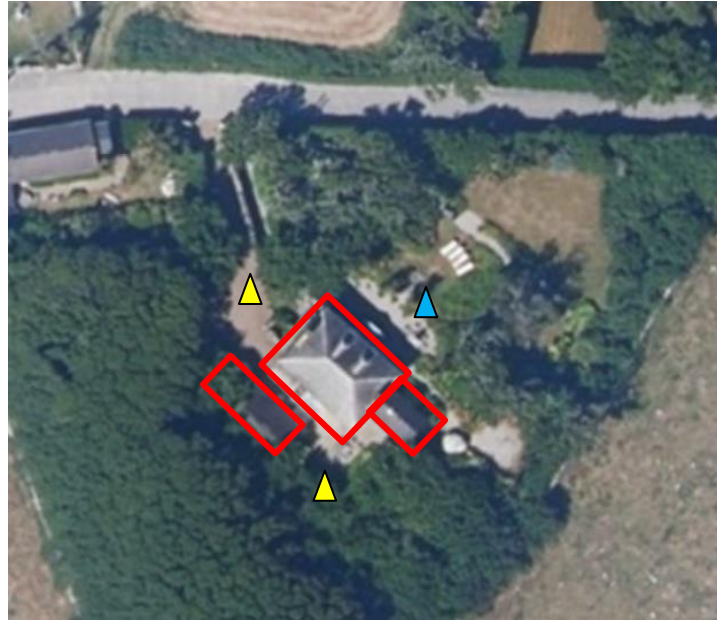
Figure 1: Emergence/re-entry surveys – surveyor locations. Dolphin House and its outbuildings are outlined in red. Yellow triangles show surveyor locations on both surveys, blue triangle shows location of surveyor 3 on the second survey

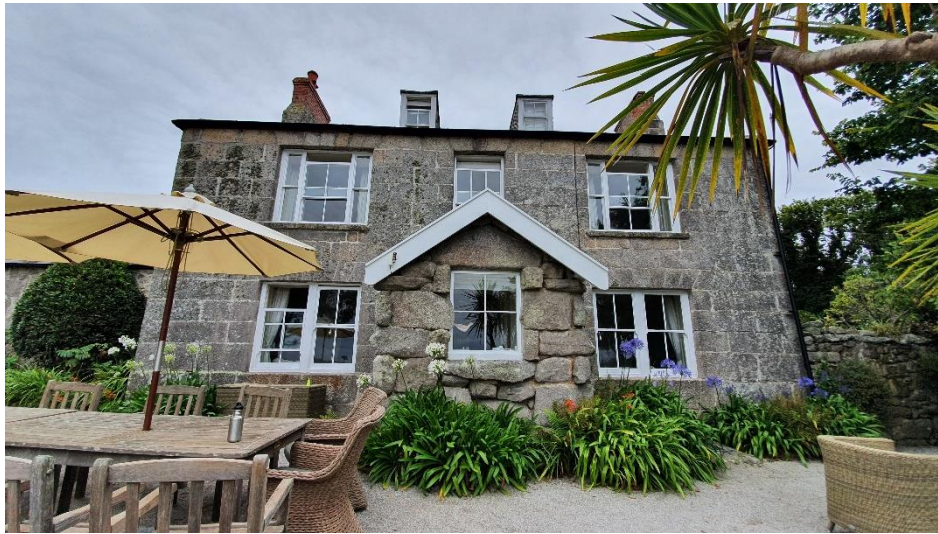
Figure 2: North-eastern elevation of Dolphin House

The property 'Dolphin House' consists of a three-storey Grade II listed stone cottage with a pitched, hip-ended roof covered with traditional slate and clay ridge tiles. On the south-eastern elevation is a single storey extension with a pitched slate roof, and on the south-western elevation is a two-storey extension with a mono-pitched roof covered with slate. The latter is proposed to be demolished. The north-eastern elevation features a small porch with a pitched slate roof.

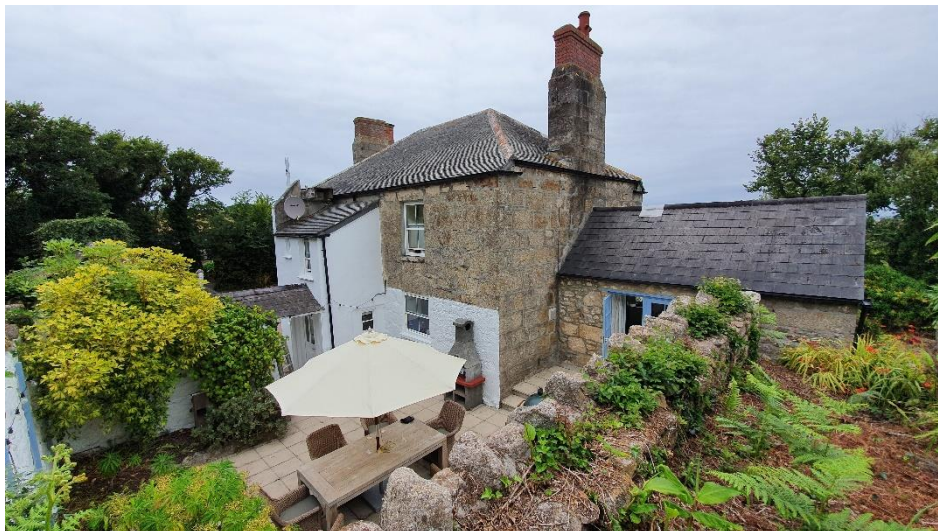
Figure 3: South-western elevation of Dolphin House

At ground floor level on the south-western elevation, the main cottage is attached to a single-storey outbuilding via a covered, open-sided walkway with a pitched slate roof. Attached to the north-western elevation of this outbuilding is a redundant roofless stone structure. The outbuilding and roofless structure are built into an earth bank along their south western elevations. A stone retaining wall to the south of the cottage, together with the extensions and outbuildings, creates a sheltered courtyard at the rear of the property (Figs 2 to 5).

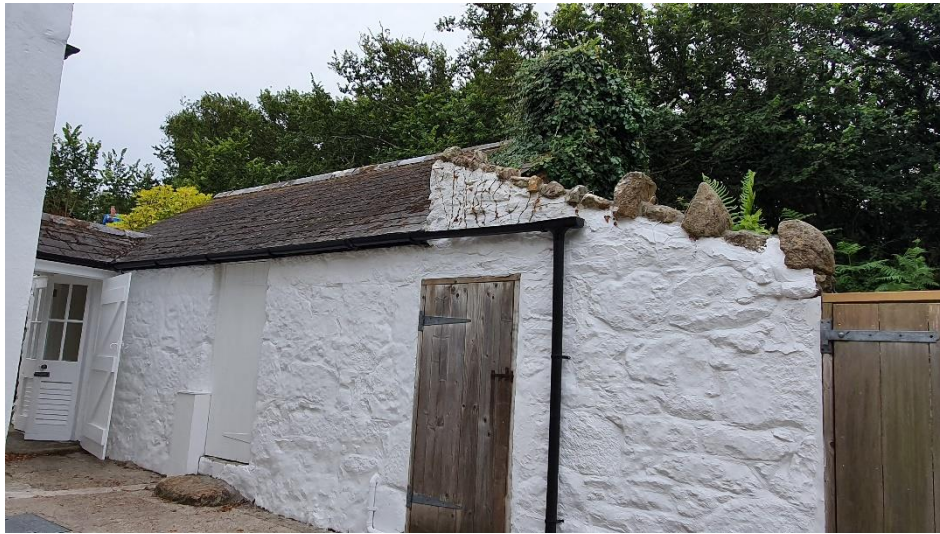
Figure 4: North-eastern elevation of outbuilding and part of roofless structure

The external walls are either bare stone or they have been rendered and whitewashed. The property features two stone chimneys, timber sash windows and timber doors and both plastic and metal guttering. There are timber fascias on the main cottage with notable gaps behind, which provide potential roosting opportunities for bats, and which could enable access for bats onto the wall tops. There are two dormer windows on the north eastern elevation of the roof with pitched slate roofs and clay ridge tiles. These exhibit hanging tiles on the sides, which are well-sealed with no notable gaps. However, there are notable gaps under the lead flashing around the dormers which provide potential roosting opportunities for crevice-dwelling bats.

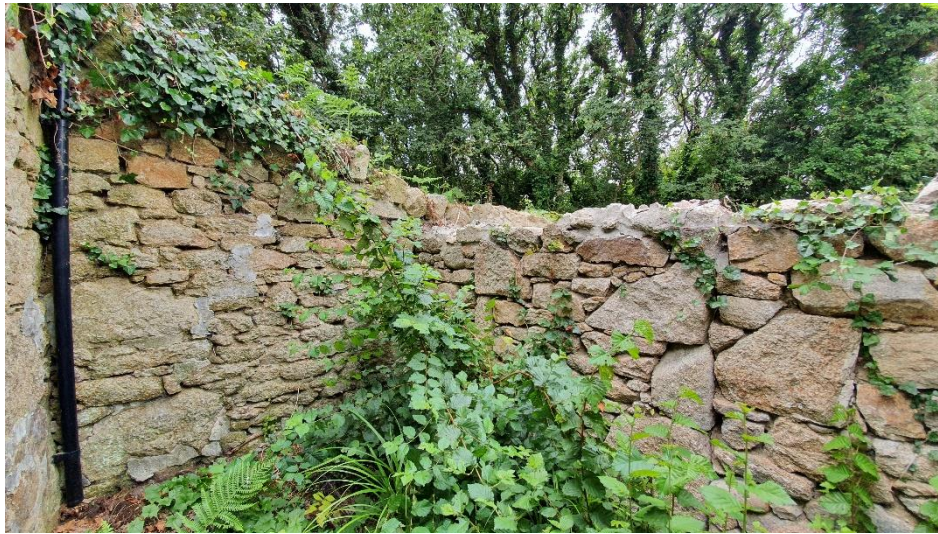
Figure 8: Interior of roofless structure (viewed towards the north-west)

The interior of the outbuilding consists of a single room open from the concrete floor to the underside of the roof, which is partly bare slate and partly boarded creating a narrow roof void above. The interior of this roof void could not be accessed. This room is light internally and is in regular use as a utility room. The interior of the roofless structure consists of two rooms with bare stone walls and earth floors with ephemeral vegetation. The rooms are accessed via timber doors on the north eastern elevation. There are crevices present within the internal walls with some potential for crevice-dwelling bats, although this building is open and exposed to the elements which would have reduced the overall likelihood of bats roosting within this building (Fig 8).

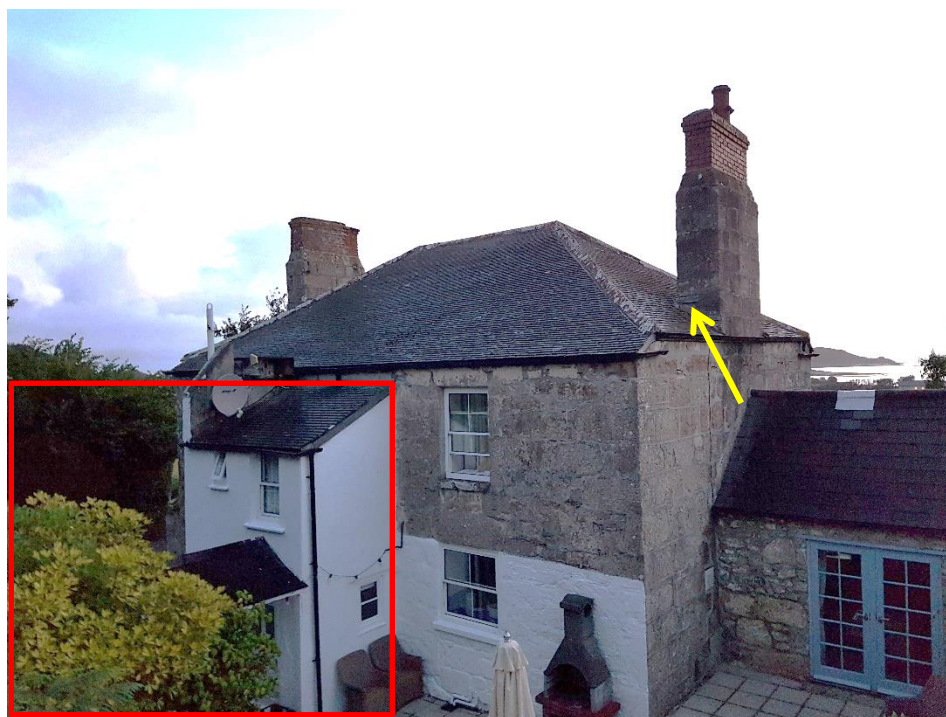
Figure 9: Re-entry location of a single common pipistrelle bat into a gap under lead flashing on the south western elevation of the south eastern chimney on 28th August 2020 (yellow arrow). Red outline shows approximate extent of proposed works at Dolphin House (including outbuildings further to the west).

No bats were seen to emerge from the buildings subject to the proposals during the first (emergence) survey. During the second (re-entry) survey a single common pipistrelle was seen to re-enter a gap underneath lead flashing on the south western elevation of the south eastern chimney on the main cottage (Fig 9).

Although bats are not currently, at the time of the survey, using the two-storey extension or adjacent outbuildings, at least one bat has been shown to roost within the south western elevation of the south eastern chimney on the main cottage, which is close to the area of the building subject to the proposed works. As far as we are aware, no works are proposed to the roof, chimneys or fascias over the main cottage and so the roosting feature will not be lost or damaged as part of the works. The proposed works are to be undertaken below the level of the roof over the main cottage, therefore disturbance as a result of noise and vibration is considered unlikely except for during demolition of the existing two-storey extension, which has potential to cause some low-level disturbance to bats within the neighbouring roost.

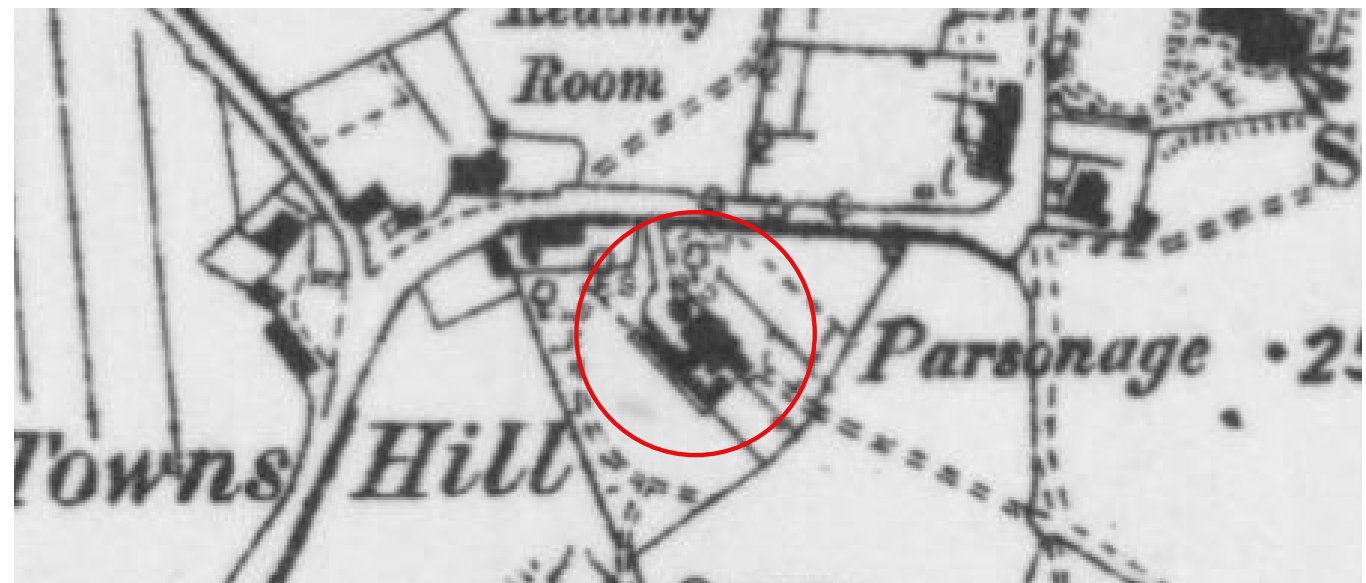
Figure 2 - Ordnance Survey Map 1889 (National Library of Scotland)

The earliest record of the building is shown on the ordnance survey map from 1889 [Figure 2]. The main house is labelled as a parsonage, which was associated with St Nicholas' Church, and accessed via a drive from the north, with a secondary route dotted in to the south east and a small outbuilding. The slight step in the primary north east elevation shows the addition of the romantic style porch in the mid-C19th. The map also shows that the service extension on the south east elevation of the main house had been added by 1889. There is a range of 'L-shaped' out buildings to the south west of the house, which, are shown to be linked to the main house, presumably with a lean-to or covered link, as extant today. As drawn on the reconstructed plan, it is likely that this would have originally been a single storey, sitting below the height and a half window onto the original staircase and providing covered access to the outbuildings. An outbuilding is shown sitting separately to the north

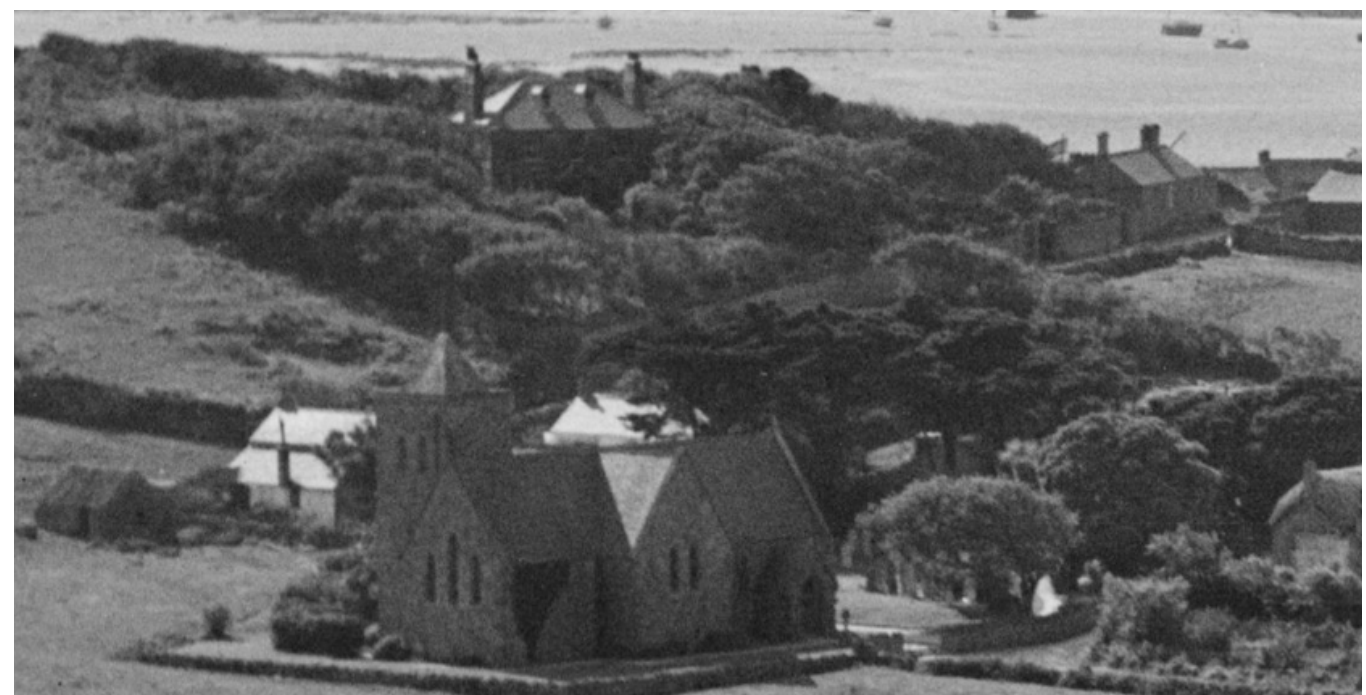
Figure 4 - Aerial photograph from 1938 (Britain from Above)

Dolphin House is shown on the 1909 ordnance survey map but the main house and outbuildings are not accurately shown and are depicted as one solid hatch. The house is shown in an aerial photograph from 1938, which shows the two tall chimney stacks and two dormers in the pitch above the primary south east elevation, which also shows the mid-19th romantic style porch [Figure 4]. The extant attic is very small and awkwardly planned. Given this, and the encumbered stair arrangement required for access, it is hard to imagine that this space was originally designed and constructed to be occupied, but was perhaps instead converted at a later date. If this was the case, the alterations took place prior to 1938.

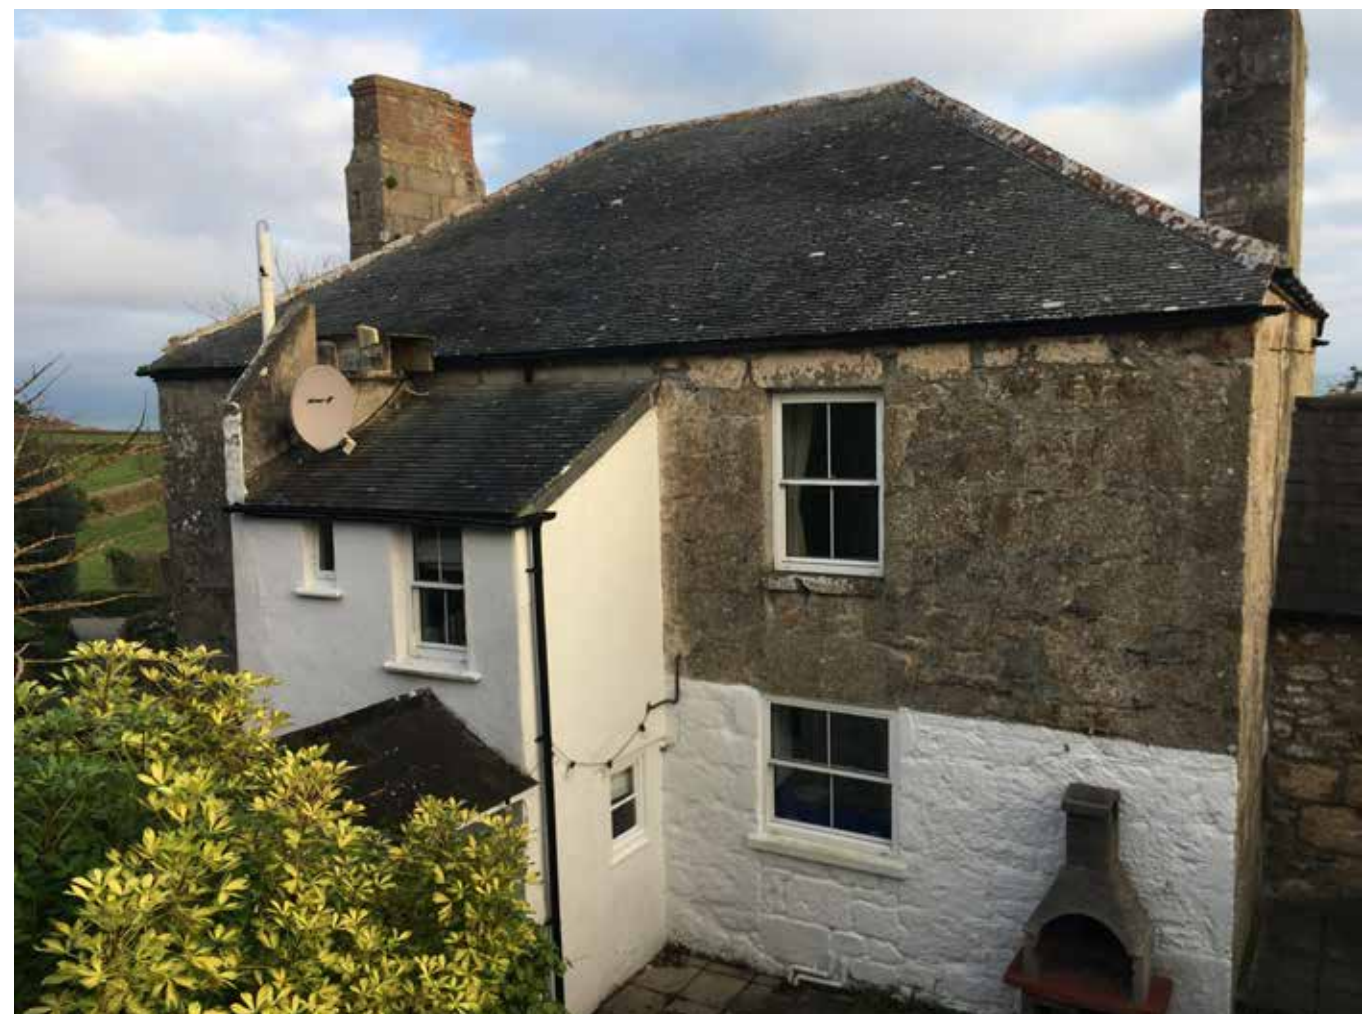
Figure 7 - Rear elevation of Dolphin House (LHL)

The original rear elevation is formed of randomly coursed, roughly squared granite, which has been painted in some areas **[Figure 7]**. The original rear elevation has asymmetrically placed sash window openings. Joinery in these openings has been replaced with uPVC imitation sashes. The window at the south end of the elevation was previously a door, now with an infilled section added during the C20th, would have lead onto a small lean-to, also removed in the C20th.

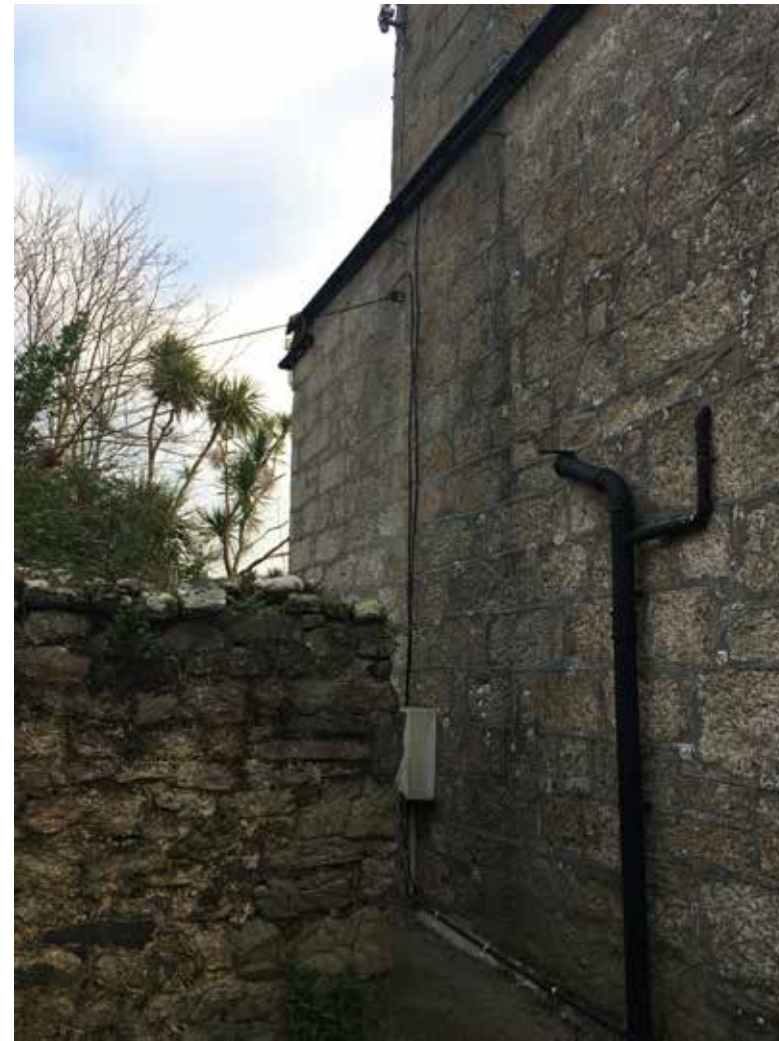
Figure 8 - North west elevation of Dolphin House (LHL)

The original side elevations are formed in randomly coursed **[Figures 8 & 9]**, roughly squared granite, and have been painted in some areas. There are no windows in the side elevations. Each features a substantial chimney breast that occupies much of the elevation. These terminate in granite stacks that have subsequently been extended with red brick, presumably to improve the draw.

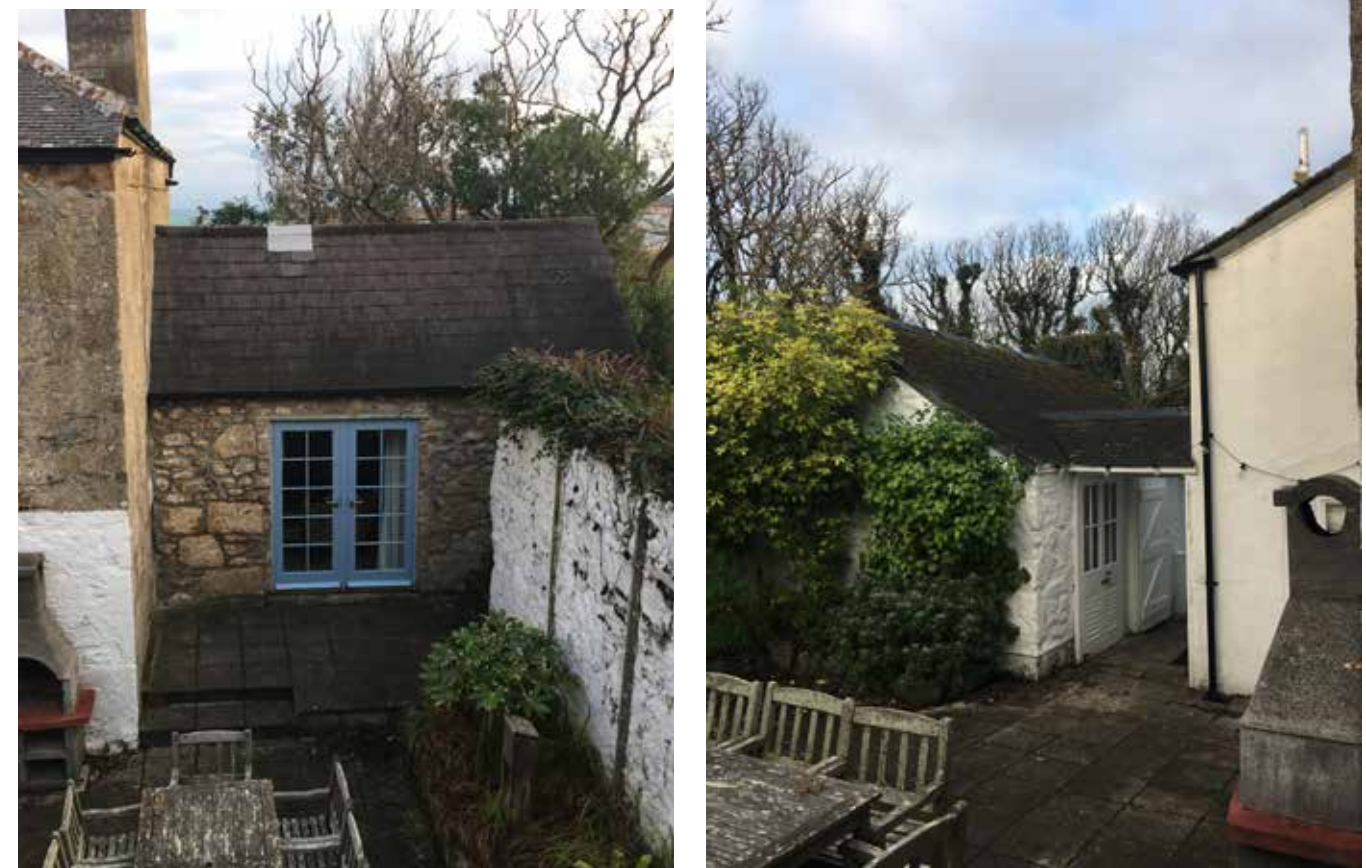
Figure 10 - South east service extension & Figure 11 - Outbuildings in the courtyard behind Dolphin House (LHL)

The building has been extended on the south east side elevation, with a small single storey masonry wing with double pitched slated roof (not scantle) **[Figure 10]**. This wing is identifiably present on the 1888 map. However, the masonry here is not jointed into the side elevation of the main body of the house, demonstrating that it not original. It is also cruder, with more irregularly sized and shaped stones, particularly on the rear elevation, which perhaps indicates that the extension has been altered or that the less visible rear elevation was built of lower quality.

To the rear of the house is a small sunken courtyard, bounded by high walls and outbuildings that retain the land to the south. The 1908 map shows these buildings formerly wrapped around all sides of the rear yard. Now only the NW portion of these buildings remains **[Figure 11]**. This is split into three cells, two of which are currently unroofed. A notably large flat granite slab is embedded into the internal masonry of the northwest elevation. A slate lined water tank, used to store rainwater when there was no mains water supply on the island, is still present adjacent to the northeast elevation.

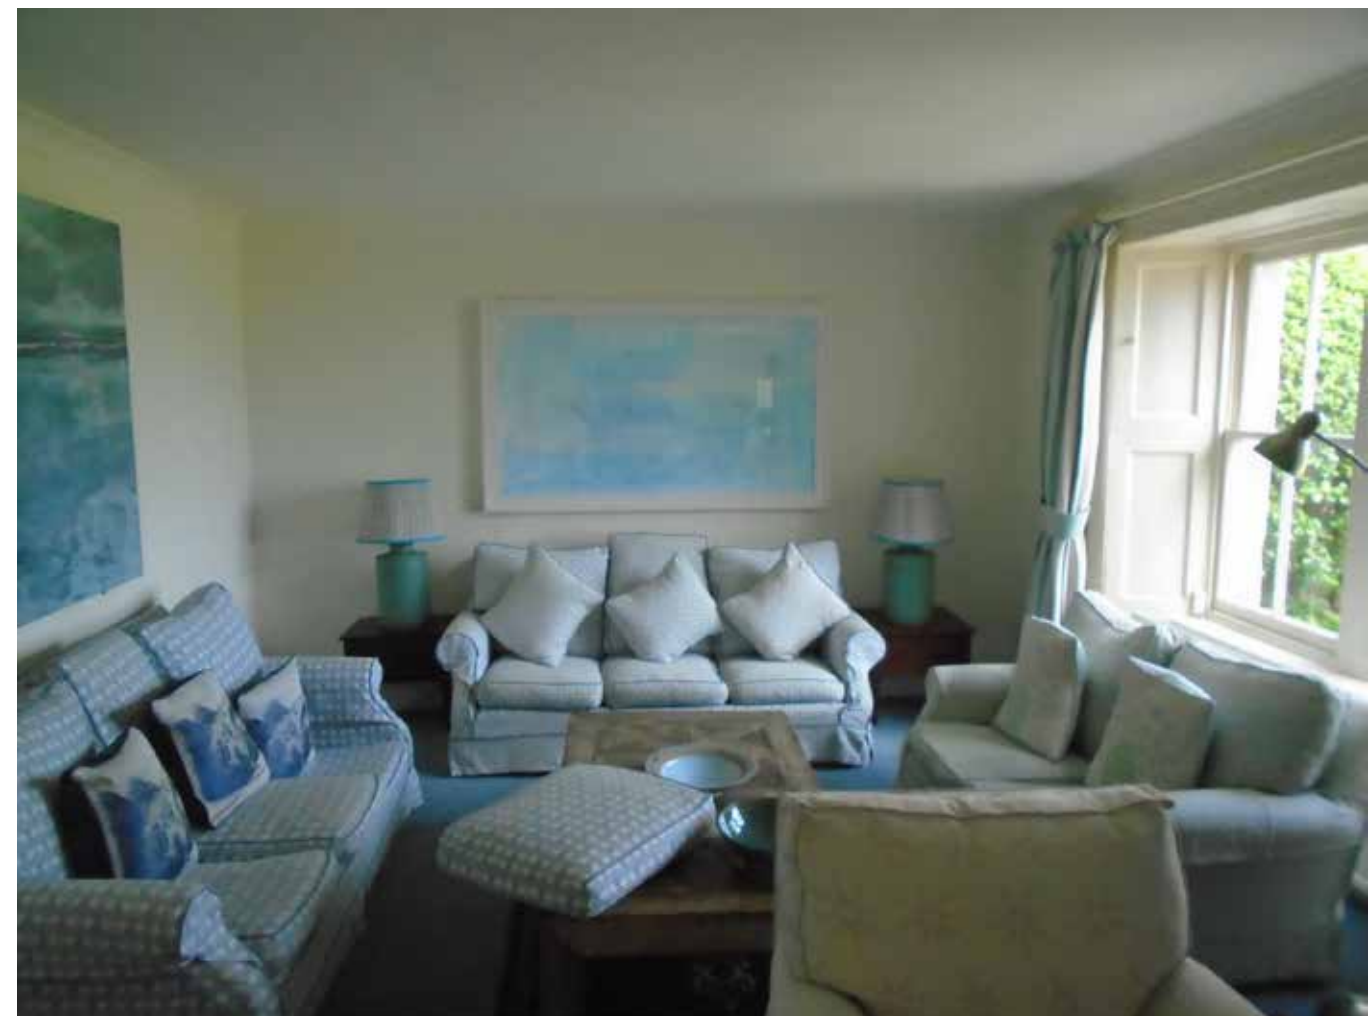
Figure 12a - Ground floor sitting room looking north west (Tresco Estate)

There is an original radial fanlight centred in the north east elevation, above an original six-panelled door, which has had the two central panels taken out and glass added. This would have been the original front door. Opposite, there is an original six panelled door onto the stair hall. Throughout the room there is modern coving and carpet. There is a large opening in the south west wall that opens onto the kitchen, with a modern architrave. There is a modern stone, bolection style fireplace with a raised hearth on the south east elevation. There are pairs of two over two sash windows, with a central mullion, which are C19th replacements. The architrave, panelled reveals, apron and soffit are original [Figures 12a and b].

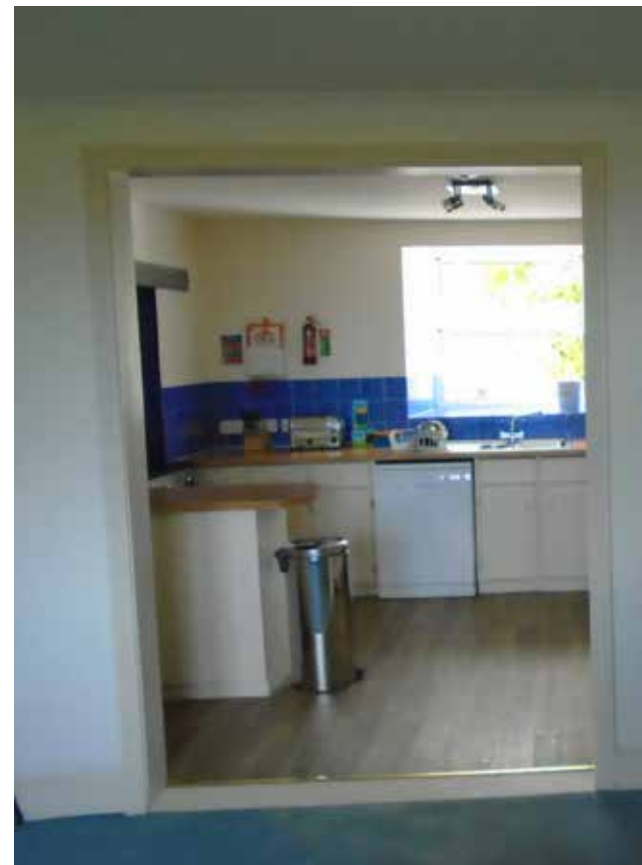
Figure 13 - Kitchen viewed from the sitting room (Tresco Estate)

The kitchen has modern fitted units and a modern laminate timber floor. There is no cornice. The sill of the window has been raised to accommodate the kitchen units and a modern uPVC window inserted. There is a non-original opening in the south east wall, formed to link the house to the eastern-service wing when this was converted from an outbuilding to an internal room. In the south east elevation the fireplace has been enlarged to accommodate a range cooker, with a modern timber lintel and extractor above [Figure 13].

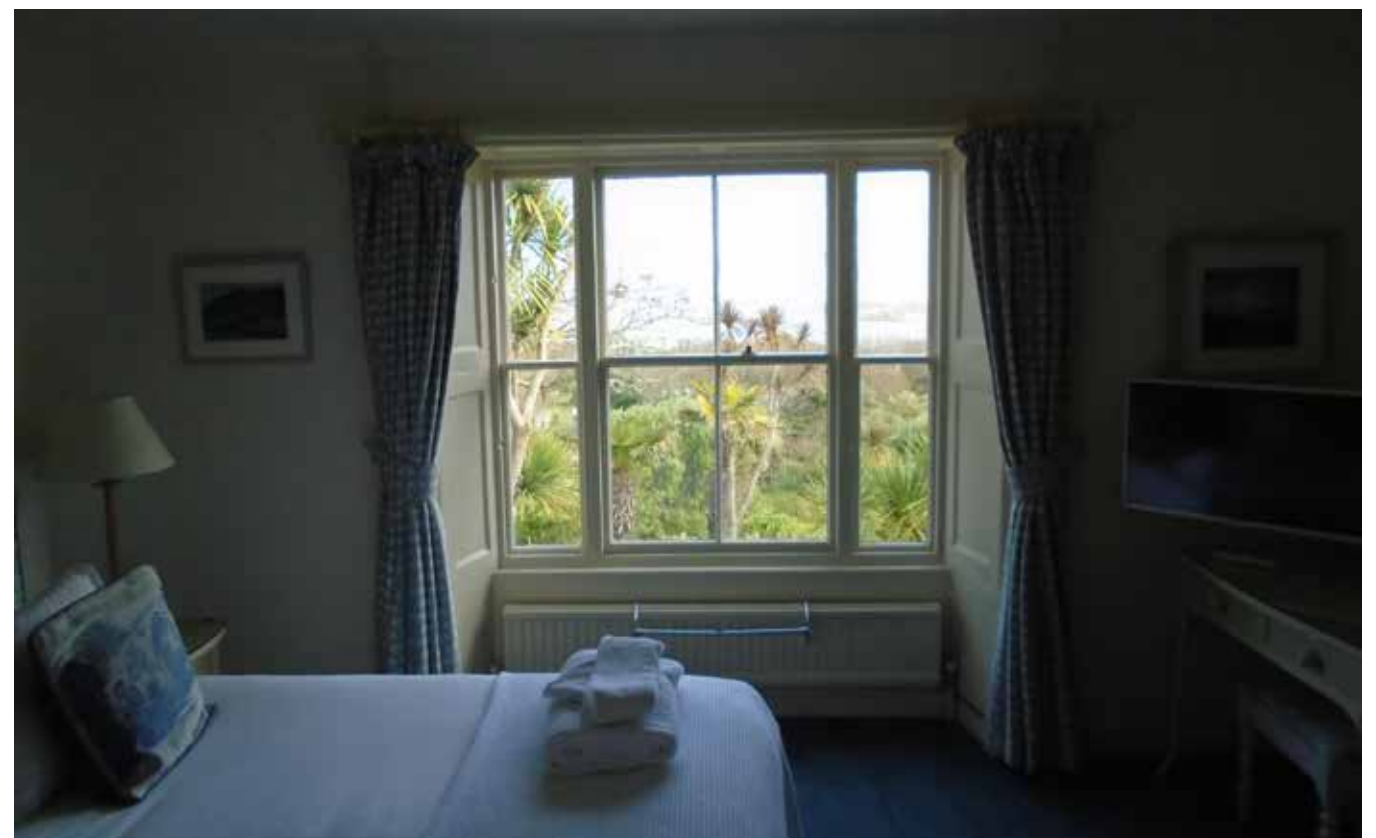
Figure 15 - Original window joinery in bedroom 2 (Tresco Estate)

There is a two over two central sash with two fixed half-width side lights, which are C19th replacements. The architrave, panelled reveals, apron and soffit are original [Figure 15]. There is an original six panelled door and architrave onto the stair landing. There is a modern cornice and carpet. The door and architrave leading onto the ensuite are modern.

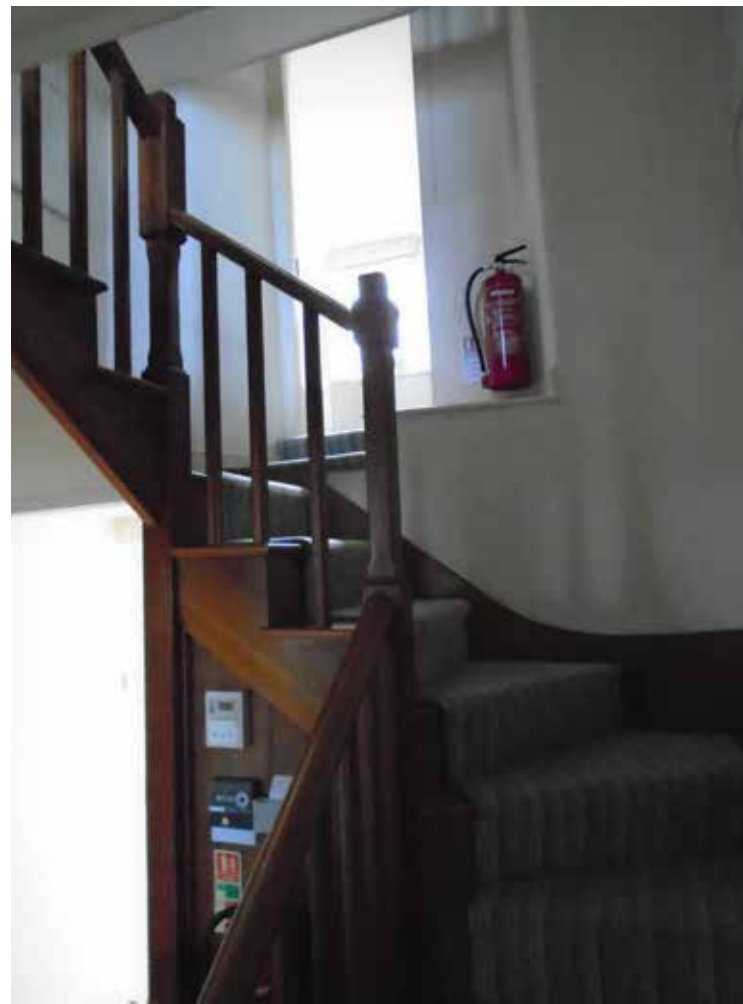
Figure 16b - Staircase ground to half landing and access to rear extension

The timber staircase is modern from the ground floor to the attic and appears to date from the mid-to-late C20th [Figures 16a, b, c, d and e]. The staircase has an awkward junction to access the half landing bathroom in the rear extension and a landing above, to access the attic, which cuts across the original opening of the stair light. Under the first floor landing and below the pitch of the roof there is inadequate headroom. The current staircase form does not likely reflect the form of the original staircase.

The staircase is a late C20th installation, of inappropriate style, and poorly planned configuration, which does not reflect the layout of the original staircase. Head clearance under the half landing to the rear entrance door is insufficient. The half landing leading to the attic bifurcates a tall one-and-a-half-height stair well window. This confident architectural gesture would formerly have flooded the stairwell with light, but is now enclosed by the rear closet wing. The awkward relationship of the modern staircase to access both the WC and the attic, suggests that the replacement of the staircase, creating access to the attic and the addition of a first floor closet wing WC, may have formed one phase of work in 1963 under planning application P.0410, *Permission granted for an extension to the rear of existing house*.

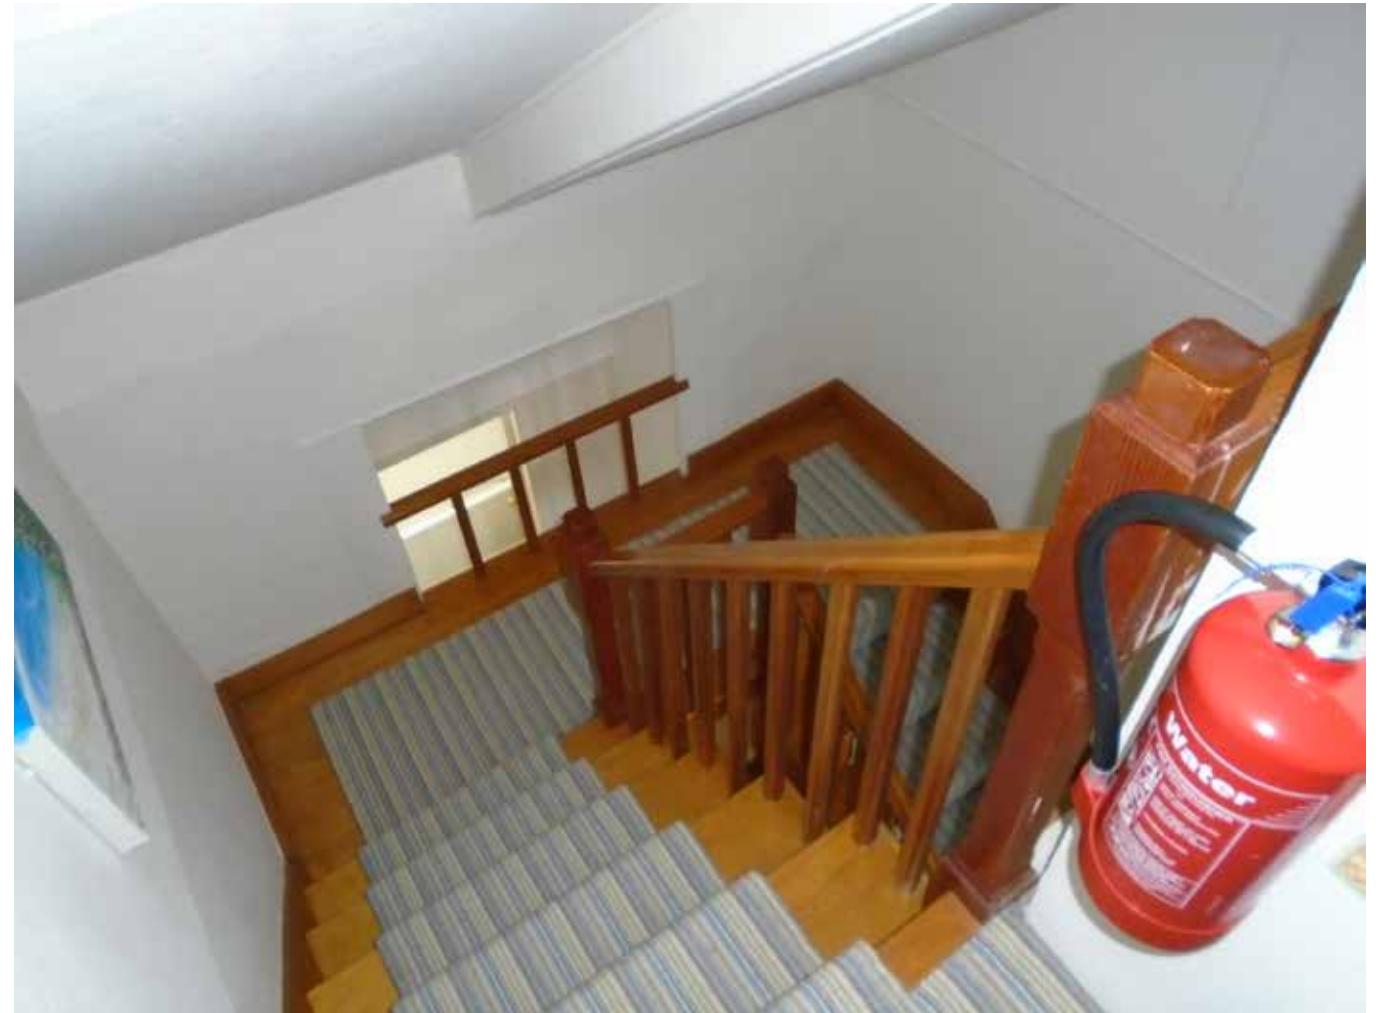
Figure 16d - Staircase to attic

The attic is small and awkwardly spilt into two small spaces, which are boarded and painted. With the insertion of the modern staircase, it is not possible to establish whether the attic spaces were originally intended to be inhabited. However, the awkward space and access, suggests that this was a later conversion.

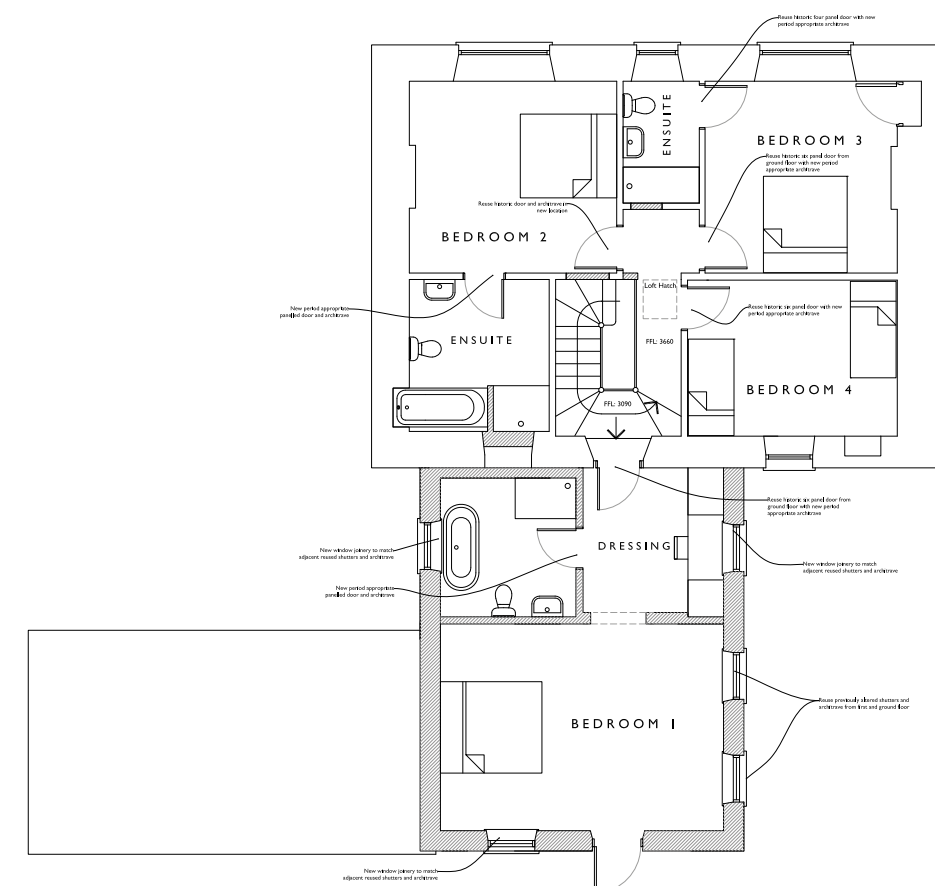
Figure 17a - Proposed Floor Plans (LHL)

Proposed First Floor Plan (LHL)

Proposed Ground Floor Plan (LHL)

This section of the building would be part demolished and enlarged. The majority of the principal north-facing granite masonry elevation, would be retained.

The gable and rear elevation (which has later poor-quality granite work and a 1980s timber French door) would be demolished and rebuilt to enlarge the size of the enclosed space. Material salvaged from the demolition would be used in reconstruction of the new masonry walls. The modern slate roof would also have to be replaced and rebuilt to suit the new footprint.
