# PRELIMINARY ECOLOGICAL APPRAISAL AND PRELIMINARY BAT ROOST ASSESSMENT OF:

GREEN FARM COTTAGE  
GREEN LANE  
PELISTRY  
ST MARY'S  
ISLES OF SCILLY  
TR21 0NX

*Client: Duchy of Cornwall*

*Our reference: BS28-2020*

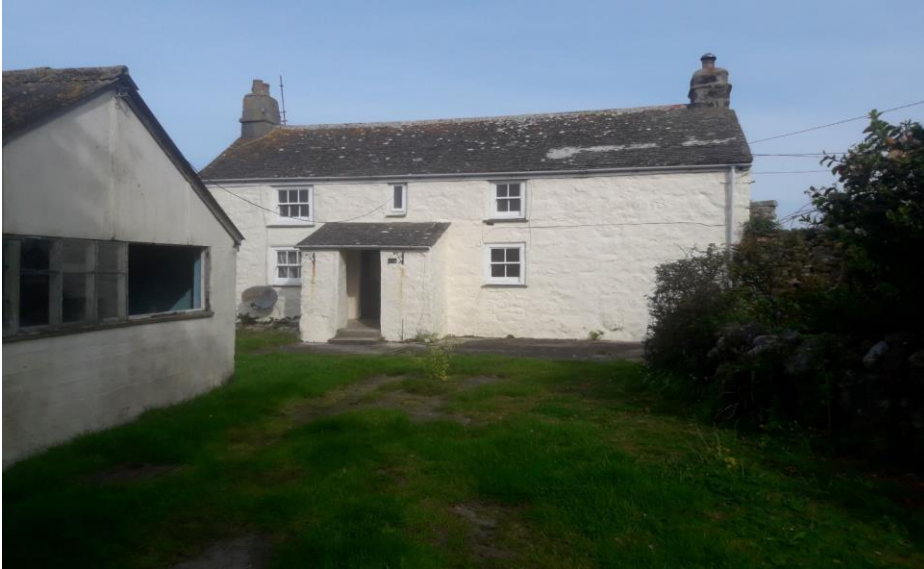
Photo 1.

The development is located at the northern end of Green Lane, Pelistry an area in the northern eastern part of the island of St Mary's (National Grid Reference SV9230611987). The application site is comprised of a detached .... (see photo 1), with two small outbuildings. The footprint of the building (including the outbuildings) is approximately 137m<sup>2</sup> and the total footprint of the site is approximately 846m<sup>2</sup> (red area, see Figure 1).

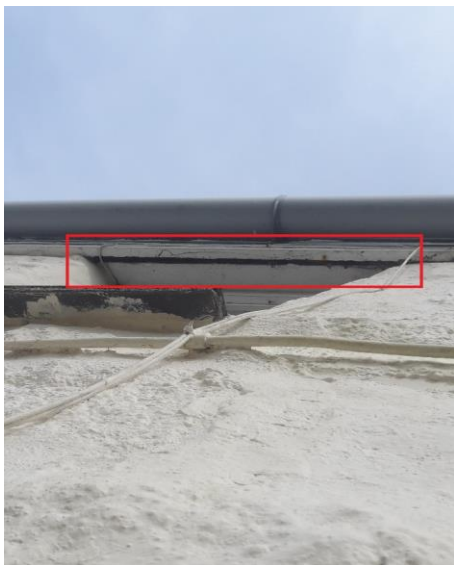
Photo 2.

- Gap between fascia and lintel above first floor window on south-east elevation (see Photo 2.)
- Large crack in render of the south-west chimney stack (see Photo 3.)
- Gap between the fascia and the south-east elevation towards the north-east corner (see Photo 4.)
- Gaps between the internal roof covering and gable wall ends of the external porch (see Photo 5.)
- Loss of scantle tile fascia in the south-east corner of the north-east gable end eaves causing gap between gable end roof tile (see Photo 6.)
- Gap between scantle tile fascia and open gable end of the north east gable end (see Photo 7.)
- Gap between fascia and smooth render of north-west elevation (see Photo 8.)
- Numerous gaps on both the north-west and south-east roof aspects between scantle tiles where mortar has been lost (see Photo 9.)

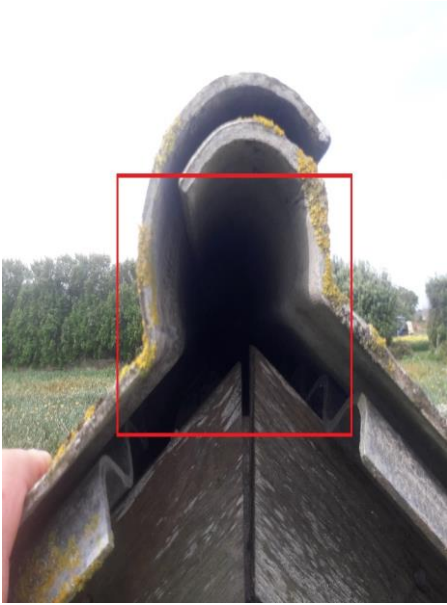
Photo 10.

- Gap between the frame and lintel and its adjacent blockwork and rafter to the entrance of the 1<sup>st</sup> outbuilding
- Gap between the corrugated fascia and the adjacent door lintel and frame of the first outbuilding
- Gap created between the overlapping ridge tiles and the apex of the north-east elevation of the 2<sup>nd</sup> outbuilding (see Photo 10.)
- Missing glazing from the windows of the 2<sup>nd</sup> outbuilding
- Gap between the timber lintel and wooden door of the 2<sup>nd</sup> outbuilding (see Photo 11.)
- Missing mortar between the granite blocks, particularly the dividing wall (see Photo 12.)
