- **BARN ON LAWRENCE'S BROW, ST MARTINS**
- **STATEMENT OF SUSTAINABLE DESIGN**
- **SITE WASTE MANAGEMENT PLAN**
- **EVALUATION OF BUILDING NEEDS**

**STATEMENT OF SUSTAINABLE DESIGN;**

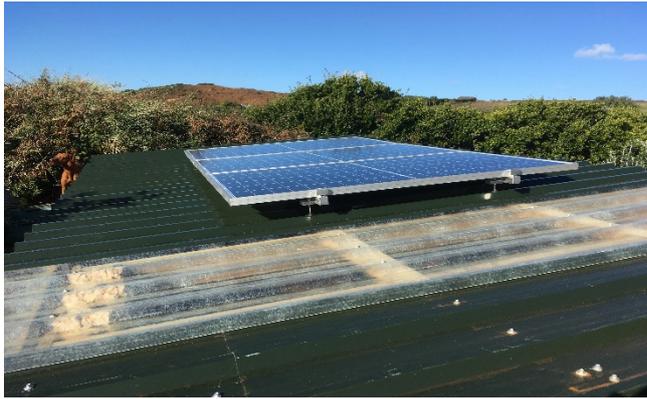
Three solar panels are mounted on the roof, to provide all electricity for the building and ancillary shower shed. (see photo's)

The barge boards, under the roof sheets have individual nesting compartments, with varying sized holes for different bird species, 14 in total. So far this season they have provided homes for 2 sparrow broods, one wren brood and a successfully fledged family of 5 swallow chicks, in the deliberately open-ended barge boards.

The corrugated roofing has been replaced, with mostly metal roofing panels except one clear roofing panel, to allow natural light inside the building.

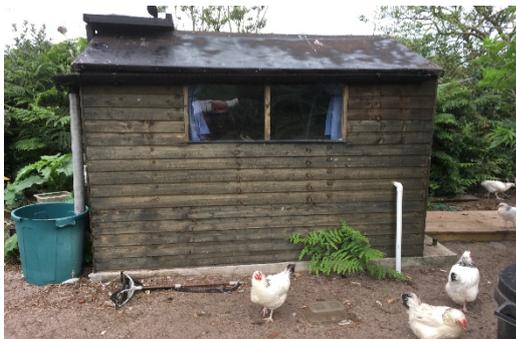
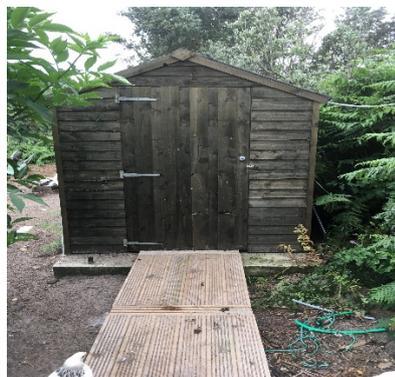
The shower shed, (Marked next to the main building, in red on the plan) is an off-the-shelf wooden 8x6 shed. (190cm H, 180cmW, 240cmL) see photo.

It is mounted on a 15cm concrete reinforced slab.

The shed also has benefit of under floor wool insulation, an electric light supplied by the main roof panels, a solar shower, by way of a roof mounted shower bag, a hand wash water basin, with the water being drawn from the main tanks by boat style bilge pumps. The waste water from these go to a submerged soak-away gravel pit.

There is a double north facing window in the shower shed, for natural light.
