### **Bat Survey Report**

Site: Moorings, Tresco, Isles of Scilly, TR24 0PW

### **Plan for Ecology Ltd**

<b>Site Name:</b>	Moorings, Tresco, Isles of Scilly
<b>OS Grid Reference:</b>	SV 8934 1560
<b>Report Author:</b>	Dr Lucy Wright BSc (Hons) MSc PhD MCIEEM
<b>Document Approved by:</b>	Dr Kim Jelbert BSc (Hons) MSc PhD MCIEEM
<b>Client:</b>	Tresco Estate
<b>Report Reference Number:</b>	P4E2290
<b>Version:</b>	01
<b>Date:</b>	30 <sup>th</sup> September 2021

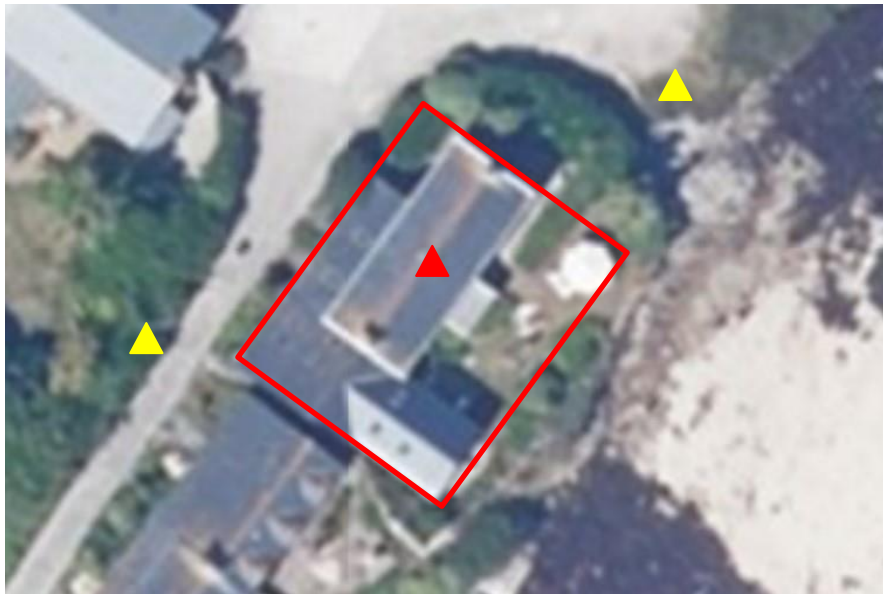
Figure 1: Emergence surveys – surveyor locations. The dwelling is outlined red. Yellow triangles show surveyor locations on both emergence surveys and the red triangle shows the location of the static detector within the roof void over the first floor (void 2); droppings were also collected here.

To provide more detailed information about bat activity, a static detector survey was carried out between the nights of 10<sup>th</sup> – 16<sup>th</sup> May 2021. A static bat detector (Anabat Express) was installed within roof void 2 above the first floor of the dwelling. The detector was set to record continuously overnight (30 minutes prior to sunset until 30 minutes after sunrise) for a total of seven nights. The Anabat Express uses the frequency division method of detecting as described in Section 3.2 above.

One sample of droppings was collected from the roof void above the first floor during the initial visual assessment (Fig. 1; red triangle). The sample was sent for DNA analysis to provide further information on the species present. DNA analysis was carried out by SureScreen Scientifics Ltd, Derbyshire, U.K.

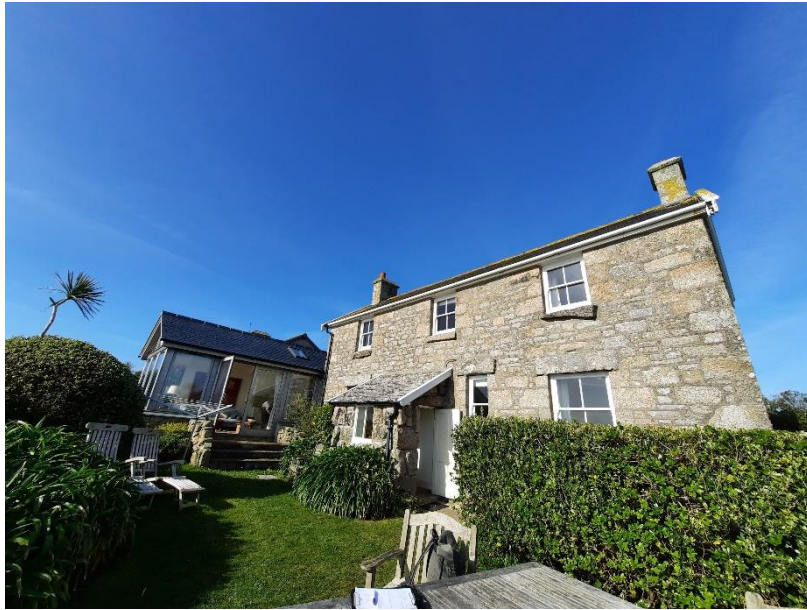
The building comprises a detached two-storey dwelling of stone construction, with a single storey extension on the south and west elevations, and a small lean-to (porch) on the south-east elevation (Figs. 2-3). The building features a pitched scantle slate roof which is largely tight with no obvious gaps. There are two chimneys on the main pitched roof, both of block construction and which appear tight, although there are occasional gaps underneath the lead flashing with potential to support crevice-dwelling bats. At the eastern elevation is a porch/ lean-to projection with mono-pitched traditional slate roof. The single-storey extension on the south-east elevation features large glass windows; here the construction and roof appeared tight with no obvious gaps.

Figure 2: East elevation of Moorings showing single-storey glazed extension to the south, and small lean-to porch.

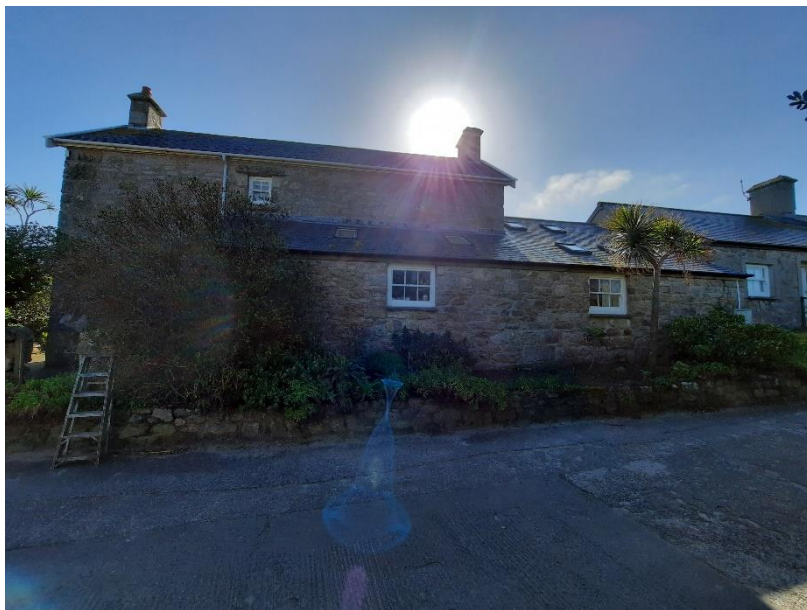
Figure 3: West elevation showing single-storey extension wrapping around the west and south elevations.

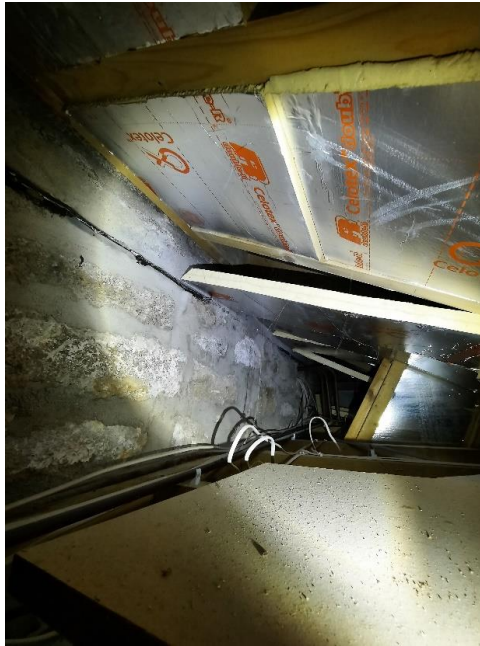
Internally the cottage features two roof voids; a narrow roof void above the single-storey kitchen extension on the north-west elevation (void 1; Fig 4) which is accessed from a loft hatch on the ground floor, and a separate larger roof void above the first floor of the main part of the house (void 2; Fig 5). Both voids were viewed only from the loft hatches.

Void 1 is a small, narrow, dark, well-sealed void and features thick insulation blocks lining the mono-pitch roof, with a bitumen membrane beneath (Fig 4). The void was densely cobwebbed. No evidence of roosting bats was found within this void, although it was not possible to fully inspect this area due to access restrictions.

Figure 4: Interior view of void 1, above the kitchen.

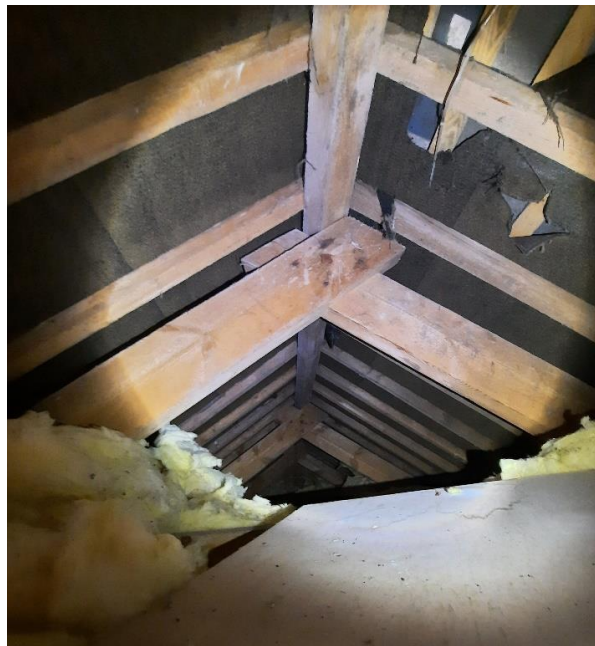
Void 2 is in the apex of the main part of the building with a shallow timber A-frame structure supporting the pitched roof (Fig 5). Within this void there is a thick layer of rolled insulation between the floor joists. The roof is lined with bitumen, which is torn and sagging in places. A light scattering of droppings (c. 20) typical of bat droppings, was noted on the insulation close to the loft hatch. It was not possible to fully inspect this area due to access restrictions.

Figure 5: Interior view of void 2, above the first floor.

DNA analysis of a sample of droppings collected from void 2 confirmed that the droppings were deposited by the insectivorous Lesser White-toothed Shrew (*Crocidura suaveolens*), and not by a bat species.
