## **Preliminary Bat & Bird Assessment**

The Moorings, Tresco, Isles of Scilly, TR24 0PW

23<sup>rd</sup> March 2021

### **Plan for Ecology Ltd**

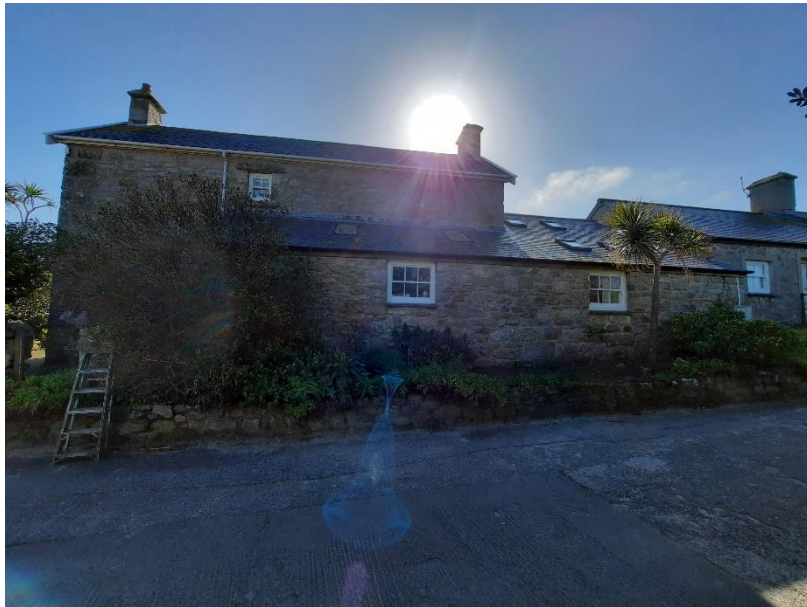
Figure 1: View of the north-western elevation of The Moorings; the existing single storey extension in the foreground will be converted as per the proposals.

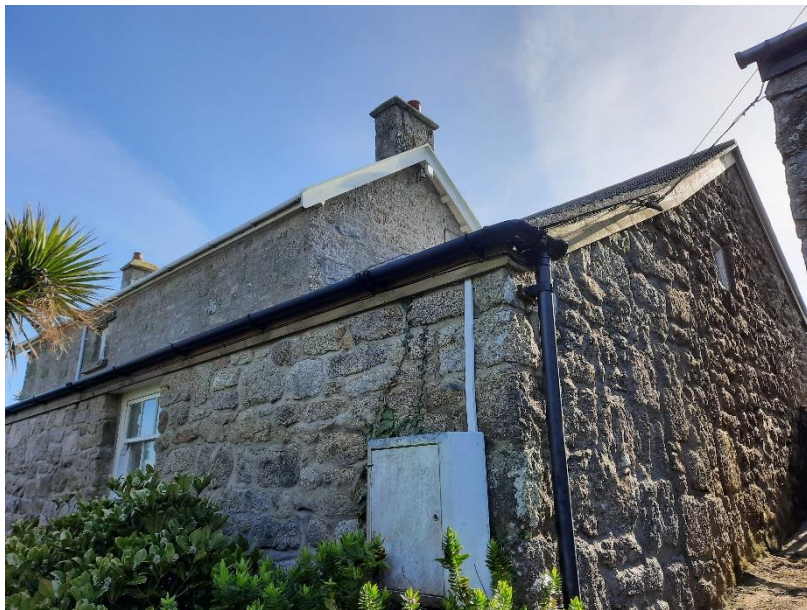
Figure 2: View of the western elevation at The Moorings.

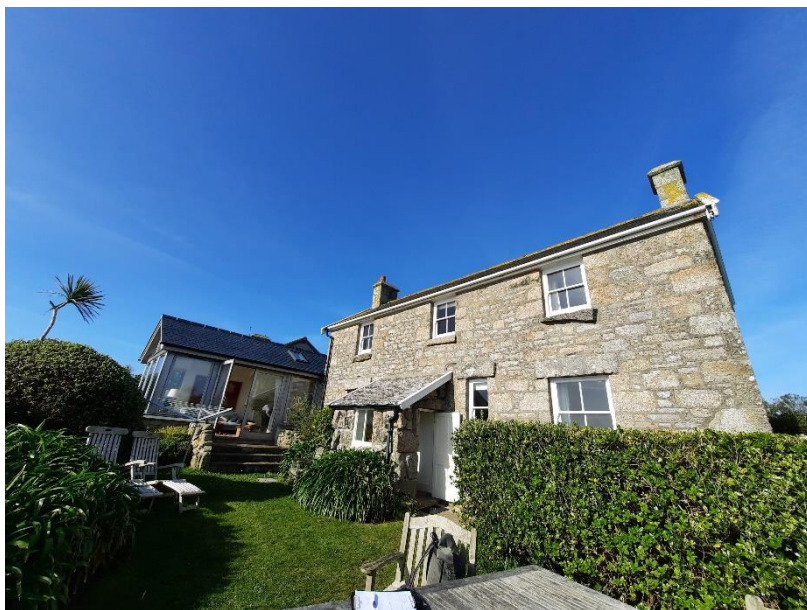
The building surveyed comprised a detached two-storey residential dwelling of stone construction, a single storey extension projects on the north and west elevations and a small lean-to (porch) on the south-east elevation (Figs. 1-4). The building features a pitched scantle slate roof which is largely tight with no obvious gaps. There are two chimneys on the main pitched roof, both of block construction which appears tight, although there are occasional gaps underneath the lead flashing with potential to support crevice-dwelling bats. At the eastern elevation is a porch/ lean-to projection with mono-pitched traditional slate roofs. A newer extension of large glass windows was on the southern elevation (Fig 3); here the construction and roof appeared tight with no obvious gaps.

Figure 3: View of the eastern elevation and a small lean-to (porch) and the southern elevation with a new/ 'modern' constructed single storey extension at The Moorings.

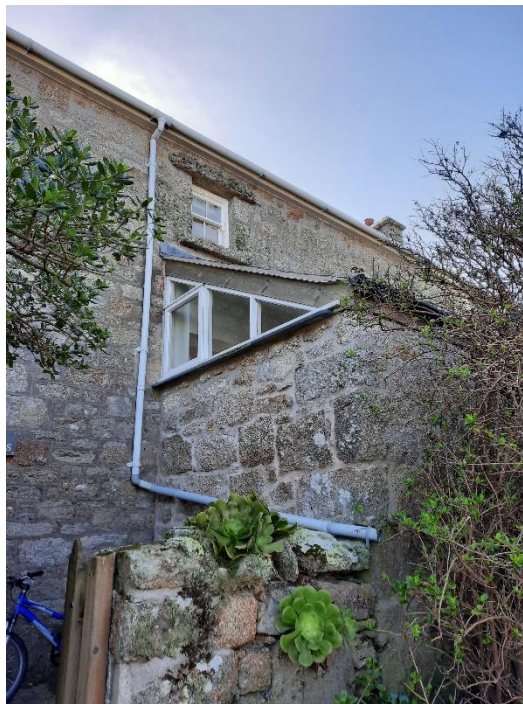
Figure 4: View of the single storey extension on the western elevation.

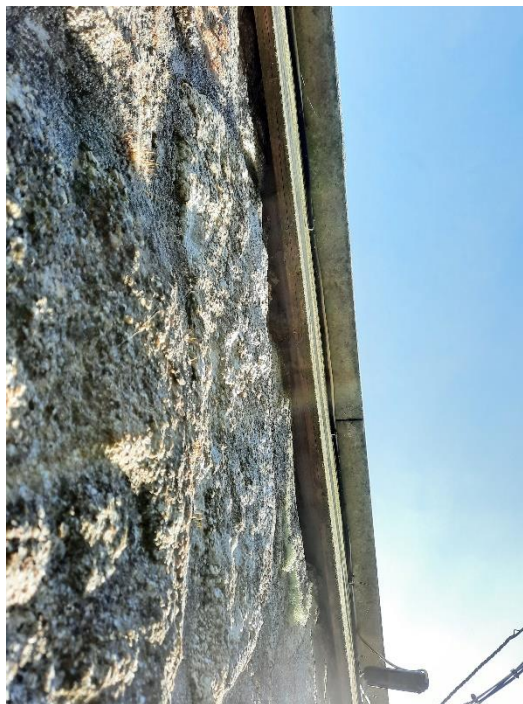
The cottages exhibit timber fascias throughout (Fig 5), and timber soffits on the northern and southern gable ends of the main house (not on the single storey extension) (Fig 6), plastic guttering and downpipes, timber doors and timber framed glazed windows. The newer extension to the south had uPVC doors and windows. Throughout the building there are notable gaps behind the fascias and beneath the soffits and stonewall (Figs 5-6), these provide potential roosting opportunities for crevice dwelling bats.

Figure 5: View of gaps beneath the timber fascia board.

No evidence of bats was observed within void 1 (directly impacted by proposals) but a number of bat droppings were seen within void 2 (not directly impacted by proposals), also a small number of exterior features on the building (gaps beneath the soffits and between the fascia's and wall tops) have some potential to support crevice dwelling bats and provide potential access for bats into the roof void. In accordance with best practice guidelines (Collins, 2016), the building was assessed as being of **'moderate suitability'** for roosting bats. **In accordance with the Collins (2016) a minimum of two bat emergence or re-entry surveys are required between May and September. Once of these should be undertaken between May and August.** These surveys will determine the species, number of individuals, bat access points, timings of usage and any requirement for a Natural England bat mitigation licence to permit works.

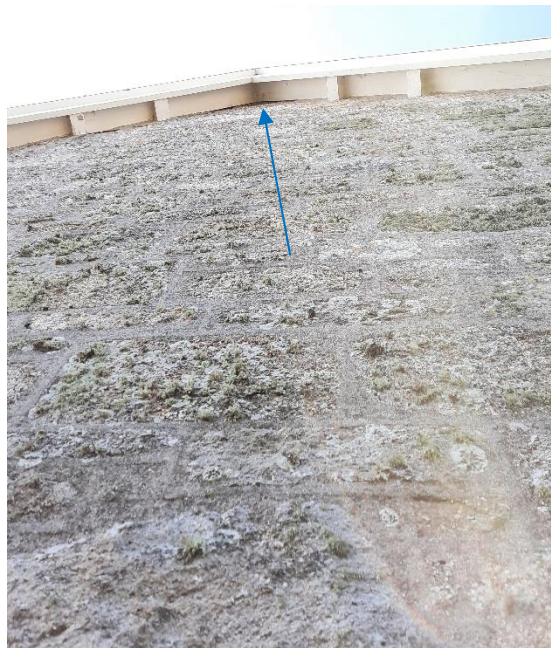
Figure 6: View of gaps beneath the timber soffits on the northern gable end at The Moorings (shown by the blue arrow).

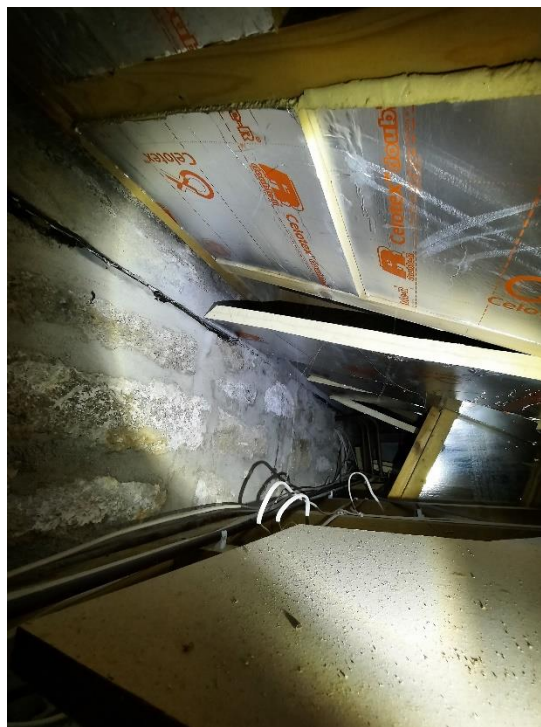
Void 1 is a narrow, dark, well-sealed void and features thick insulation blocks between the timbers supporting the roof and the void floor, with a bitumen roof membrane lining the roof (Fig 7). The void was densely cobwebbed. The void was adjoining the wall of exposed stone. No evidence of roosting bats was found within this void, although it was not possible to fully inspect this area due to access restrictions.

Figure 7: Interior view of void 1, above the kitchen.

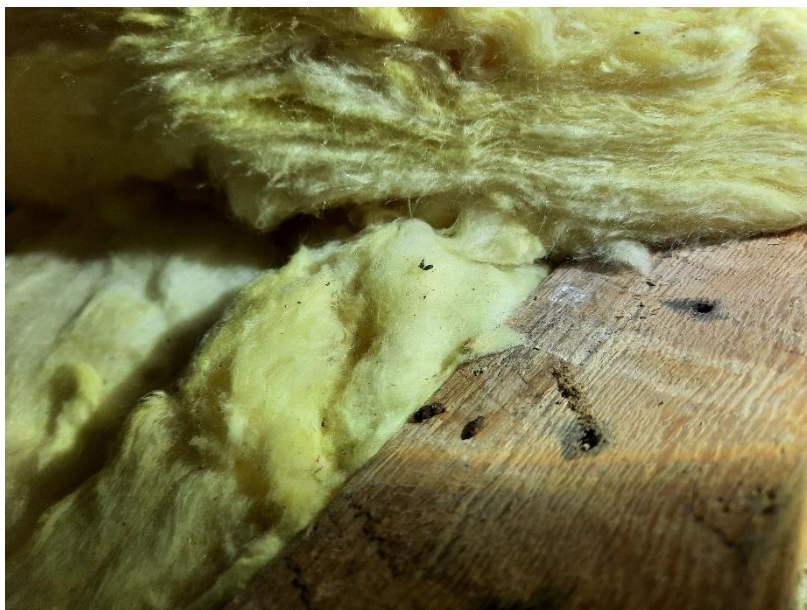
loft hatch and the droppings were characteristic of a long-eared bat spp., likely to be brown long-eared bat (*Plecotus auritus*) as the site is outside the known range of grey long-eared bat (*Plecotus austriacus*). NB: species present must be confirmed with DNA analysis of bat droppings.

The Moorings, a confirmed bat roost, was assessed as being of '**moderate suitability**' for roosting bats.

Figure 9: View of three bat droppings (one crushed) within void 2 at The Moorings.
