**RESULTS OF A VISUAL ASSESSMENT
AND FURTHER BAT SURVEY WORK ON
VERONICA LODGE, GARRISON WALK,
HUGH TOWN, ISLES OF SCILLY**

September 2020

O.S. Grid Ref: SV 9004 1054

Report No: 19-267/DofC/Veronica Lodge, St Marys, I of S_Further Bats

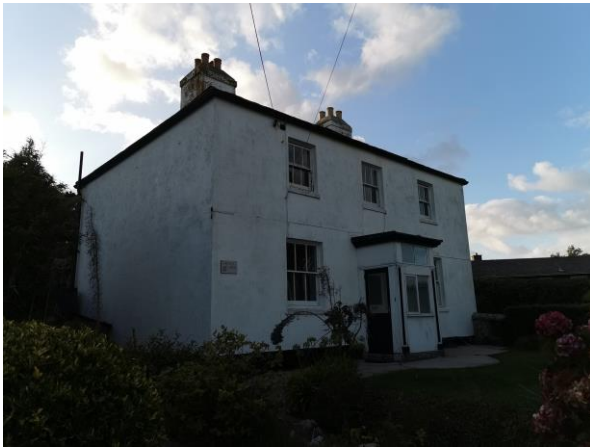
Photo 1. Showing the front of the house from the south east

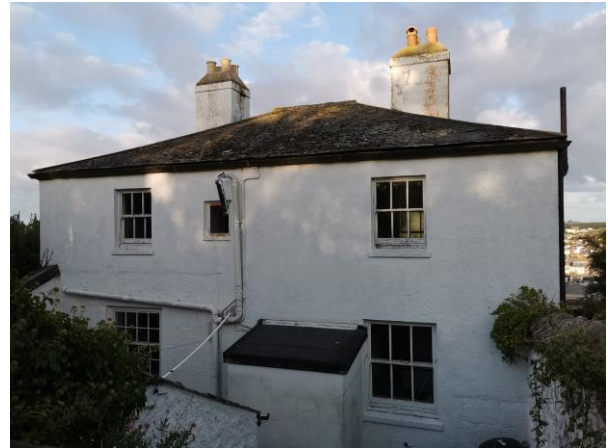
Photo 2. Showing the rear of the house from the west

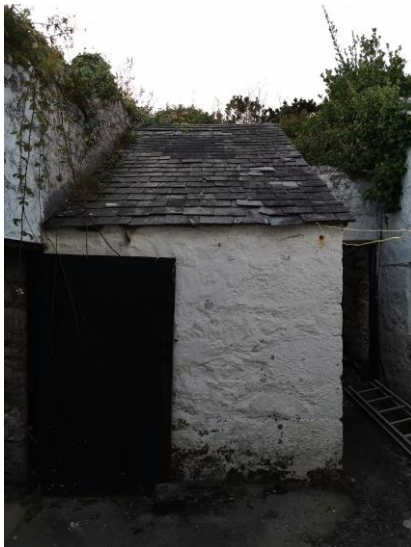
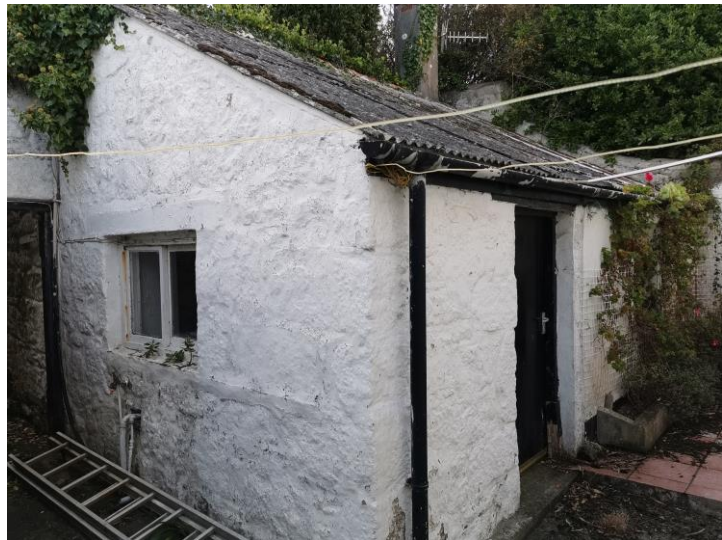
Photos 3 and 4. Showing the outbuildings located to the rear of the house

The southern outbuilding to the rear of the house is a fairly narrow building with white painted stone walls and an unlined slate covered roof. Internally it is a single dark, cold and damp room accessed by a timber door, there are a small number of lifted slates but these do not appear to extend to create cavities in which bats are likely to roost.

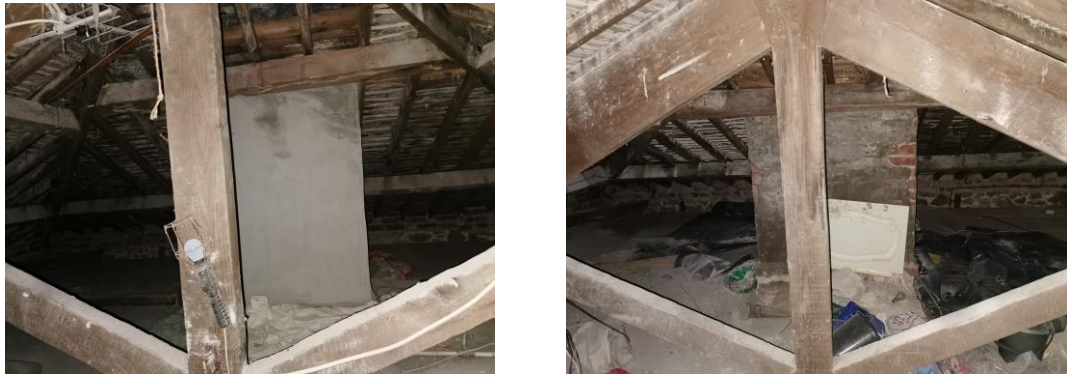
There is a single roof void over the house with two chimneys passing up through it and the roof has a fairly shallow pitch with a small section of ridge in the centre. The roof is supported by timber trusses, making it fairly open, and the underside of the roof is lined in places with lime render, see photos 5 and 6.

Photos 5 and 6. Showing the interior of the roof void over the house

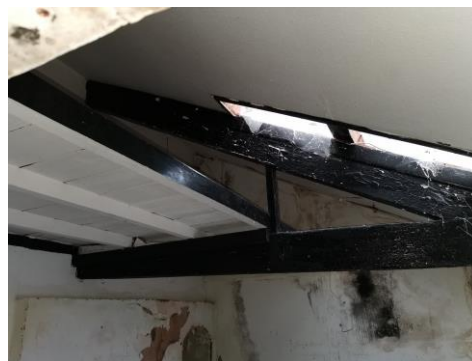
The northern outbuilding is larger, it is also built from stone and is roofed with corrugated cement fibre sheeting. It is divided into two rooms internally, which are fairly light due to windows and roof lights, the southern one being smaller and containing a sink and a fridge and the northern one being open. Within this building the underside of the rafters supporting the roof are lined with plasterboard creating a small enclosed area, see photo 7. This building also appears damp.

Photo 7. Showing the interior of the northern room within the northern outbuilding
