Heritage Statement & Impact Assessment

Proposed Alterations and Refurbishment

Veronica Lodge

Version 3: 24 June 2021 Silverlake Design Ref: 3386HIA

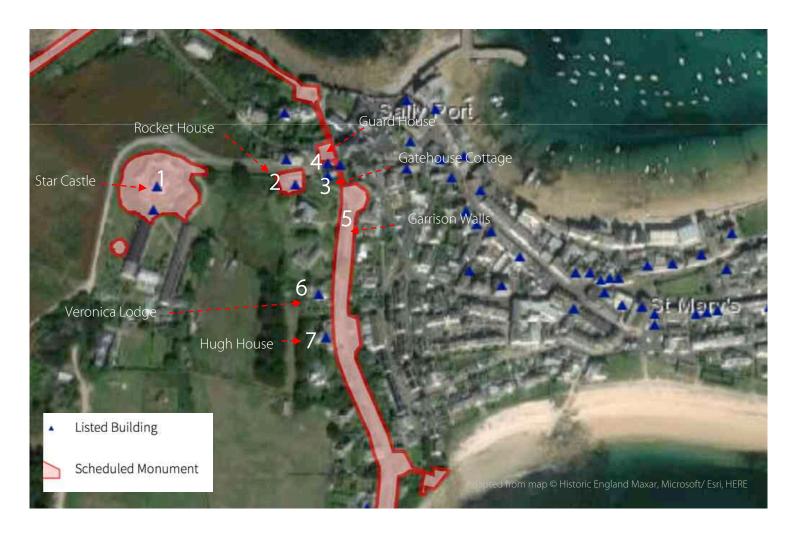
Map ⁵ showing Veronica Lodge (no 4) and relevant heritage assets within its setting. The numbers correspond to those in the table overleaf.

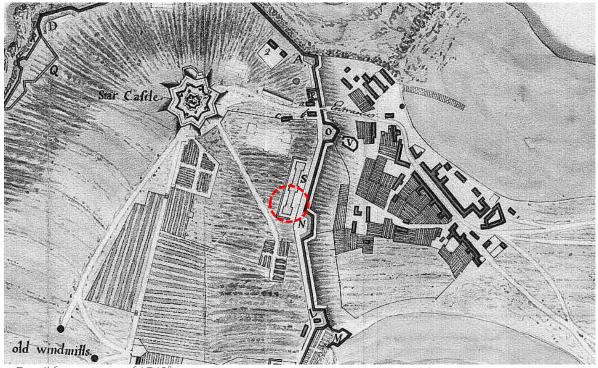
Detail from a map of 17428

The approximate location of Veronica House, which has yet to be built, is shown. The 'S' on the site denotes "A Barrack Projected", indicating a previous structure pre-dating Veronica Lodge. The area denoted 'N' to the south is coded as "garden platform" which, in 1750 was described as a "spacious kitchen and flower garden lying about half a furlong from Star Castle, in a level turfy plain⁹". This was associated with the historic gardens laid out in the C17 for the Lieutenant Governor.

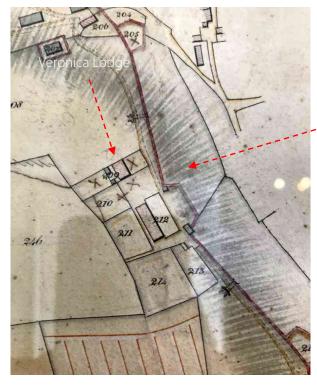
Veronica Lodge and Hugh House are depicted on a map of the garrison By Hillman 1829¹⁰. The map was annotated at an unknown date to show X denoting houses and gardens occupied by the coastguard service. The house lacks the porch to

the east side. The outbuildings to the west side appear consistent with those in the present.

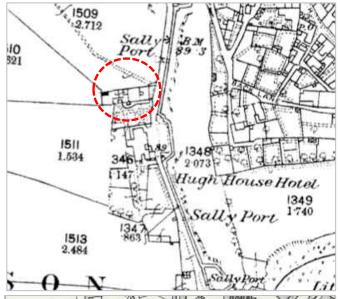
OS 25 inch 1890¹²

The house has acquired a porch to the east side, and possibly a structure to the rear conforming to the palimpsest of a single storey structure which is visible in the present.

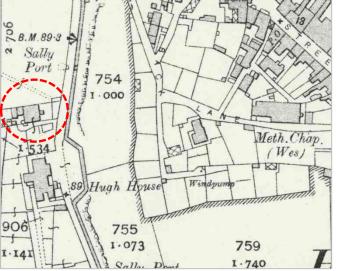
OS 25inch1908¹³

The east porch and structure attached to the rear (west) of the house are clearly depicted. The structure is possibly the single storey addition, no longer extant, but which conforms to the palimpsest on the west wall. Given that this would occlude the only window to the rear room it would be reasonable to assume that this was a glass house/conservatory.

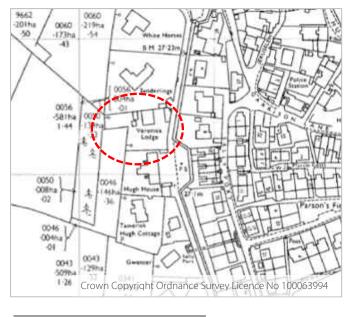
OS 25inch 1980¹⁴

Although the accuracy of depiction on the map cannot be confidently assumed, it suggests the structure to the rear is no longer extant. The map indicates the buildings show a remarkable continuity over time.

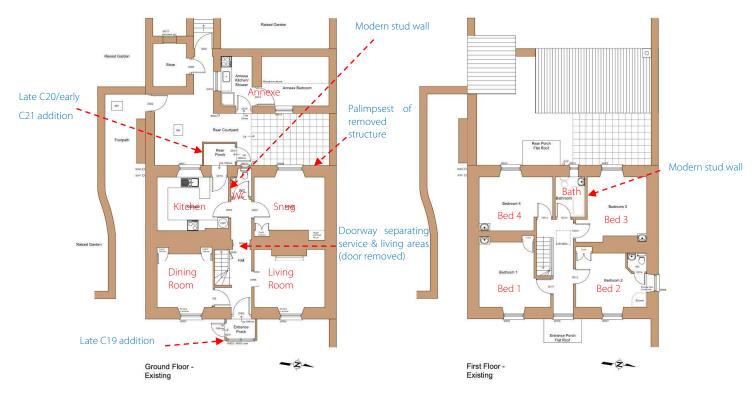
Drawing adapted from Duchy of Cornwall Existing MYS-VL-01Draft. January 2021.

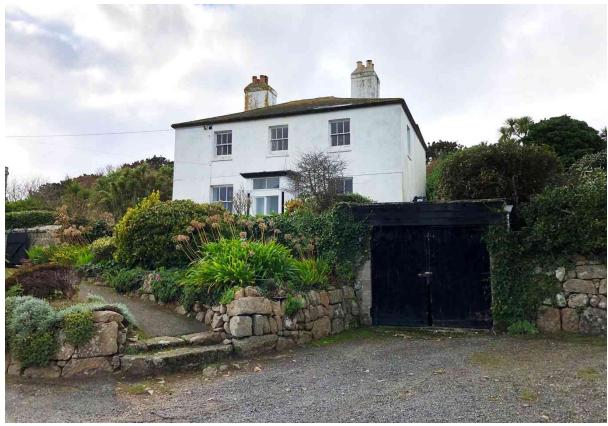
Top: The main elevation facing east

Below:The rear, west, side of the house showing the C20 porch and the ceramic tiles where a single storey addition was historically in situ

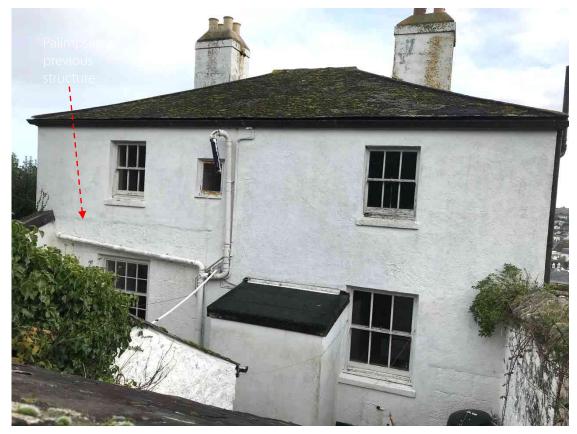
Rear (west) elevation of the property showing porch, palimpsest of former structure (possibly a conservatory) and the three windows scheduled for replacement.

Proposed work	Significance	Justification for proposed work	Further Guidance and Mitigation ⁴⁰
	of fabric/area	Impact on historic fabric/ heritage asset/setting/ significance	
Demolish the west (rear porch)	House: Medium Porch: Negative value	 This is an entirely C20 construction of poor quality and detracts from the property. Demolition and making good the area will aesthetically improve the rear courtyard and reveal the original plan, modestly enhancing significance. The existing modern glazed door will be replaced with an unglazed timber door, matching existing elsewhere to the rear. Impact: Minor -Beneficial	
Remove 3in1 waterproof wall lining and dry-lining and insulate walls with insulating lime plaster	House: Medium. Walls: Lining: Negative value Inappropriate impermeable lining over modern gypsum.	 Cornicing is modern and all walls appear to be gypsum plastered, likely all late C20. The 3in1 will serve to keep moisture trapped in the masonry wall fabric and is therefore likely to be detrimental. Removal is often challenging and may involve loss of the modern plaster, however the gypsum plaster is impermeable and may be contributing to the damp problems Woodfibre board insultation was been considered, but an insulating lime plaster was considered more appropriate for walls which are damp due to the exterior render. Further details for the insulating proposal are to be confirmed once walls are assessed for damp after a period of drying following 3in1 removal and any causes of continuing moisture identified. Insulation will enhance energy efficiency Impact: Potentially Minor -Beneficial 	o It is advisable to trial methods of removal of the 3in1 lining so as to cause least harm. Although most skirting appears modern, if any historic features survive then it is suggested these are carefully removed so they can be reinstated following works to the walls.

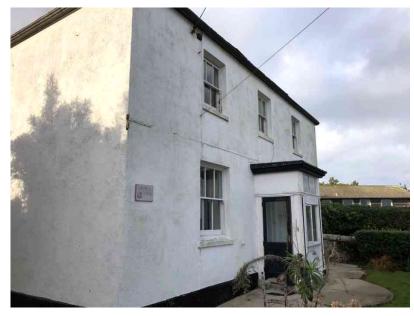
The east porch

- o The flat-roof porch appears entirely of C20 piecemeal construction, using various pieces of timber which may have been re-used from different contexts, including a four-panelled interior panel /door (original context unknown) and pieces of hardboard. Non-invasive investigation suggest this work substantially dates to the 1970s modernisaton, but has been augmented and repaired more recently by a tenant.

- o It does not appear from initial investigations that any elements original to the porch are incorporated, and although this may be clarified as works progresses, investigation also indicates that timber elements to be substantially rotted and beyond reasonable repair.

The porch is entirely modern materials and construction. It is in dilapidated condition and not considered of architectural or historic significance, indeed it detracts from the building.

Demolish and rebuild the front (east) porch	House: Medium Setting: High	 The porch is a mid/late C19 addition to the building and has been substantially altered in a piecemeal fashion since. The existing fabric is largely modern and no historic features of significance remain. It is currently detrimental to the building. The replacement porch will retain the same footprint and form, utilising the existing granite threshold. The door will be moved to the front. The new exterior door echoes the 6-panel design of the interior doors and would be typical of that period The existing inner door will be removed. The new inner door incorporates panels reflecting existing doors, with multi-light glazing so is more sympathetic to the building. Ceramic tiles and screed will be carefully removed from the granite threshold The proposed design is more sympathetic to the building Impact: Negligible-Beneficial

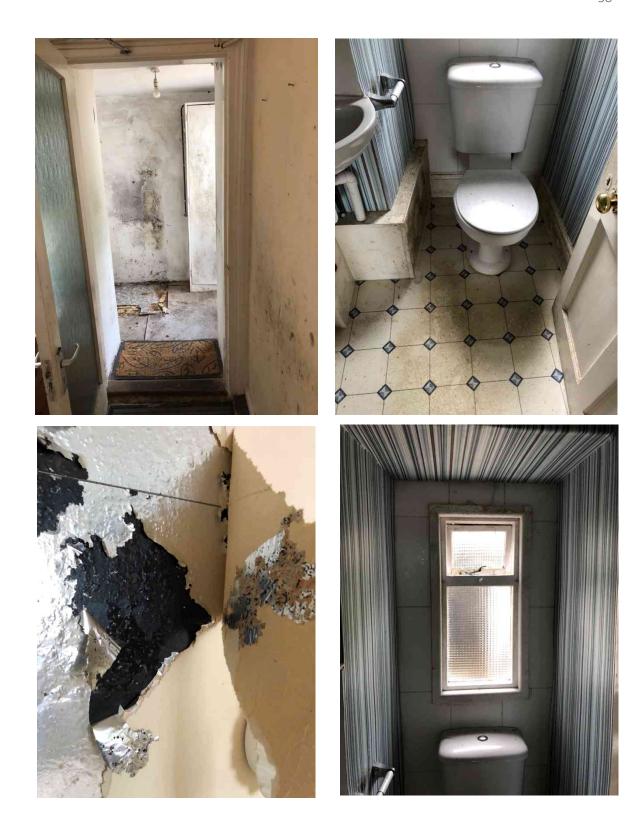
Many of the internal walls have been entirely covered with '3in1' impermeable lining, comprising foil, bitumen coating and waterproof paper. It is presumed this was to protect interior finishes from damp. As mentioned, this will contribute to keeping moisture trapped within the fabric of the wall, adversely effective performance and thermal efficiency.

Porch and WC Below left: Detail showing the 3in1 wall lining (bitumen, foil and waterproof paper)
