# PRELIMINARY ROOST ASSESSMENT (PRA)

## BARN AT HILLSIDE FARM, BRYHER, ISLES OF SCILLY

*Client: Ruth Eggins*

*Report date: 12<sup>th</sup> February 2022*

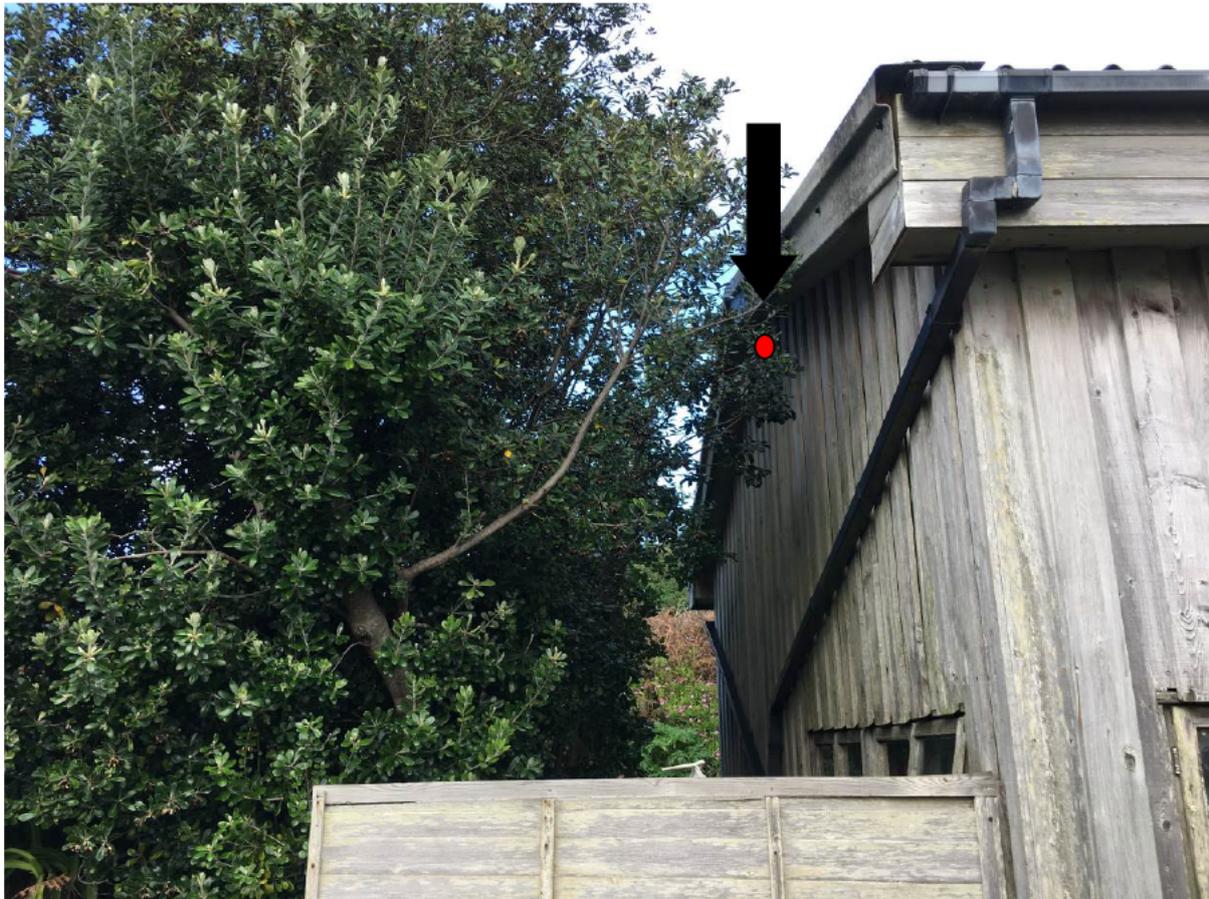
The box should be sited close to the apex on the western gable of the barn in the location indicated through the red circle on the photograph below. Positioning to the side of the door would avoid any risk of nuisance through bat droppings etc. as the open based box would avoid the requirement for cleaning or other maintenance.

This location has been chosen as it provides vegetated fly-in/out habitat for bats.

In order to enhance the provision of roosting opportunities in the local area, it is recommended that a wall-mounted bat box be installed on the western gable of the renovated barn. This should be positioned so that it not above the door – as an open-based box design it would not require cleaning and its positioning would ensure that no issues arise through bat droppings below the box. The location and aspect would be optimal for bats such as common pipistrelle which is the dominant species present on the island and the most likely species to use the environs for foraging and roosting. The proximity of the western gable to existing vegetation would secure a vegetated fly-in/out habitat.

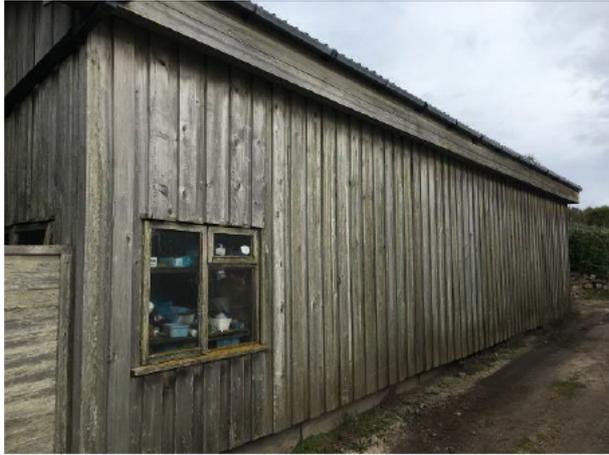
**Photograph 1:** Showing the southern aspect of the barn with one of the timber windows.

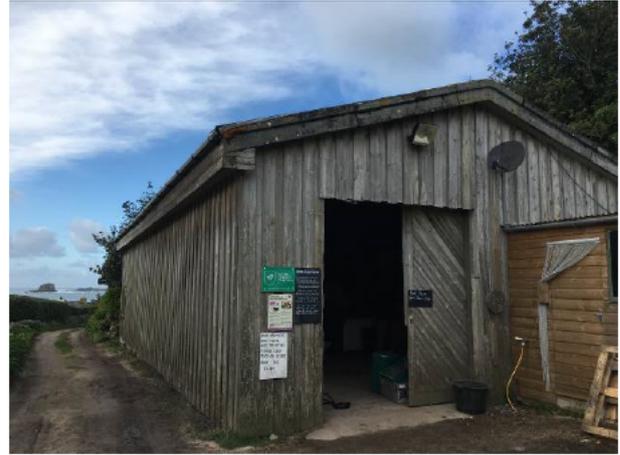
A small single-storey kitchen is attached to the right of the main doors on the eastern aspect – this is a separate, recently constructed building with shiplap cladding and a flat corrugated roof. Internally this is entirely sealed and hygienic with no external access features noted. No potential habitat for bats was identified associated with this attached building.

**Photograph 2:** Showing the eastern aspect of the building with the full-size barn door. The small kitchen associated with Scilly Chilli is visible to the side of this door.

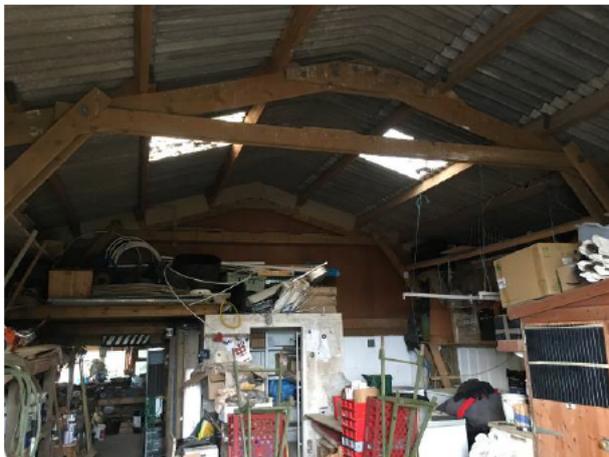
A careful internal inspection of the agricultural element of the barn identified no evidence of current or historic use by bats.

**Photograph 3:** Showing the interior of the main workshop/agricultural component of the barn

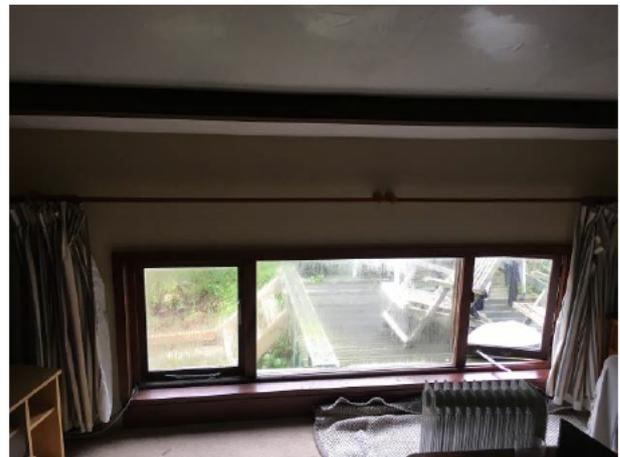
The residential component of the building is the only part of the structure that has two external layers which create a void. A close inspection of the exterior of the cladding in this section identified only a single location with a potential access to this void – on the western gable. An endoscope inspection identified dense cobwebs and no associated evidence of historic occupation. The corrugated roof sheets are well-sealed at the eaves preventing access to the void between these sheets and the ceiling of the residential component.

**Photograph 4:** Showing the interior of the residential component of the building with boarded out walls and ceiling

There is a negligible risk of individual bats accessing the void between the hit and miss cladding and the internal boarding on the western aspect of the building, by means of a single hole in the cladding. This aspect of the barn should be exposed carefully through removal of either internal or external boarding, and the area inspected visually for evidence of roosting bats prior to work proceeding further.

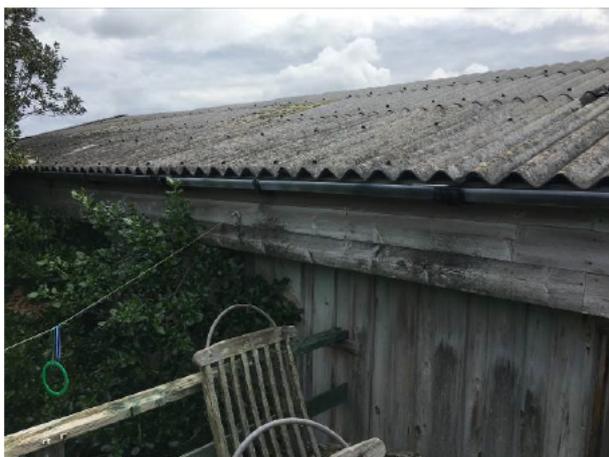
The corrugated sheets associated with the roof structure are tightly overlapping and no gaps were identified at these unions. The capping on the gables was generally tightly fitting or sealed with expanding foam – there are small gaps in the overlapping in places, though an inspection at height using a video endoscope identified that these were highly superficial and unlikely to be occupied by roosting bats.

**Photograph 5:** Showing the northern aspect of the building with the corrugated roof structure apparent.

The conversion works would result in the closure of the barn to nesting birds – this would prevent swallows from nesting. In order to address this, externally-mounted nest boxes for this species should be provided. These should be situated on the northern aspect of the barn where there is a good fly-in access for this species and where disturbance would be minimal.

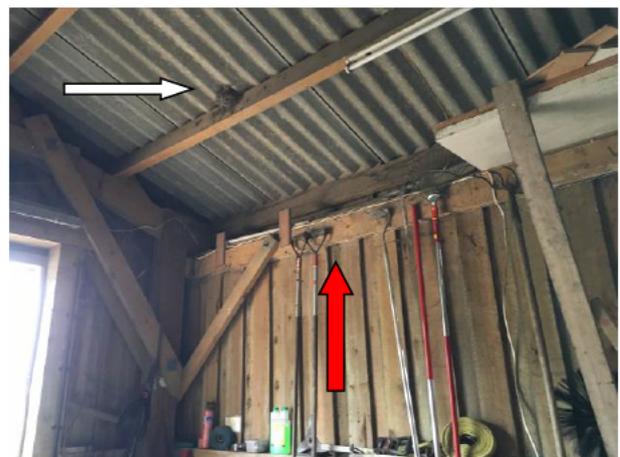
Internally within the agricultural element of the structure, there are limited features which could potentially be used by roosting bats. These are restricted to locations where there is an internal barge board running along the top of the internal hit and miss below the eaves; these features do provide apex cavities indicating notional suitability although inspection with an endoscope identified dense cobwebs and dust indicating no occupation by bats over a long timeframe. The ongoing use of the barn as both an agricultural workshop and as access for residential use means that disturbance, noise and light levels in evenings would make the interior of the barn a suboptimal location for a roost.

The building is confirmed as providing suitable nesting habitat for typical species including swallow – nests from last season were noted at the time of survey.

**Photograph 6:** Showing the interior of the workshop/agricultural component of the building. The swallows nest is visible (white arrow) and the barge board above the hit and miss boarding can also be seen (red arrow).

There is a negligible risk of individual bats making transient use of gaps between the hit and miss and the fascia board running along below the eaves internally in the workshop/barn component of the building. The fascia board should be removed carefully and by hand such that in the highly unlikely event of bats being present, they are not crushed and can disperse freely.

Careful observation of any potential nesting sites, including the confirmed swallow nest but also locations suitable for more discreet species such as robin or wren, would be required to ensure that the parent birds are not visiting a nest and provisioning the young. Nests are only protected if they are active (i.e. being used to rear young) or in the process of being built.

- Where active nests are identified, works affecting these areas must be delayed until the chicks have fledged the nest.
- Once it is confirmed that nests are absent or no longer active, the relevant features should be dismantled carefully and by hand as a precaution.
