# Heritage Statement & Impact Assessment

Proposed Re-roofing:

Ashvale

Silverlake Design Ref: 3643HIA

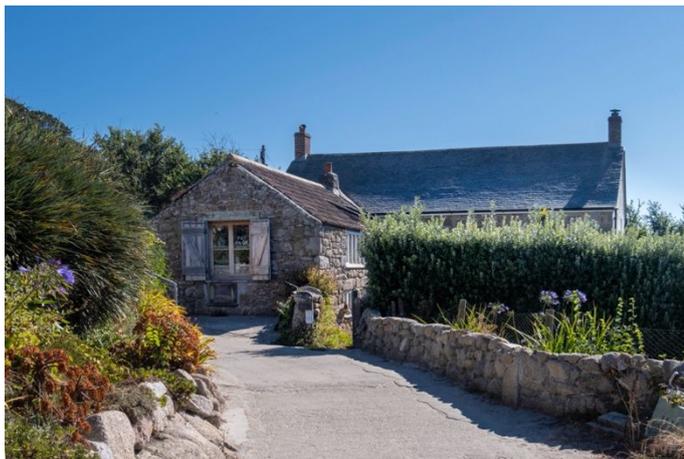
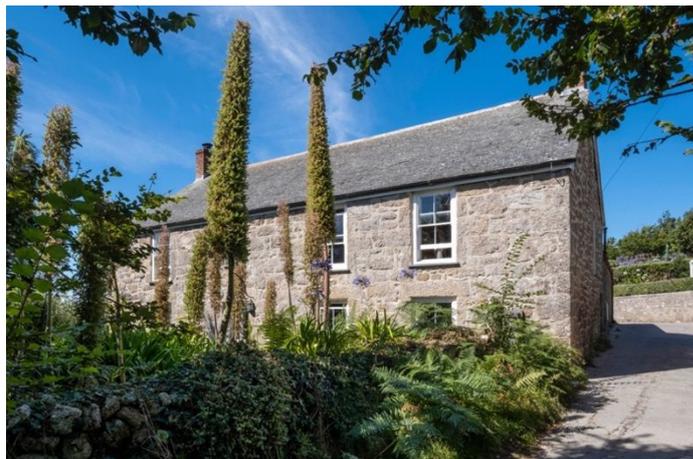
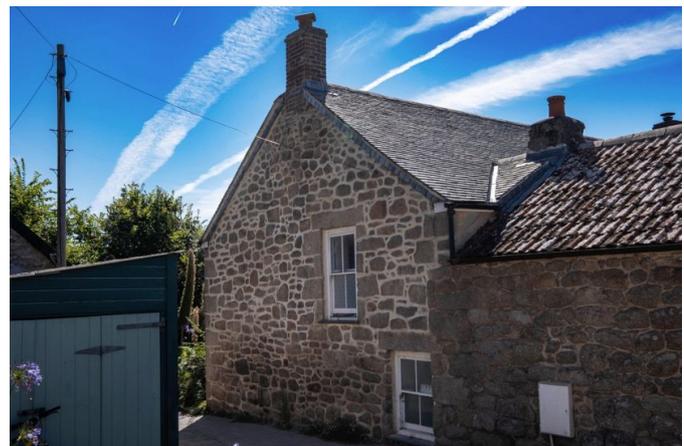
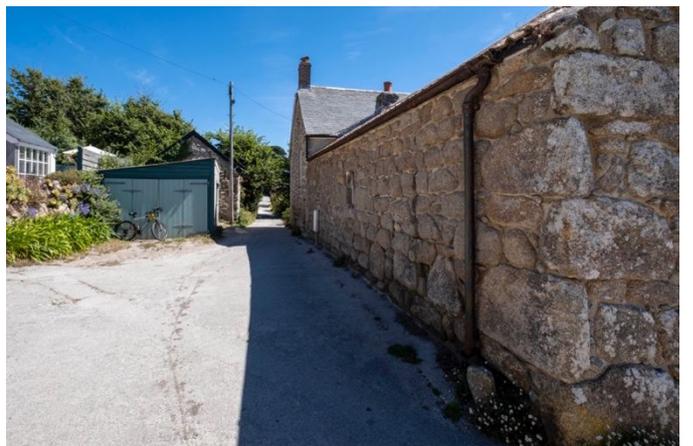
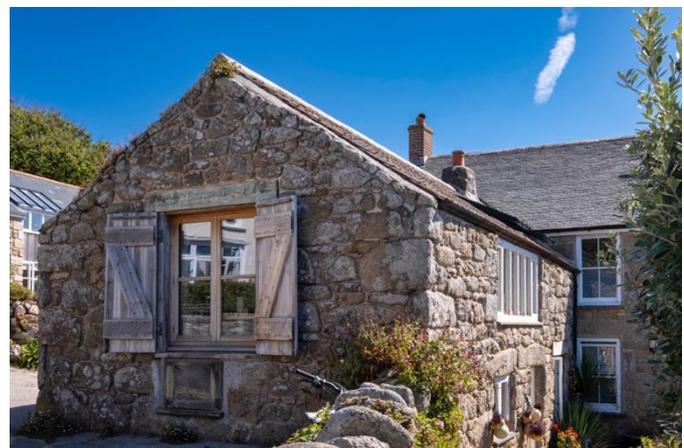
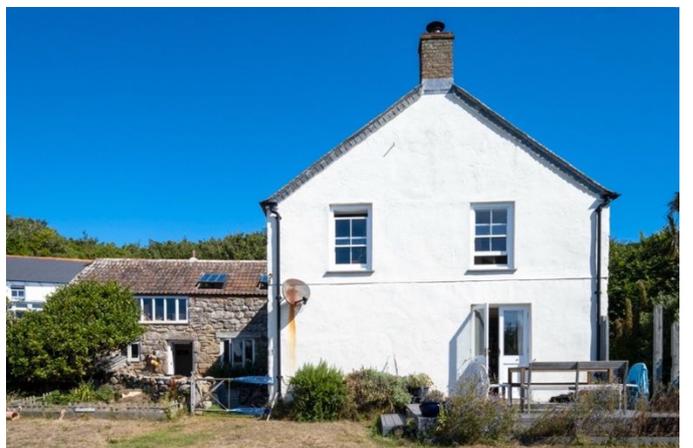
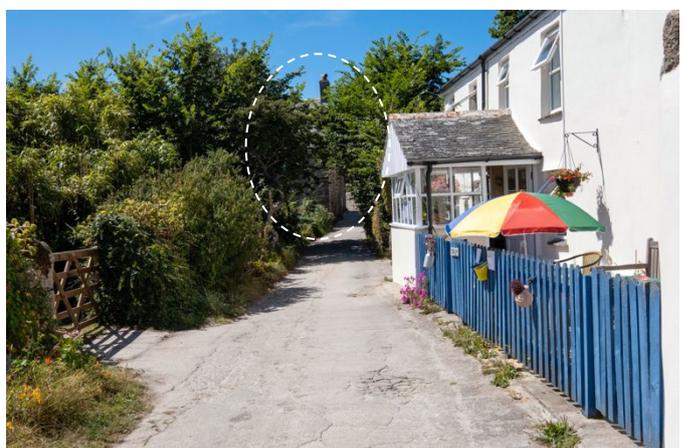
Top Left: West elevation  
 Top Right East elevation  
 Row 2 left: North gable  
 Row 2 Right: North elevation looking east  
 Row 3 Left: West elevation  
 Row 3 Right: South Elevation  
 Right: Look west to the east and north elevations

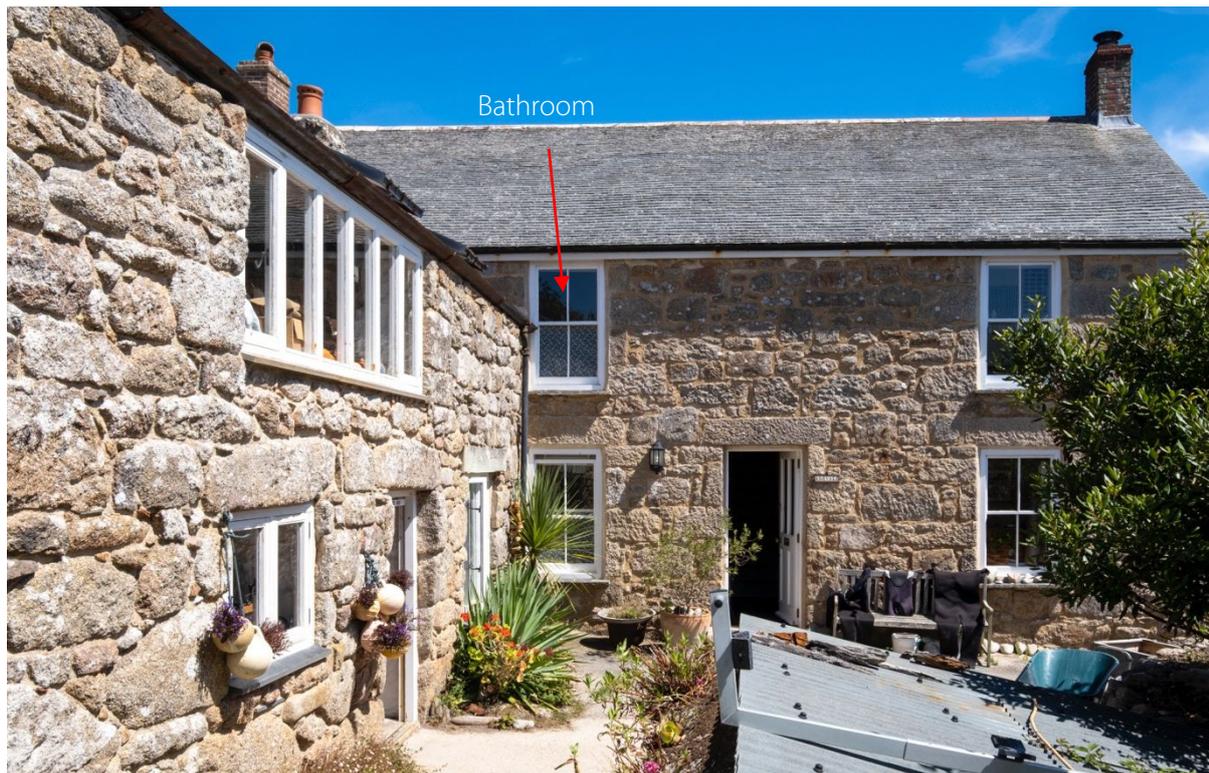
West elevation

Example of the friable mortar around windows and doors

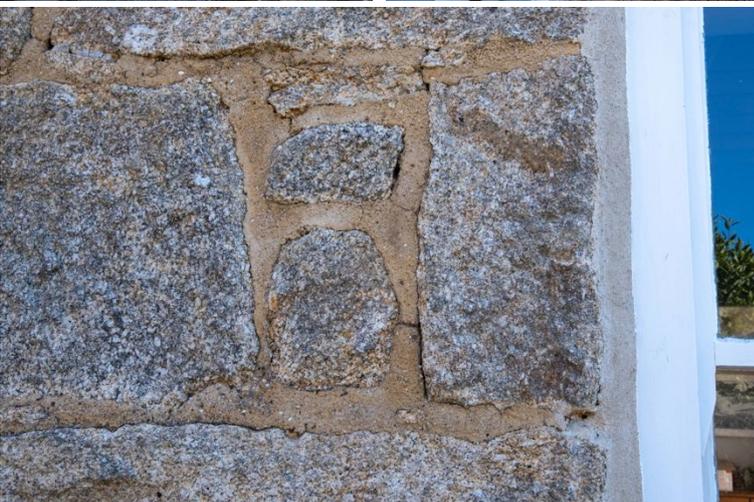
Example of perimeter shrinkage and cracking of mortar

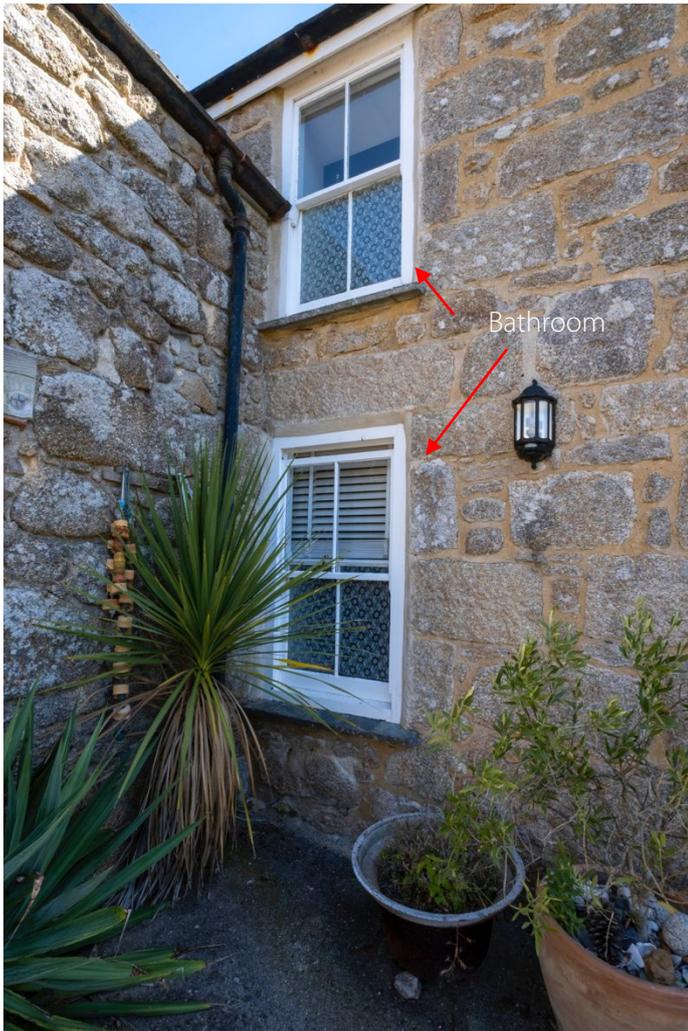
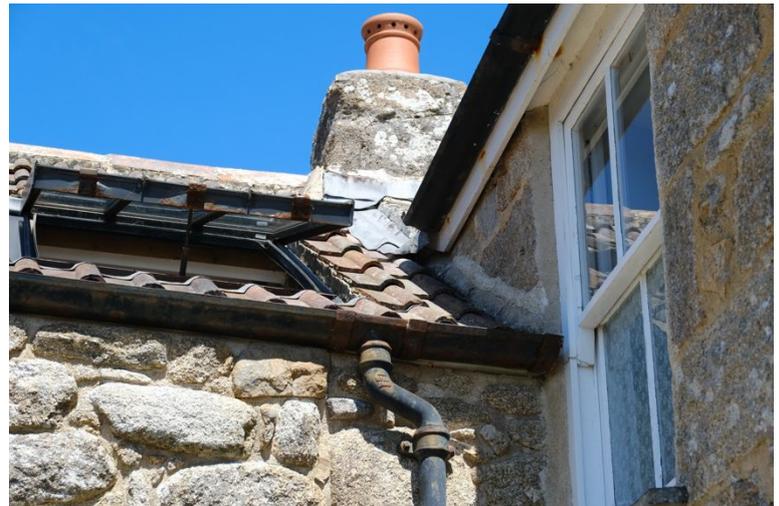
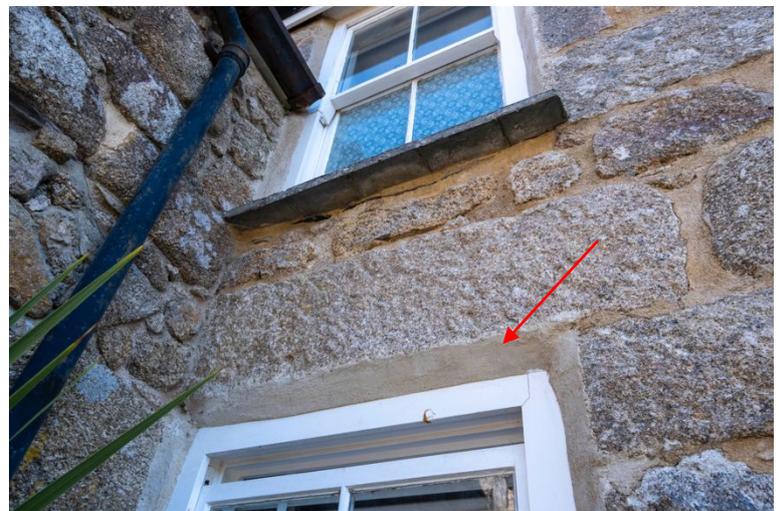
West elevation and junction between house and barn

Below right shows the angled mortar beneath the lintel which may contribute to the wetting of this window.

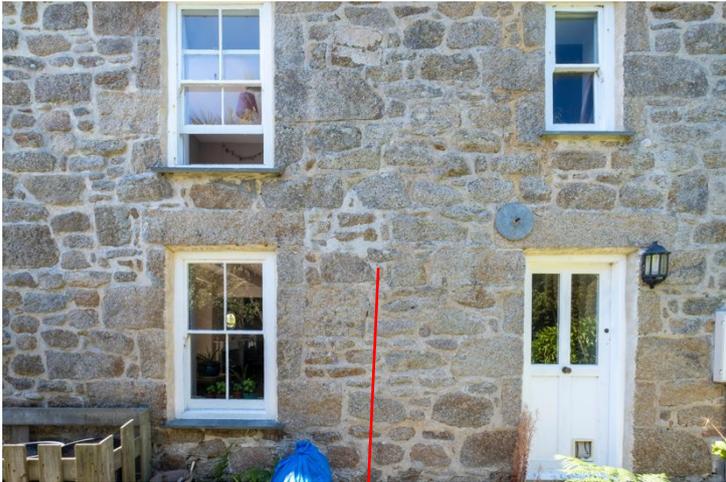
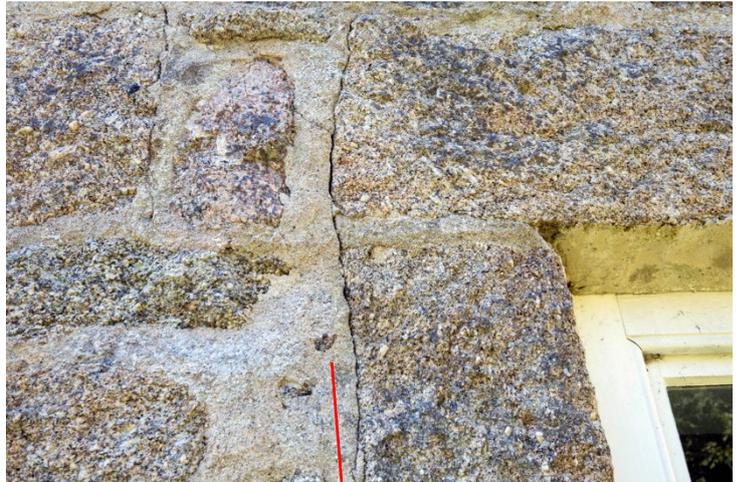
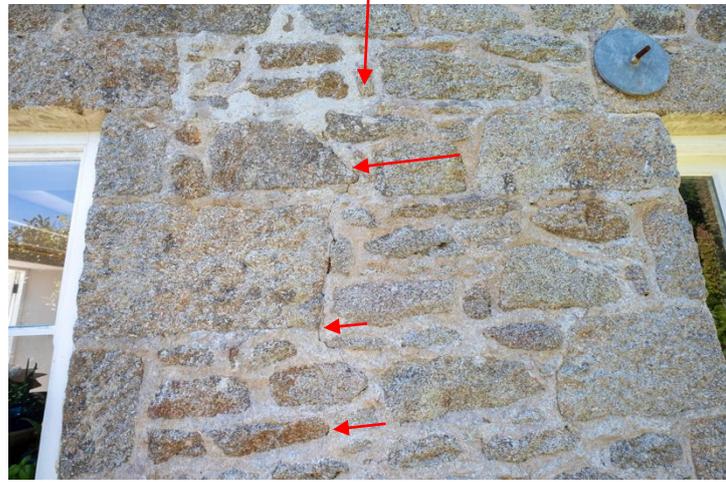
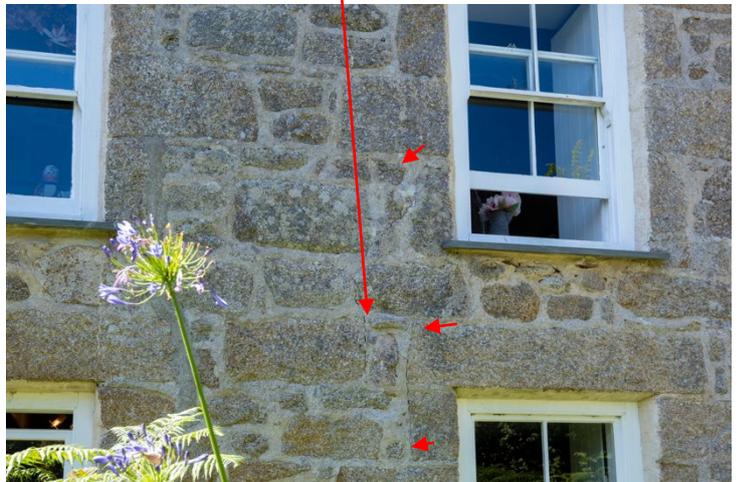
East elevation indicating cracks in mortar

- o The east elevation evidences some cracking following the mortar lines
- o There are some small areas on the east and west side where there is missing mortar, and particularly if these at eaves level, may contribute to allow water ingress.

- There is also cracking to the lime applied around the windows on the east elevation. Again, such problems can be due, for example, a mix which is too strong, too wet, over-worked, or other factors such as sulphate attack.

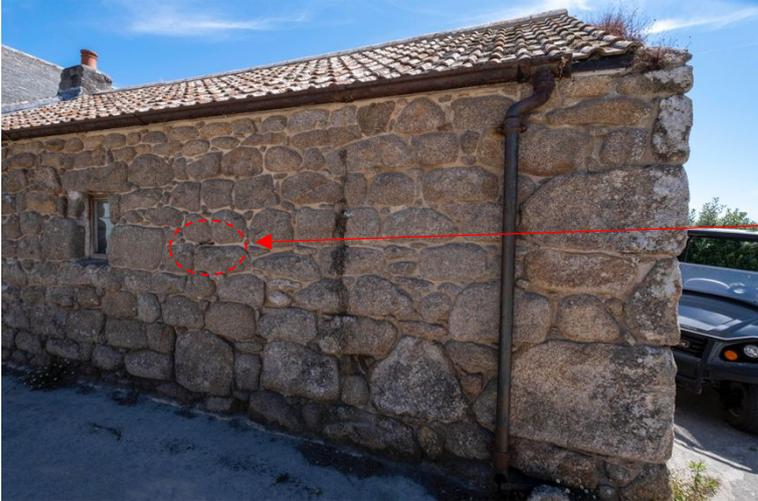
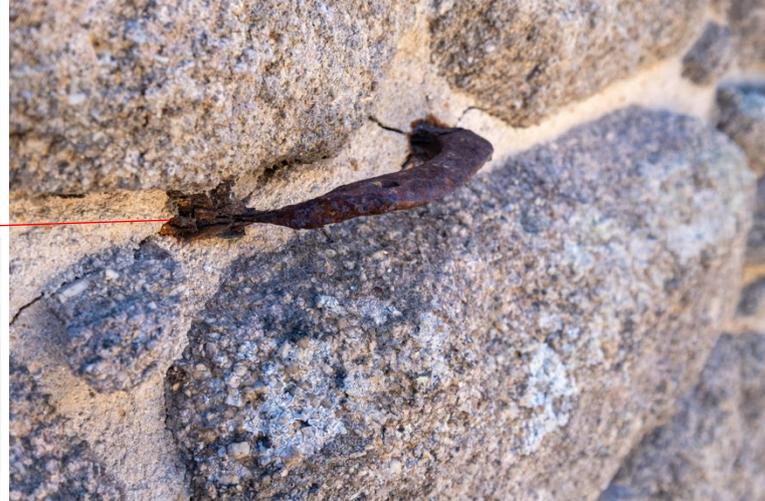
North Elevation

Top: Embedded horseshoe causing rust-jacking

- The north exterior barn wall has an embedded horseshoe, and there is evidence of rust-jacking, i.e. The swelling of the corroded metal has caused cracking to the mortar. Whilst this might be minor, there is the risk of further expansion so repair and monitoring is suggested.

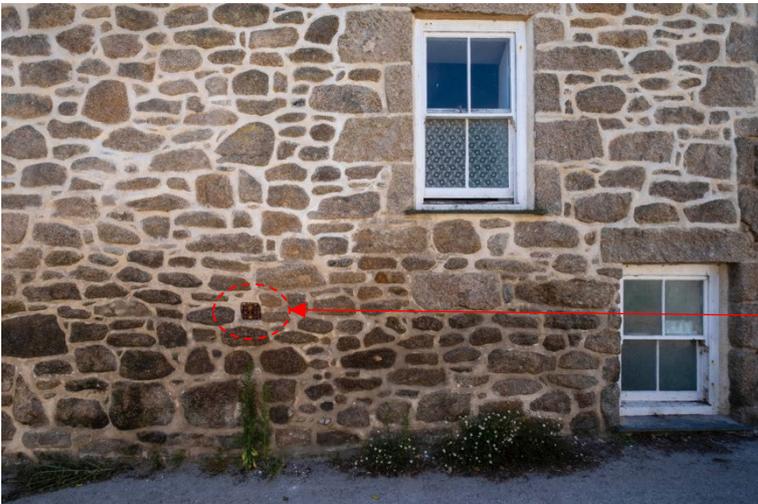
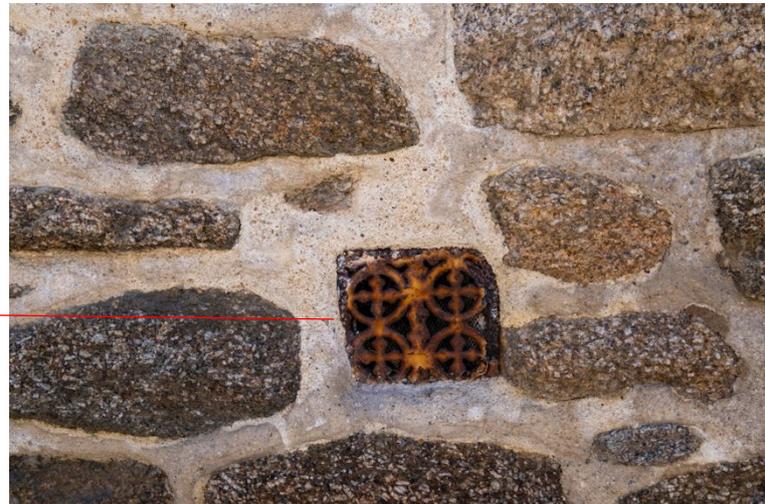
Centre: North gable showing discolouration of mortar at lower level and cast iron ventilation grille

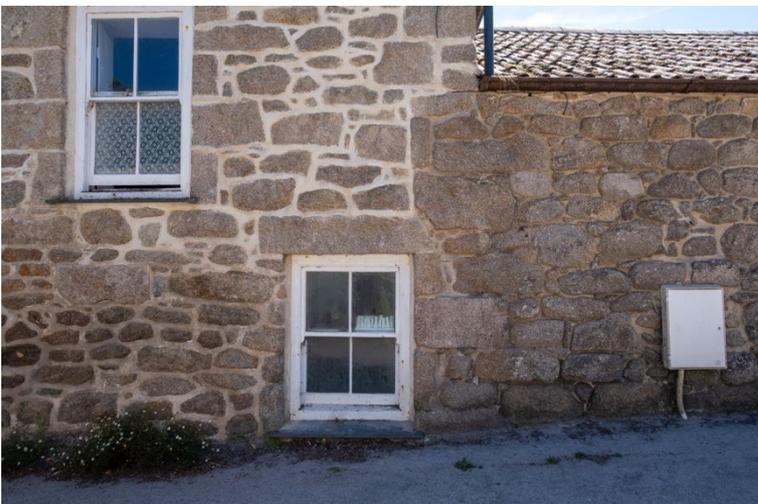
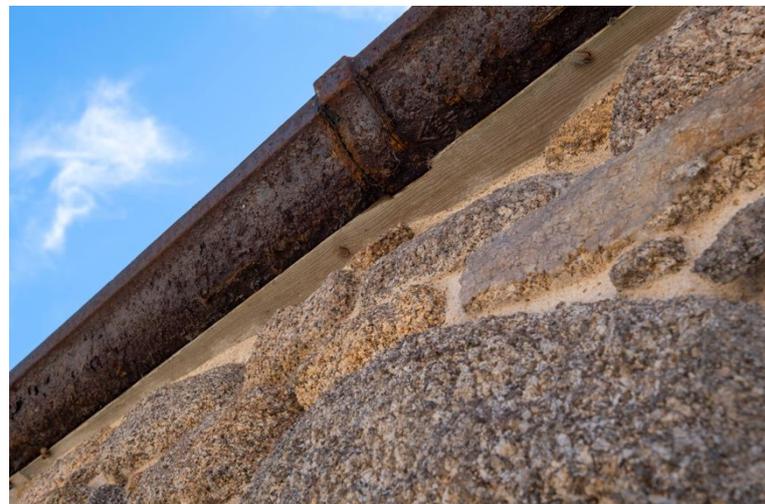
Below: Junction between house and barn and guttering to barn

- The east interior barn wall runs with water following rain suggesting there is problem with the junction detailing or flue.

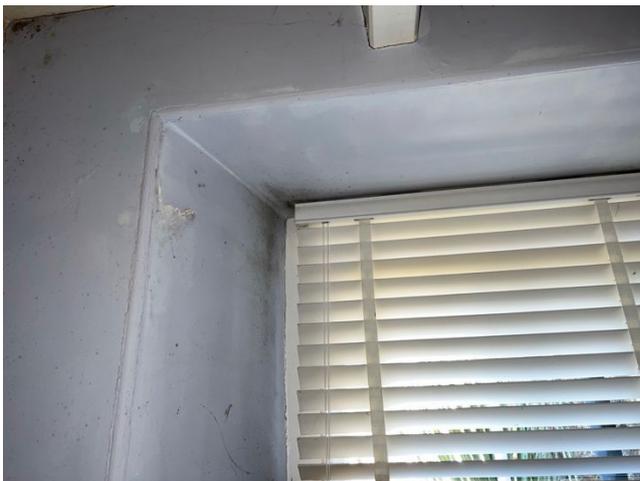
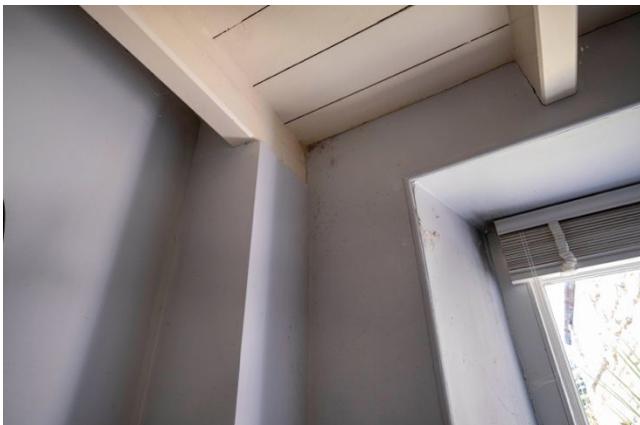
Ground Floor Bathroom  
Shows damp to reveals and wall at ceiling height

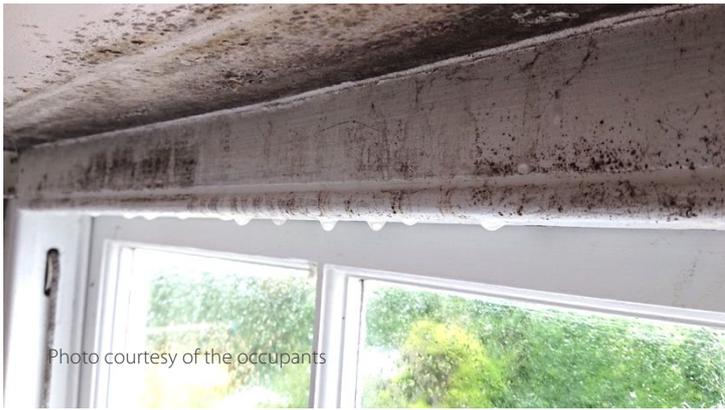
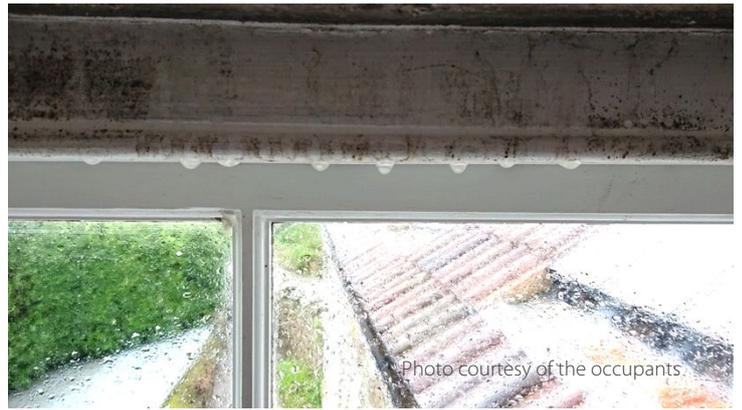
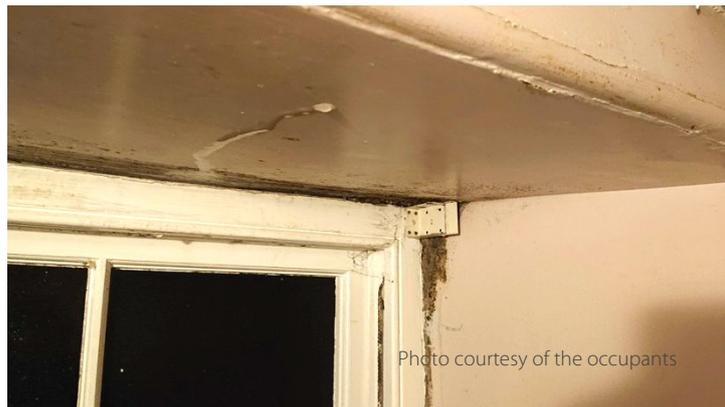
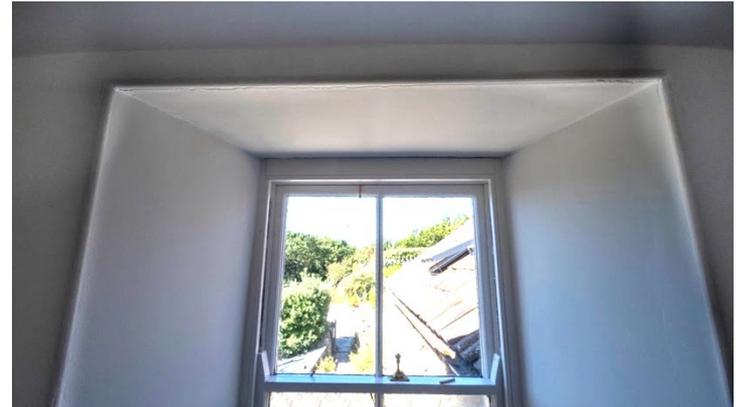
- Most notably, the first floor bathroom window (west elevation) head runs with water during rain and a temporary system has been installed to direct it away from the wall head. A new bathroom interior window reveal head has been recently installed due to the damage from water ingress, however, an inspection by the Duchy of Cornwall's Deputy Head of Building IOS has shown the wall plate above the window to have rotted and in need of urgent repair. There is also an area above this where roof timbers require repair due to decay. The bathroom ceiling was also partially replaced due to water damage. Despite being repainted within the year, and with prolonged dry weather, there are still obvious signs of damp to the window and ceiling in this area.

Top: First floor bathroom window showing running water, prior to temporary repair and renewal of window head.

Centre: FF bathroom window prior to repair and renewal

Centre right: FF bathroom now, following repair and renewal of window head.

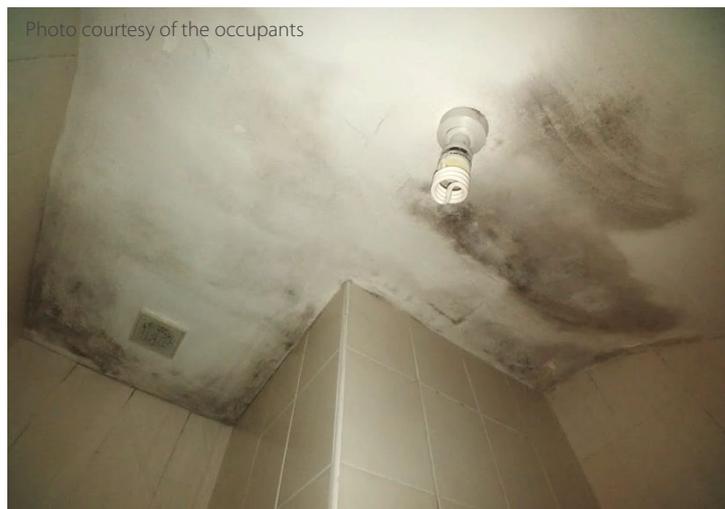
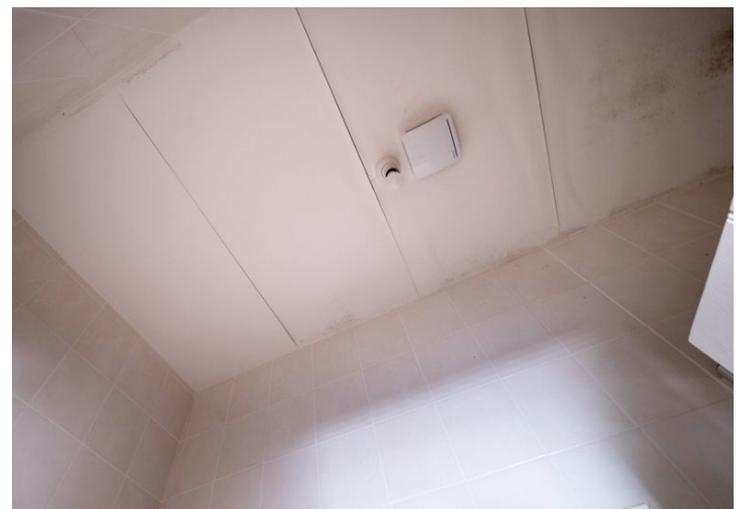
- The south bedroom ceiling has several areas where damp has penetrated the ceiling, which is repainted every couple of years to disguise the problem. Again, despite the prolonged dry weather damp staining is extensive. The ensuite ceiling also evidences considerable patches of mould, despite remedial intervention.

Below left: Ensuite to S bedroom prior to recent redecoration

Below right : The ensuite now, following recent redecoration, still shows significant mould

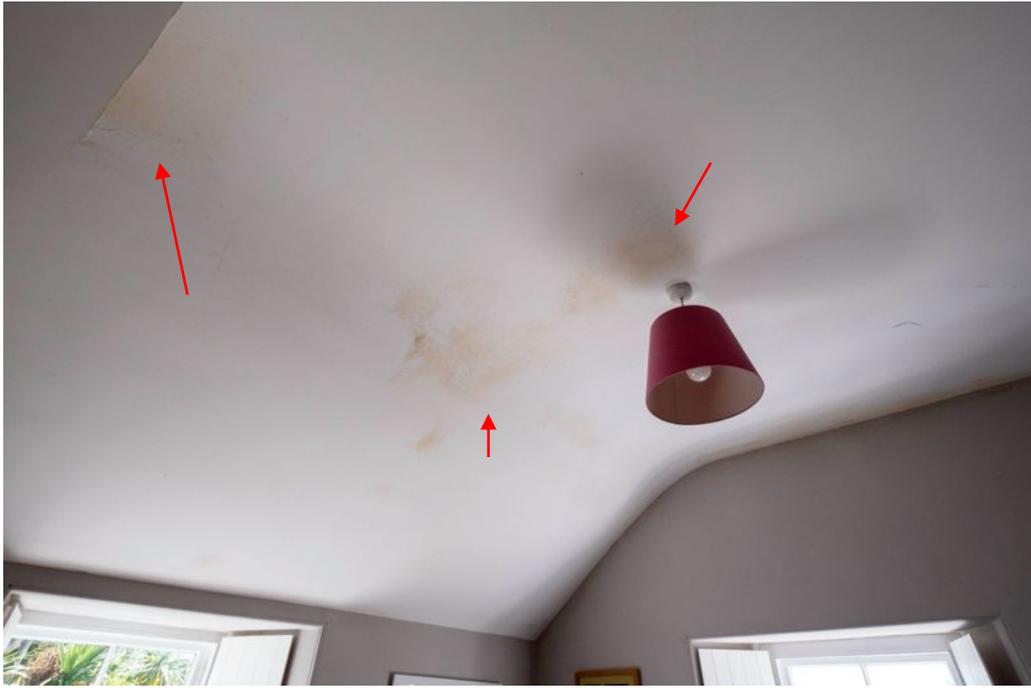
Top: South Bedroom showing damp to ceiling within 2 years of painting.

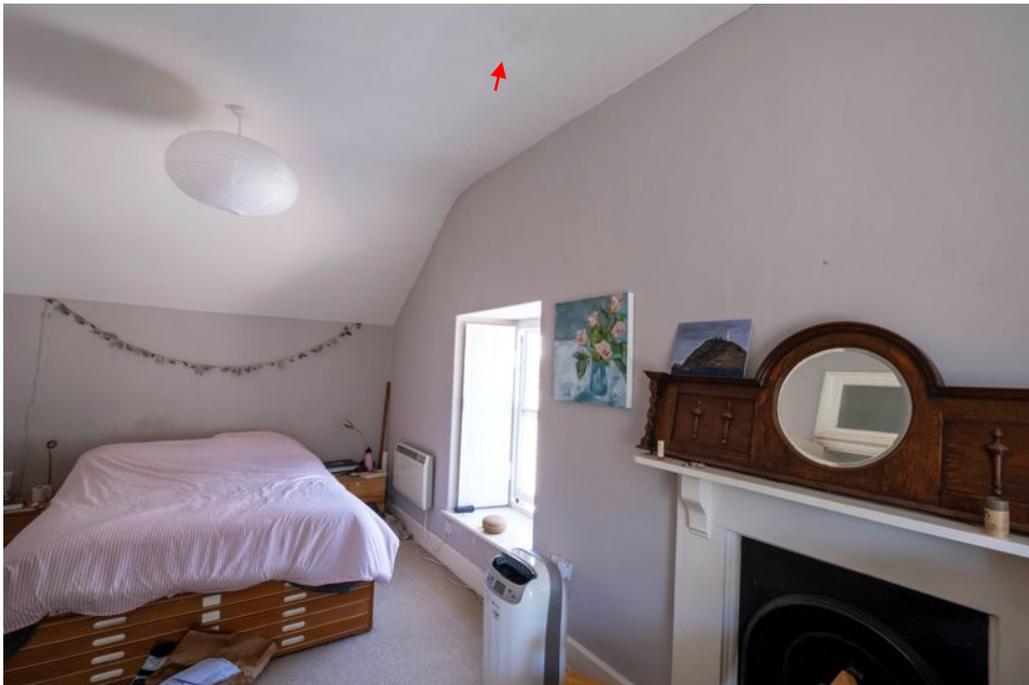
- o The north bedroom ceiling has some small areas of damp, although the most significant problem to the NE corner of the room, at the junction between wall and ceiling, is most likely due to the end of the metal gutter having corroded, leading to wall wetting.
- o Black mould growth is extensively visible, but there is also likely to be hidden growth. It arises from problems such as condensation, thermal bridging, damp from water ingress. Fungal growth can produce toxins known to adversely impact on human health such as respiratory symptoms. The occupants report that family friends with asthma have stopped visiting because of exacerbation of their symptoms.

Below: North bedroom shows small areas of damp.

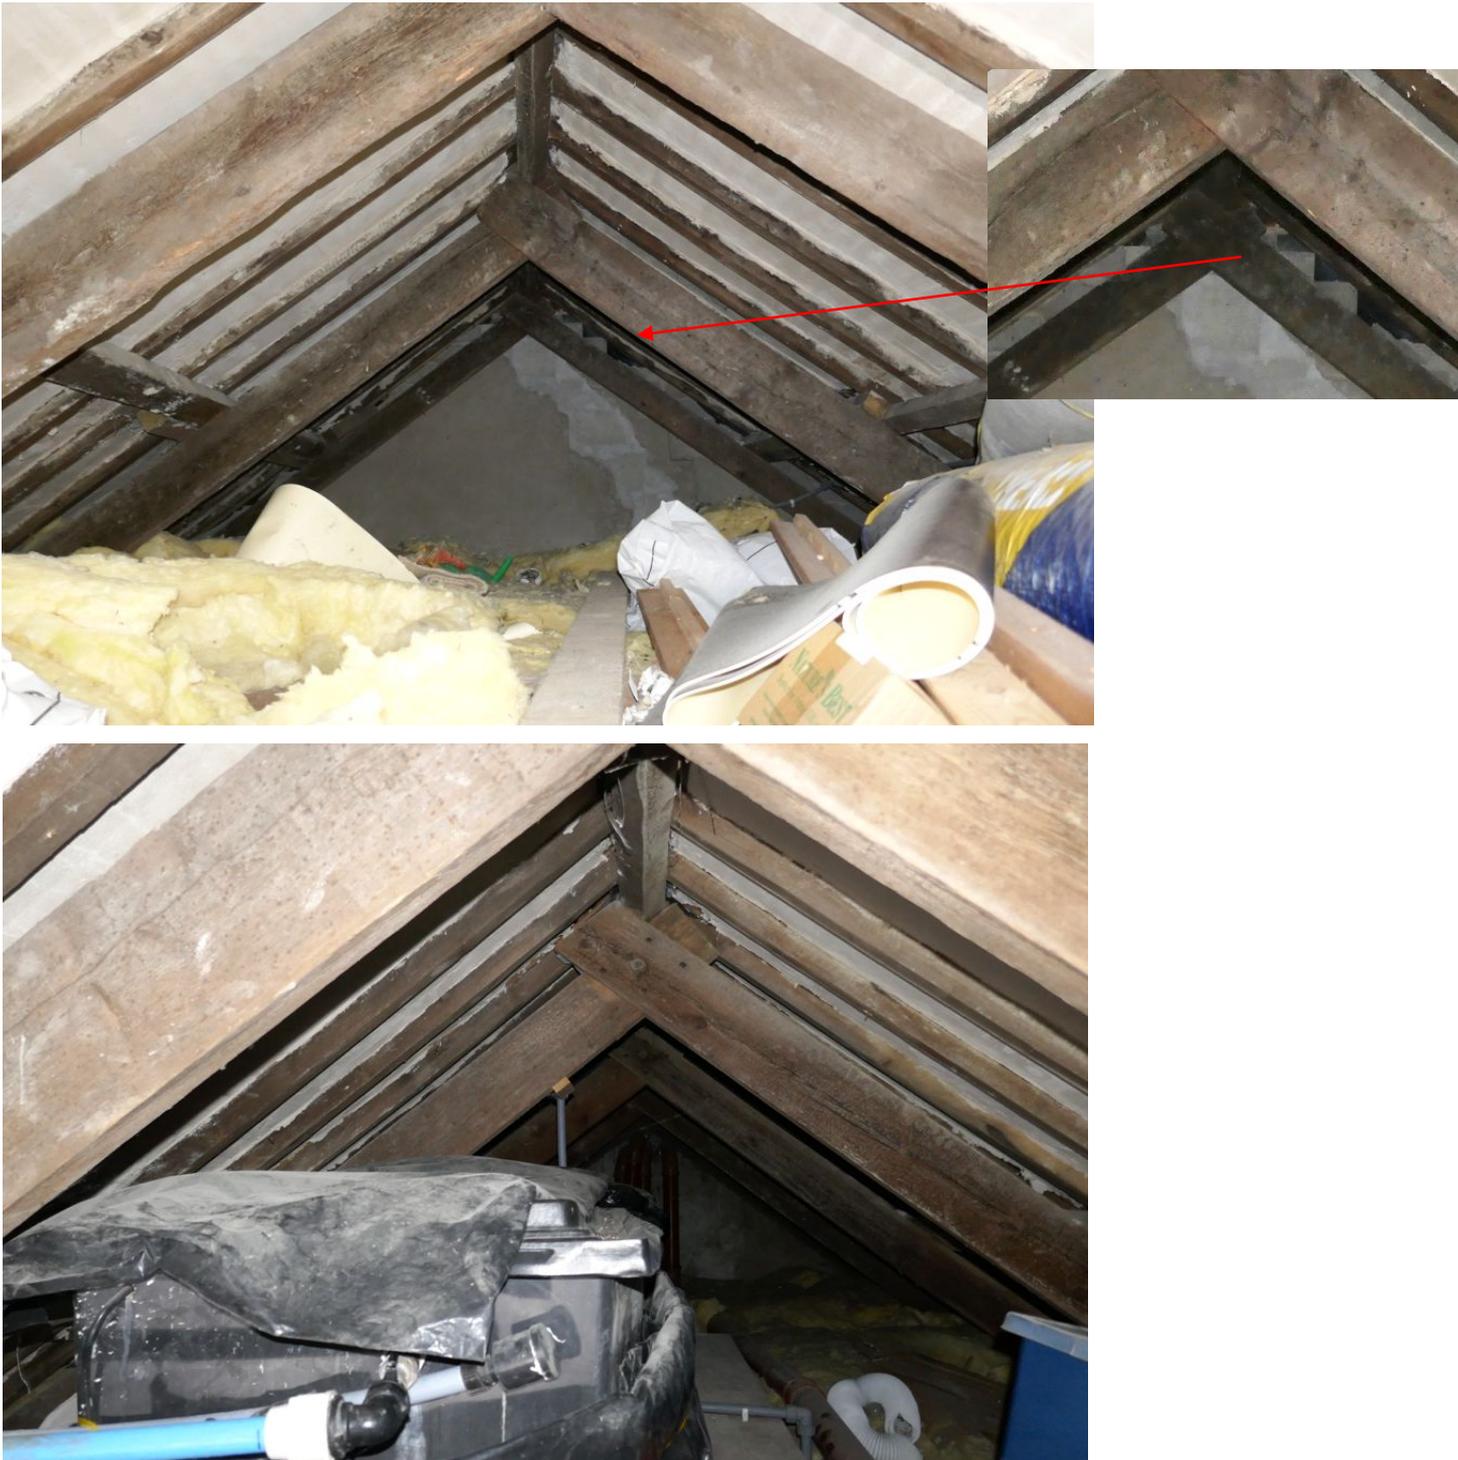
- Principal rafters do not appear of uniform sizes suggesting some later replacement and/or, as is common on the islands, architectural salvage. High collar trusses appear half lapped, pegged and nailed and appear of late C19 in character. All timbers appear saw cut. Some small sections of historic sawn purlins remain, largely partnered with new timbers. There are emergence holes indicative of wood boring insects, although it not clear if there has been a recent infestation. However, the current damp conditions in the roof space would create vulnerability to insect and fungal attack.

Top: Roofspace looking to the rebuilt south elevation showing incomplete infill to the west side

Below: Looking to the north elevation showing pegged and nailed trusses

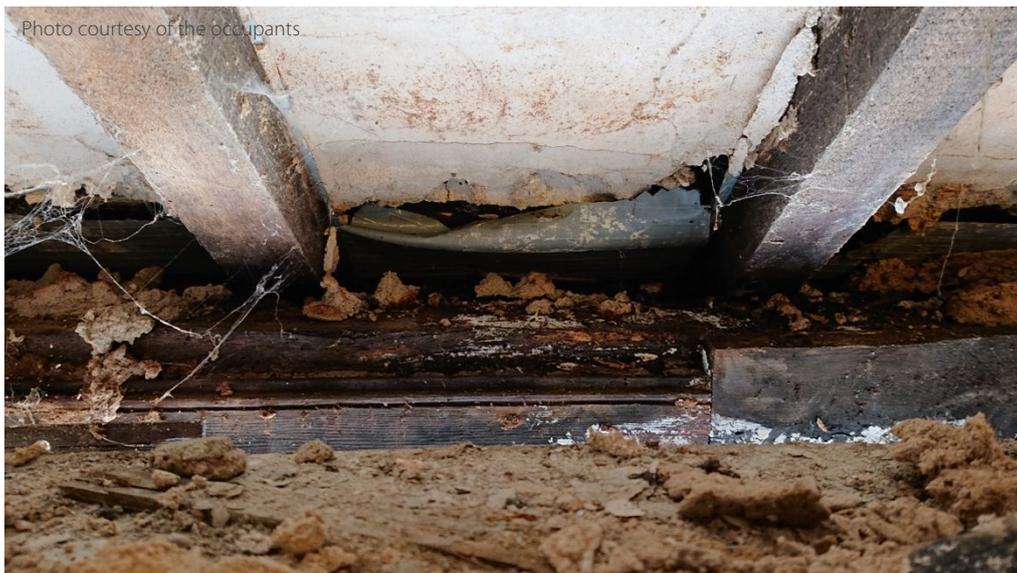
Above the first floor bathroom window prior to temporary repair. Note the two different pieces of timber

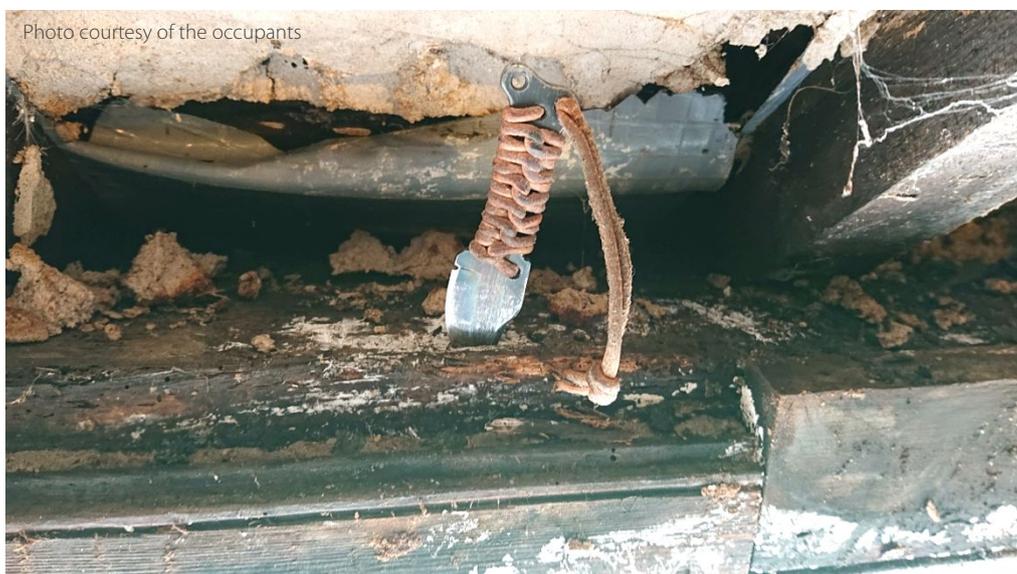
As above. A small blade (approx. 6") shows the decayed timber

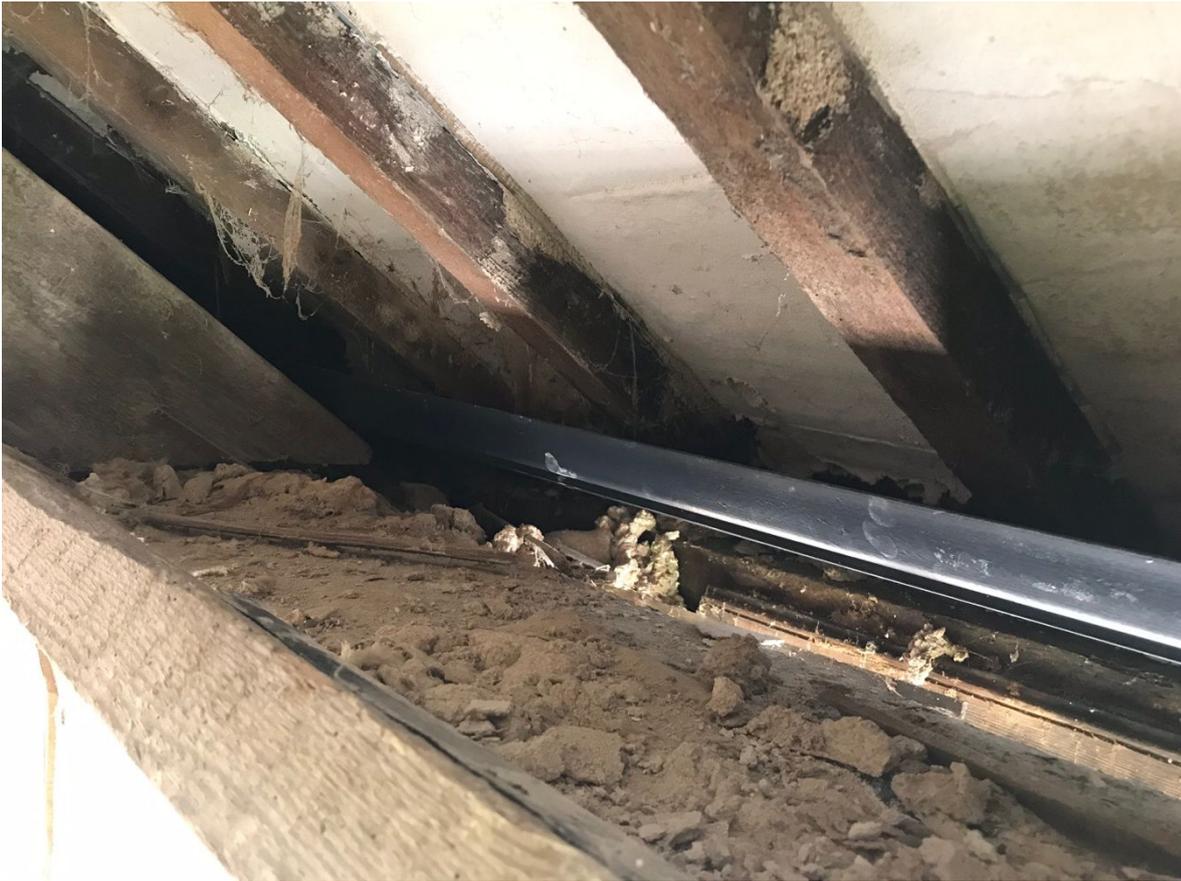
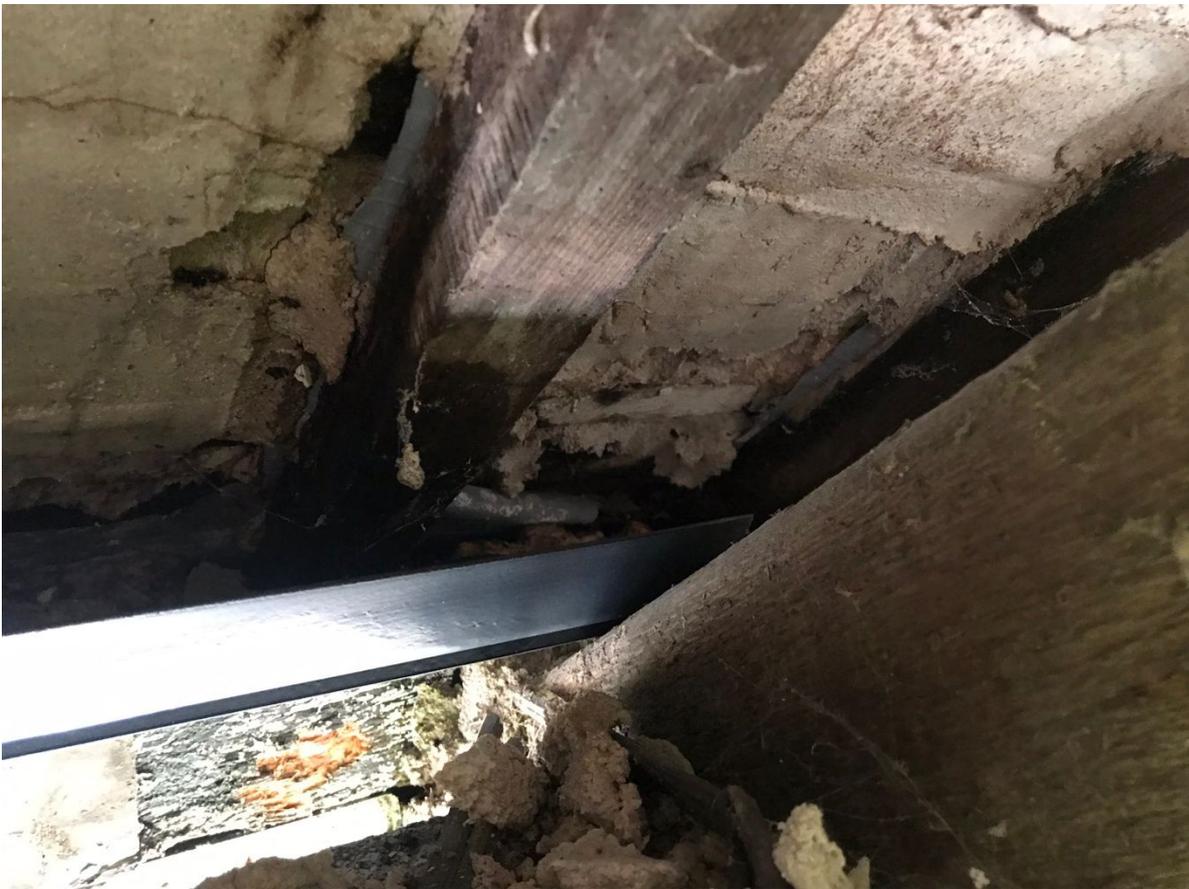
Photographs courtesy of the Duchy of Cornwall showing the temporary repair above the bathroom window to provide drainage

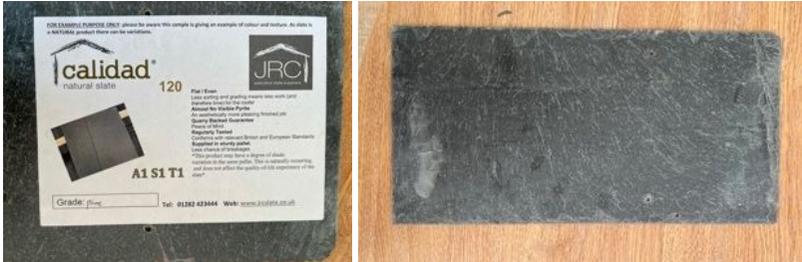
Proposed work	Significance of fabric/area	Justification for proposed work Impact on historic fabric/ heritage asset/setting/ significance	Further Guidance and Mitigation
<p><b>MATERIALS AND METHODS cont...</b></p> <p>Calidad natural slate 200 x 400mm slates with a 100mm lap</p>		<ul style="list-style-type: none"> <li>Small sized slates are proposed. Calidad 120 is a prime quality Spanish slate sourced to provide a textured surface, napped edge and colour which is almost identical to traditional slates from Delabole and Trevillet quarries and consistent with existing slates. It also has a high durability. Examined samples are pictured below.</li> </ul>

The textured surface, riven edge and colour are a good match for the North Cornwall products. The slates will be 200 x 400mm with a 100mm lap resembling the small scantle slates. A bitumen roofing felt will be used as specified by the ecology report as suitable for the bats. Roof timbers are to be repaired using established conservation techniques.

<ul style="list-style-type: none"> <li>No historic slates will be lost as all were replaced with new circa 2000. Existing ridge tiles, which were re-used in 2000 will be re-used if condition allows, and any shortfall be made up with matching.</li> <li>The new roof would not be mistaken for wet laid with diminishing courses, so there would be some change to its character but the size, colour and lap would provide a similar overall aesthetic to a casual observer. At best it may therefore maintain, rather than enhance character and at worst, there will be a slight erosion of existing appearance and character through a change from the traditional materials and methods. It is anticipated that it will not significantly detract from the barn, which is the most distinctive and prominent element of Ashvale.</li> </ul> <p>Whilst a wet laid scantle roof would be the optimum replacement, a key challenge has been to balance the appearance of the roof with the urgent need to make the building weatherproof and prevent further deterioration of the historic fabric. Historically, evolution of vernacular traditions on Scilly has been in response to contextual factors, e.g., economics and availability of materials and skills/labour. Similar issues are still relevant and the consideration for this scheme has been how to weigh the varying factors and adapt to the challenges, whilst minimising as far as possible the change to the aesthetic of the building, loss of fabric, and the story it tells about building traditions.</p> <p><b>Impact:</b>  <b>Minor.</b> At best it may maintain, rather than enhance character and at worst, there will be a slight erosion of existing character through a change from the traditional materials and methods.  <b>Negligible</b> It is anticipated that it will not significantly detract from the barn, which is the most distinctive and prominent element of Ashvale and how the listed building is mainly experienced and appreciated within its setting is likely to be negligible. The existing roof covering is new and the vast majority of the roof structure will remain so impact upon historic fabric will be Negligible.  <b>Beneficial</b> The historic fabric of the house will be protected</p>
