## RESULTS OF FURTHER BAT SURVEY WORK

ASHVALE, LOWER TOWN, ST MARTINS,  
ISLES OF SCILLY

June and August 2021

**Report No:** 20-248/DofC/Ashvale, St Martins, IofS\_FB

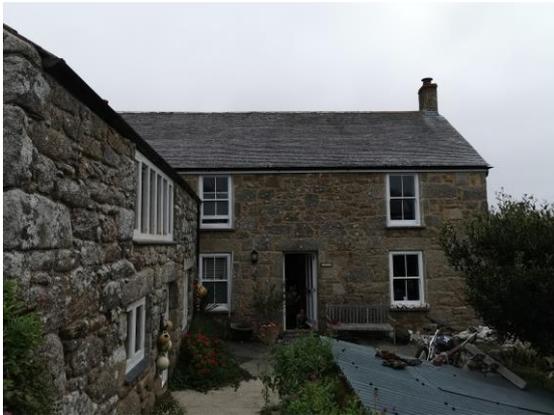
The building subject to this survey is a large two-storey rectangular stone house which has a pitched natural slate covered roof, with gable ends on a north south alignment, see photos 1 to 4. There is an attached stone barn used as a jewellery workshop and shop which has a pitched roof covered with clay tiles, but this building was only indirectly and not comprehensively covered by the survey.

Photo 1. Showing the western elevation of Ashvale and attached barn

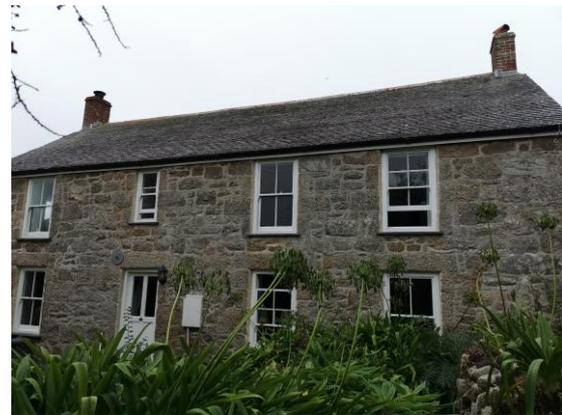
Photo 2. Showing the eastern elevation of Ashvale

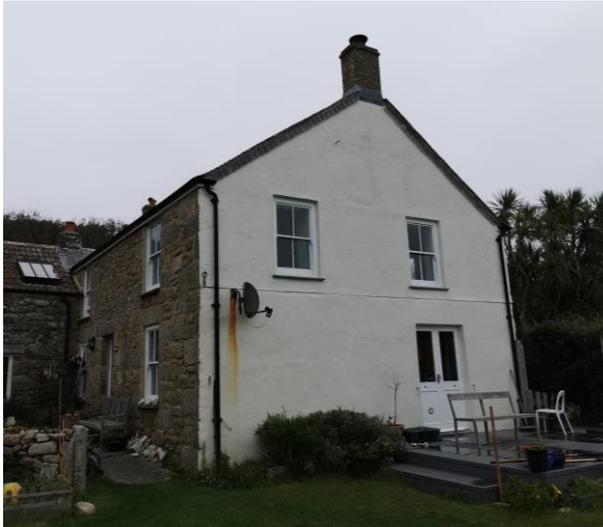
Photo 3. Showing the southern gable end

The southern gable end is reasonably well sealed with the exception of a gap behind the leadwork around the chimney. The ridges and slates themselves seem relatively well-sealed.

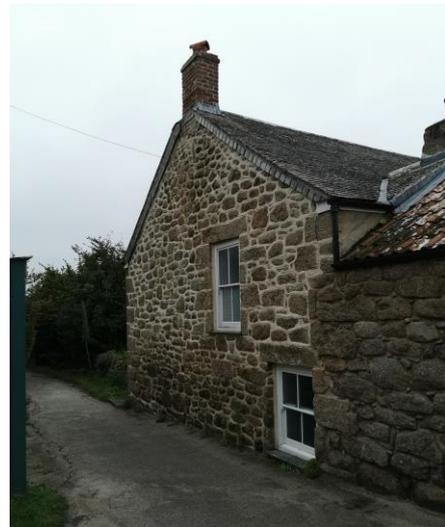
Photo 4. Showing the northern gable end

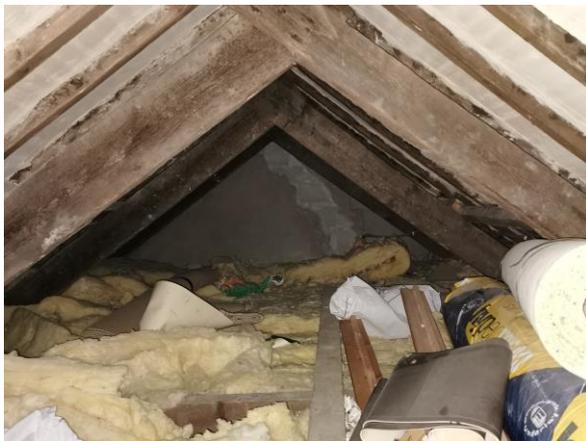
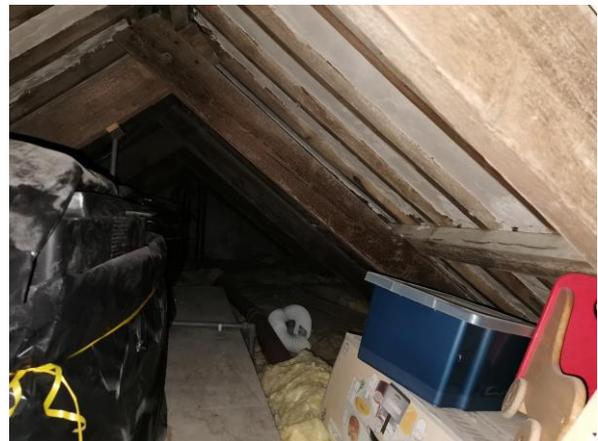
Internally there is a single open roof void which stretches the length of the building. The roof is supported by timber trusses and is open with no crossing timbers but does contain a large water tank. The underside of the roof is lined with lime mortar as the roof is covered with wet-laid scantle slate, see photos 5 and 6.

Photo 5 and 6. Showing the roof void over the house

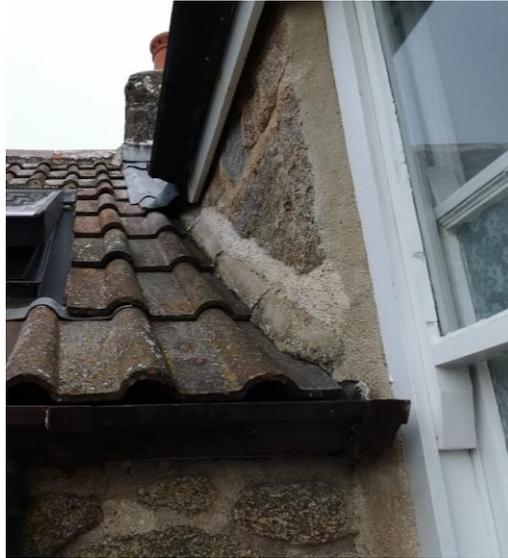
Externally the southern gable end is rendered with the other walls being stonework. There are deep cavities behind the fascia board on the two long walls, creating roosting habitat for bats, which extend up the wall tops above creating access to them for roosting bats. There are similar cavities behind the row of hanging slates lining the northern gable end giving access to the wall tops and behind the leadwork where the house joins the attached barn, see photo 7.

Photo 7. Showing the point where the house and barn join  
and an example of the gaps behind the fascia board

All the existing access points (the gaps between the fascia boards and walls) will be unaffected by the works and all the existing roosting sites will be recreated. As a result, the only impact should be temporary damage and disturbance. Only Bitumen type 1F roofing felt can be used in areas which will be accessible to bats.

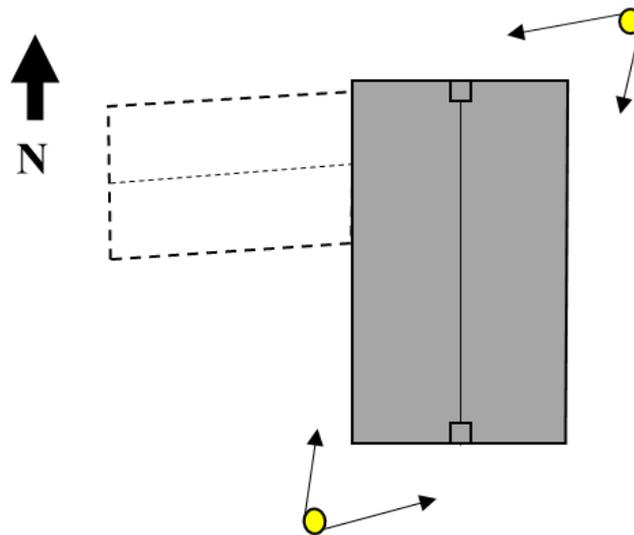
On 25<sup>th</sup> June 2021, Simon Barnard and Debra Barnard were positioned on opposite corners of the house so that all aspects could be watched.

Figure 1. Locations of the surveyors and location of remote detector

On 10<sup>th</sup> August 2021, Simon Barnard and Debra Barnard were positioned on opposite corners of the house so that all aspects could be watched, see Figure 1. The survey was carried out during suitable weather conditions for bat activity with the weather being still, calm and dry with 100% cloud cover and a starting temperature of 18°C dropping down to 16°C by the end of the survey. The survey started at 20.39 and continued until 21.54 with sunset being at 20.54.

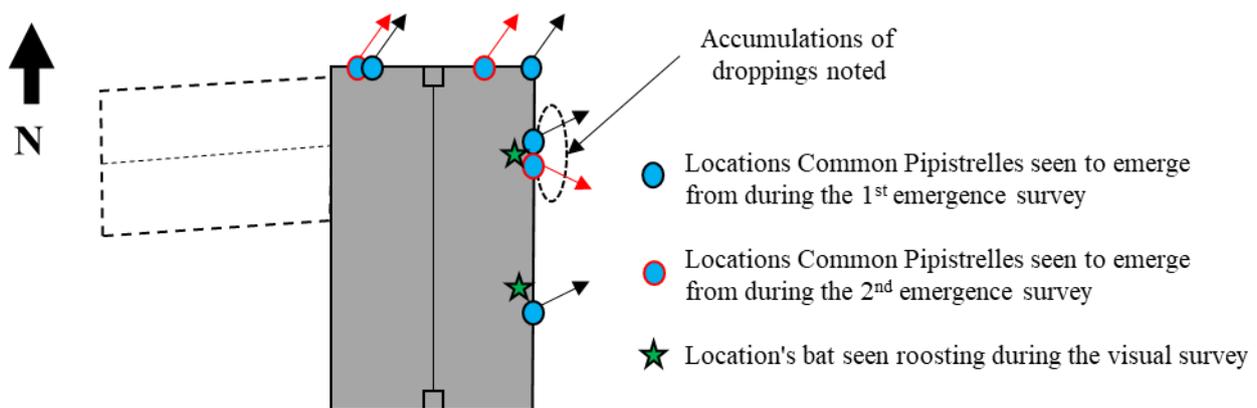
The first bat activity noted was from a Common Pipistrelle which emerged from the junction of a gap between a hanging slates and fascia board on the north eastern corner of the house at 21.54. At 21.56 a single Common Pipistrelle was seen to emerge from the southern half of the eastern side of the house from behind the fascia board. Between 21.57 and 21.59 six Common Pipistrelles were seen to emerge from the gap behind the fascia board from the northern half of the eastern side of the house. A 22.02 a single Common Pipistrelle was seen to fly backward and forwards a number of times to the access point behind the fascia board from the northern half of the eastern side of the house with a final Common Pipistrelle seen to emerge from behind the hanging slates on the north western corner of the house at 22.04.

**9 Common Pipistrelles were seen to emerge the house during this survey with six individuals coming from a single location, see figure 2.**

The first bat activity noted was from a Common Pipistrelle which emerged from the gap between the row of hanging slates on the western side of the northern gable end at 21.13. At 21.19 a Common Pipistrelle was seen to emerged from the gap behind the row of hanging slates on the eastern side of the northern gable end. Between 21.20 and 21.25 three Common Pipistrelles were seen to emerge from the gap behind the fascia board from the northern half of the eastern side of the house. Single passes by Common Pipistrelles were noted during the remainder of the survey.

**5 Common Pipistrelles were seen to emerge the house during this survey, see figure 2.**

Figure 2. Summary of the location's bats were seen to emerge from during the emergence surveys

In this instance, all the existing access points (the gaps between the fascia boards and walls) will be unaffected by the works and all the existing roosting sites will be recreated. As a result, the only impact should be temporary damage and disturbance. The stripping of the roof coverings, in particular along the eaves, will need to be carried out under the direct supervision of the ecologist named on the licence and only Bitumen type 1F roofing felt can be used in areas which will be accessible to bats.
