PERMISSION FOR DEVELOPMENT

Application No: P/21/068/HH **Date Application Registered:** 16th August 2021

Site address: 6 Bay View Terrace Telegraph Road Porth Mellon St Mary's Isles Of Scilly
Proposal: Re-build two storey side extension, replace windows and doors and alterations and improvements.

PRELIMINARY ROOST ASSESSMENT (PRA)

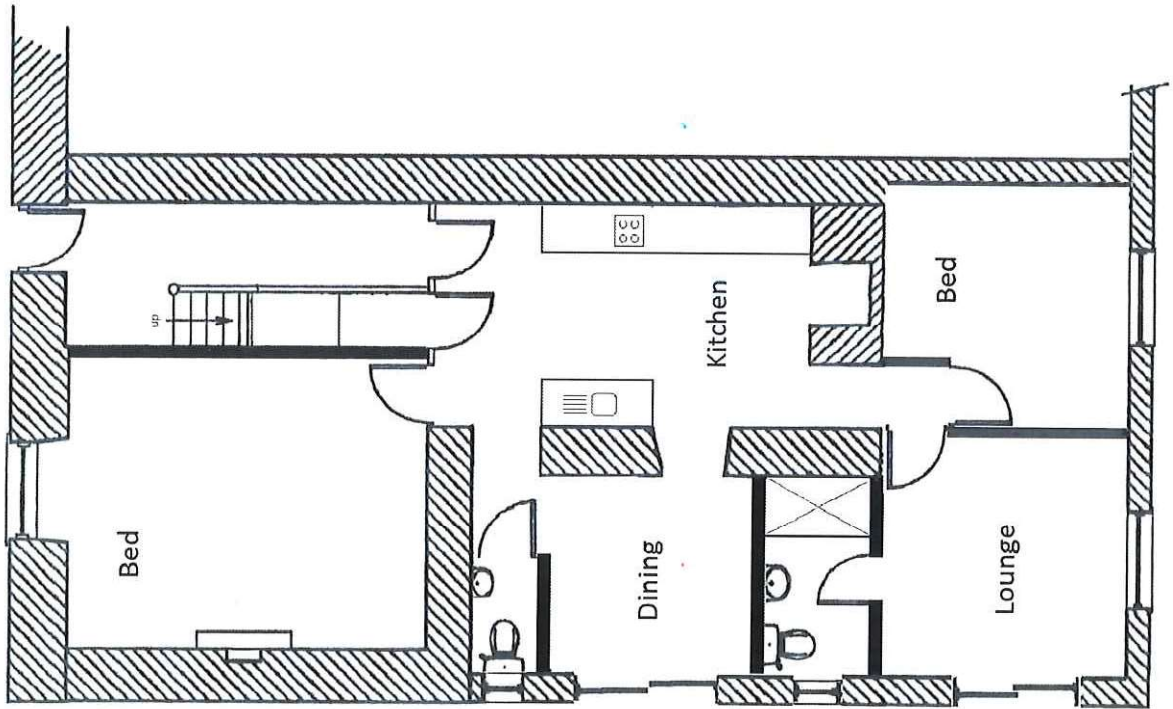
Ground Floor

PROPOSED FLOOR PLANS

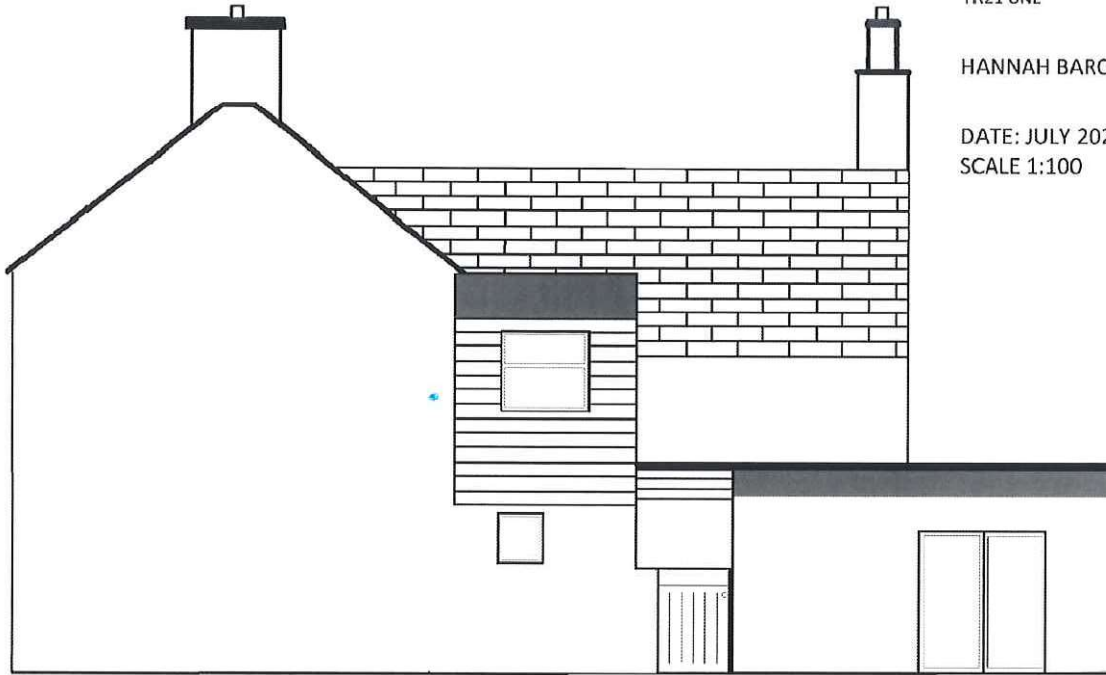
EXISTING South East Elevation - Side

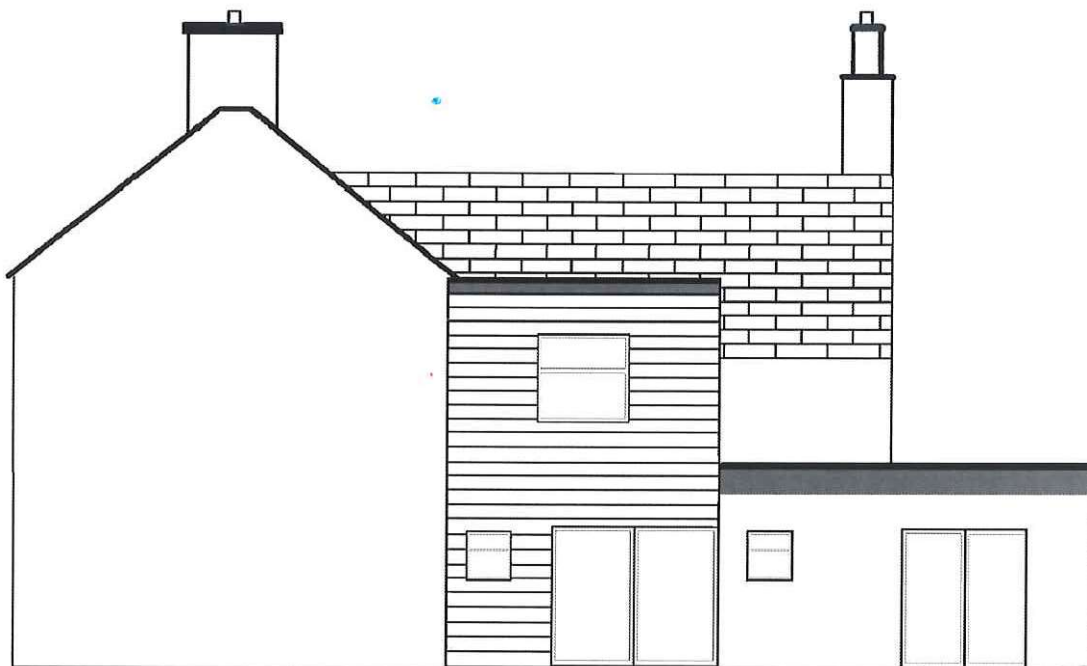
PROPOSED South East Elevation - Side

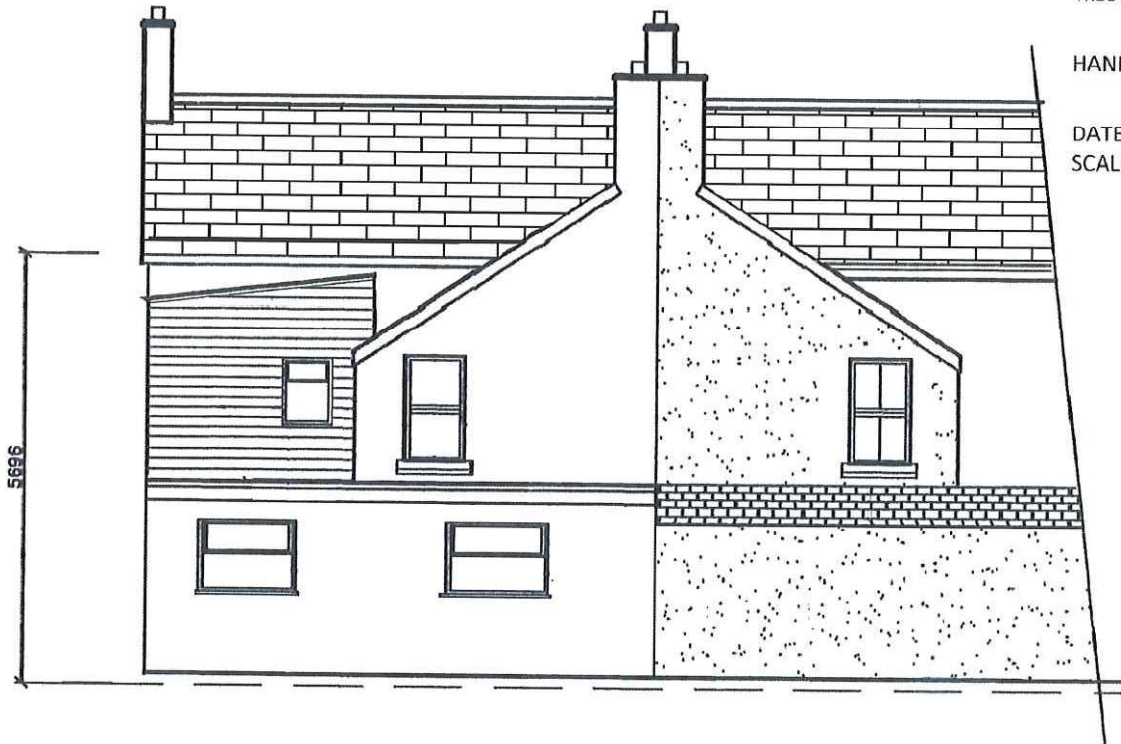
EXISTING North East Elevation - Rear

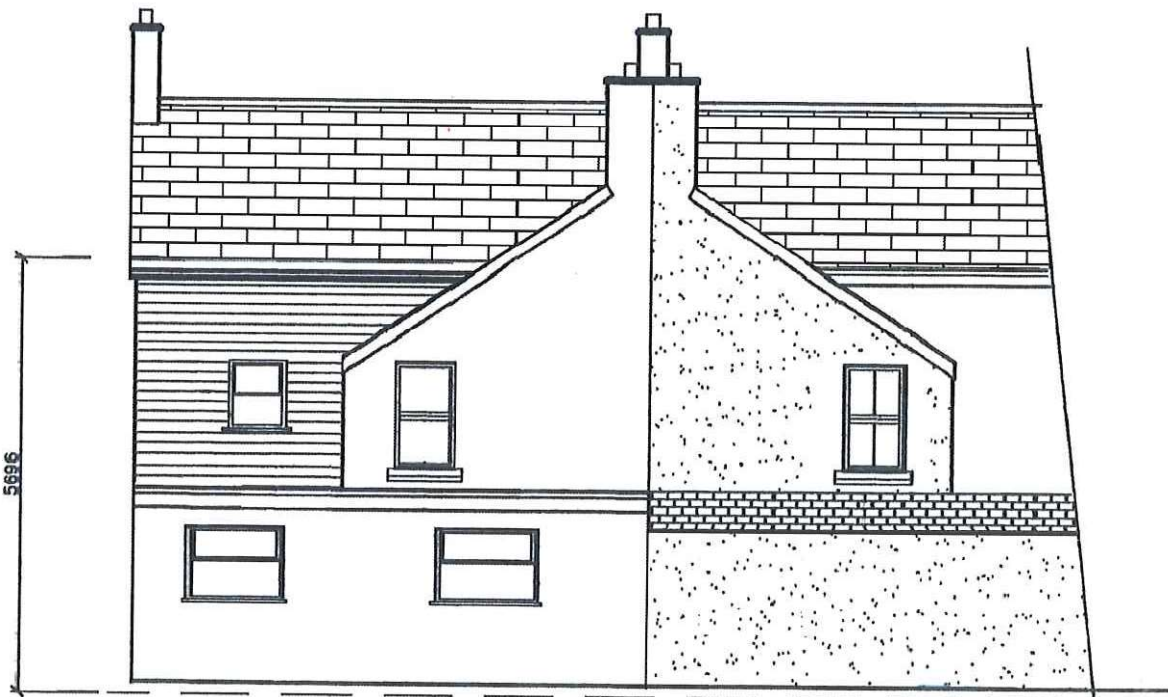
PROPOSED North East Elevation - Rear

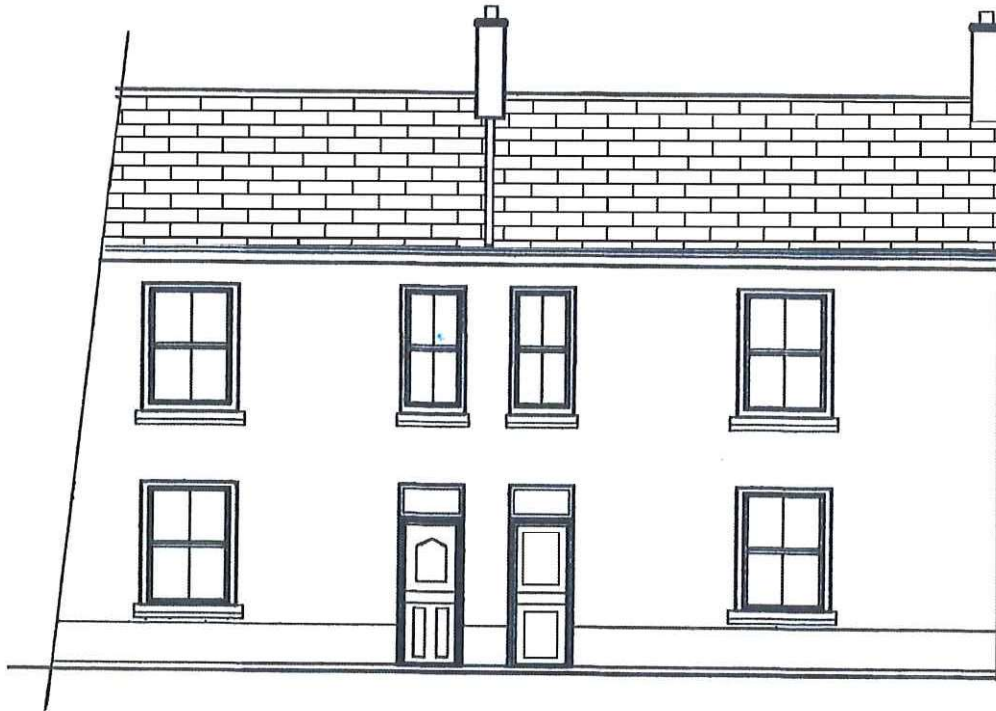
EXISTING South West Elevation - Front

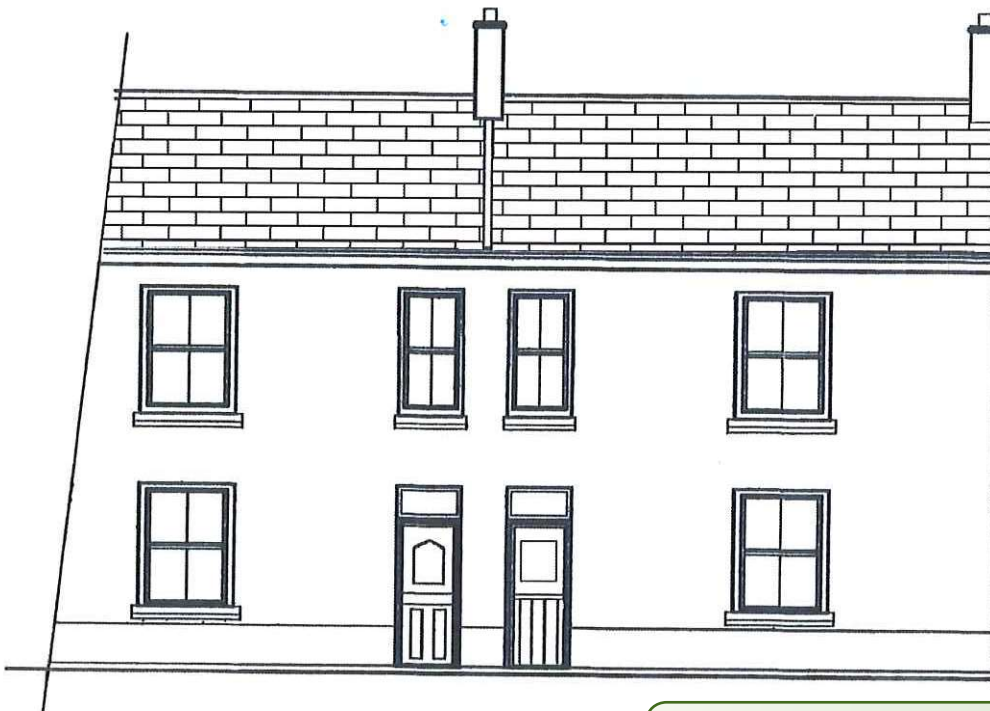
PROPOSED South West Elevation - Front

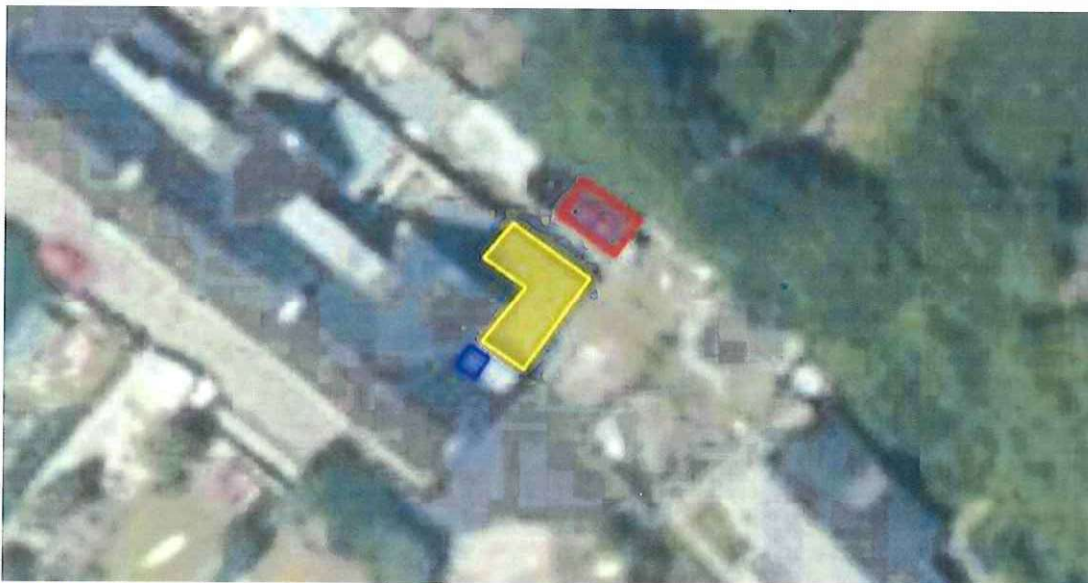
Map 02 – Illustrating the discrete elements of the property surveyed. The **Chalet** is shown in red; the **Garage** is shown in yellow and the **Dormer Bathroom** is shown in blue. Other elements of the property, excepting those directly impacted by the proposals for the dormer bathroom, were not subject to survey.

Building Description(s): Three discrete elements of the property were identified as subject to the Planning Application by the client. All areas identified were assessed during the PRA and are described individually.

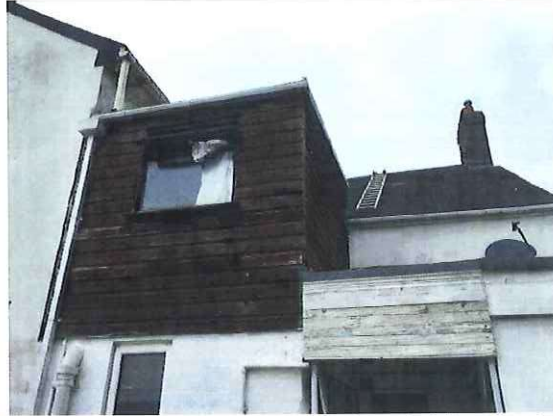
Photograph 2: Showing the timber cladding on the exterior of the bathroom dormer.

The timber-clad, first floor bathroom extension is in a poor state of repair, and would like to replace it with a slightly larger room. The first floor bathroom could then accommodate a bath, the hot water cylinder (currently located on the far side of the house) and a large built-in storage/airing cupboard.

The side elevation of the property is exposed to the elements coming across the moors from Old Town and we would like to clad the bathroom extension in a low maintenance cement fibreboard which has the appearance of timber planks but is harder wearing, longer lasting, has good thermal properties, and is commonly used across the islands. This cladding will be continued down to ground level for an improved aesthetic.

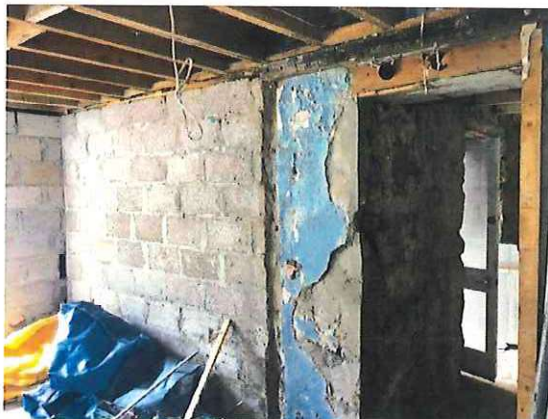
Photograph 10: Showing the interior of the garage with exposed breeze block walls and exposed timber roof structure above.

GARAGE	<p>The garage is a single-story construction attached to the main residential property on the north-eastern aspect. It is a twin-skinned breeze block construction with no insulation in the void between the blocks. It has a flat, bitumen felted roof. There is no external door fitted at present with the void partially filled allowing free access above. uPVC windows are present on the north-eastern aspect - these are tightly fitted.</p> <p>The walls are rendered externally – this is in good condition providing an effective seal to the breeze block walls which are exposed internally. The void between the blocks is accessible where the door has been removed, but this is open at the top internally which both minimises its suitability as a roosting opportunity (offering no apex niches) and ensures that in the unlikely event of bats accessing this temporarily exposed void, there is no risk of entombment.</p> <p>The roof is supported by timber battens – these are exposed internally with no ceiling void. Chipboard is visible above the timbers and the felt is laid directly onto this offering no voids or gaps associated with the structure. The felting is tightly lapped over the eaves offering no roosting opportunities.</p> <p>There is potential access for bats or birds to enter the building through the missing garage door at present. Internally there are suitable niches for use by nesting birds. Potential roosting opportunities for bats entering through openings are restricted to free-hanging from the timbers.</p> <p>The garage remained in use for storage at the time of survey. A full inspection for signs of bat occupation including droppings or feeding remains identified no evidence.</p> <p>A fibreglass roof connecting the garage to the main dwelling was also inspected – no potential features suitable for use by roosting bats or nesting birds associated with this element of the construction were identified.</p>
