#### PERMISSION FOR DEVELOPMENT

**Proposal**: Removal of the redundant chimney stack to 31/33 Porthcressa Road and making

good of the roof covering to match the existing surroundings.

# 31 & 33 PORTHCRESSA ROAD, HUGH TOWN, ST MARY'S, ISLES OF SCILLY

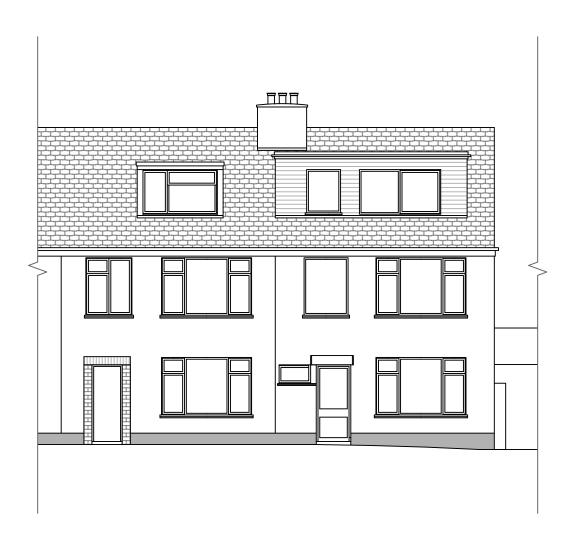
Existing South Elevation 1:100

Works to consist of the removal of the redundant chimney stack and making good of the roof covering to match existing surroundings.

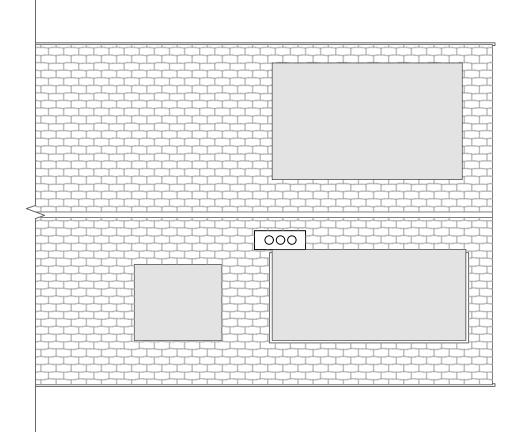
**Existing Roof Plan** 1:100

Works to consist of the removal of the redundant chimney stack and making good of the roof covering to match existing surroundings.

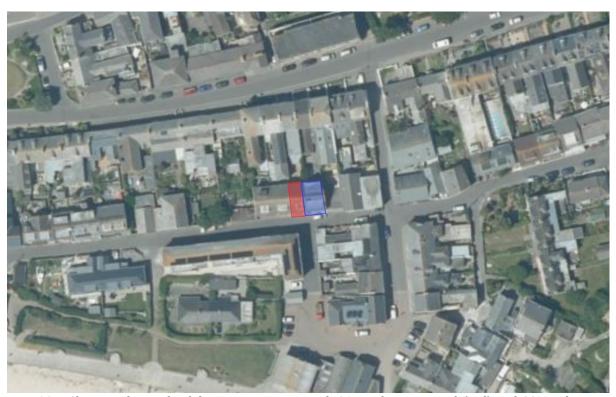
**Map 02** – Showing the roofs of the two properties with 31 Porthcressa Road (red) and 33 Porthcressa Road (blue). The chimney is situated at the intersection between the two properties on the southern pitch of the roof.
