PRELIMINARY ROOST ASSESSMENT (PRA)

2 ENNOR CLOSE,
OLD TOWN, ST MARY'S, ISLES OF SCILLY

Our reference: 22-11-2

Report date: 26th November 2022

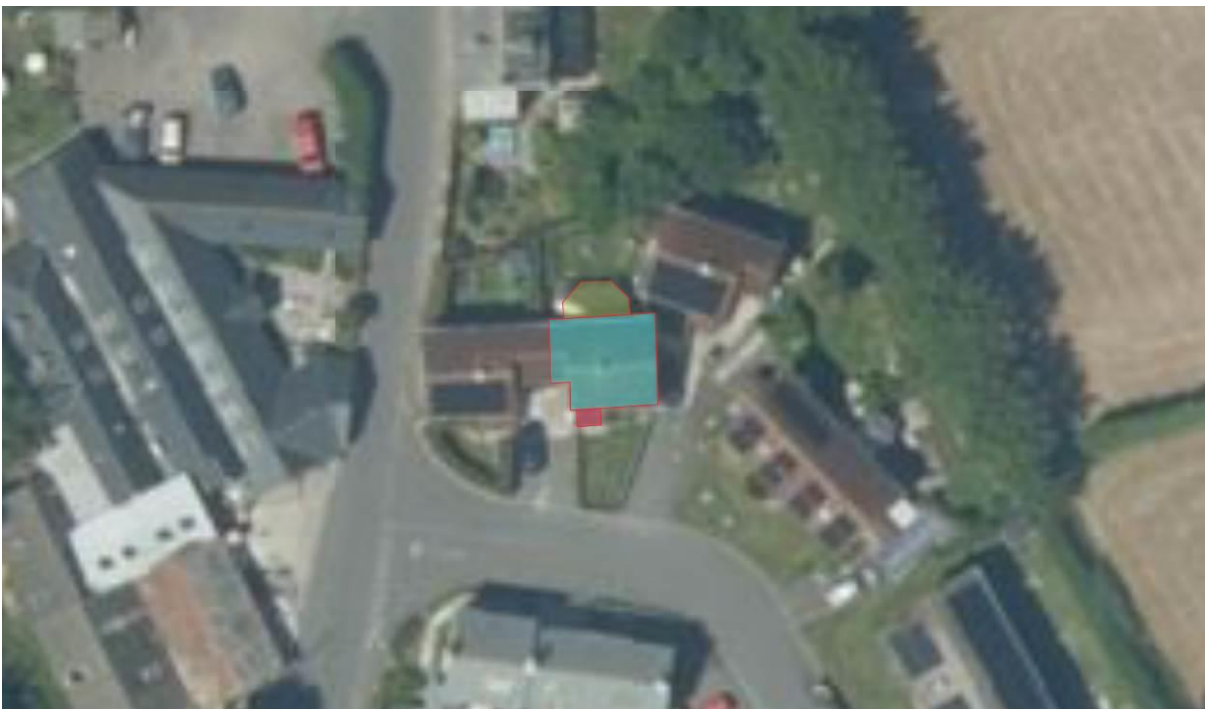
Map 02 - Showing the main dwelling house (aqua wash) with the conservatory to the rear of the property (yellow wash) and the porch to the front of the property (red wash).

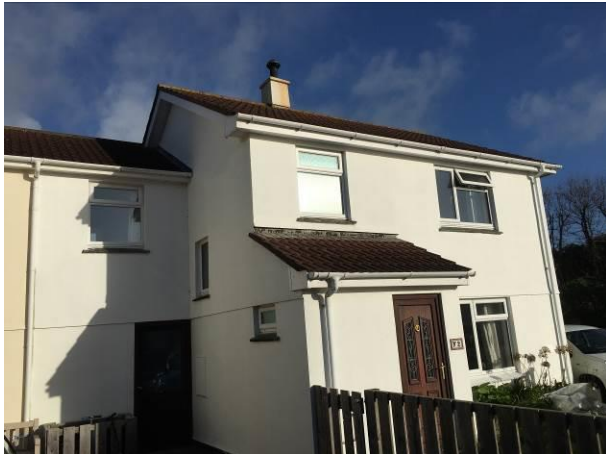
Photograph 1: Showing the property from the front including the porch to be demolished.

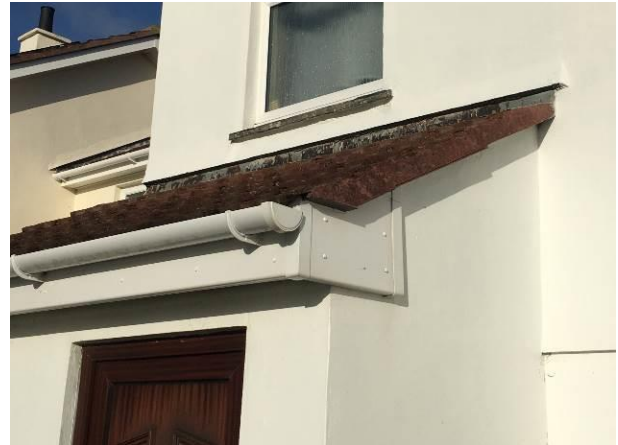
The porch is rendered externally to a high standard in a contiguous style with the rest of the house. It has a single-pitch, tiled roof with pre-fabricated interlocking tiles which are well sealed and in good condition with no gaps either between tiles or at the eaves. The verge is concreted and well-sealed and the lead flashing at the union between the porch roof and the main property is tightly fitted. A uPVC soffit is present above the door – this is well-sealed. The door itself and a window in the western aspect are uPVC with well-fitted frames – no gaps were noted.

Photograph 2: Showing a closer view of the porch roof with the well-sealed uPVC soffit on the front, and the well-sealed verge on the gable.

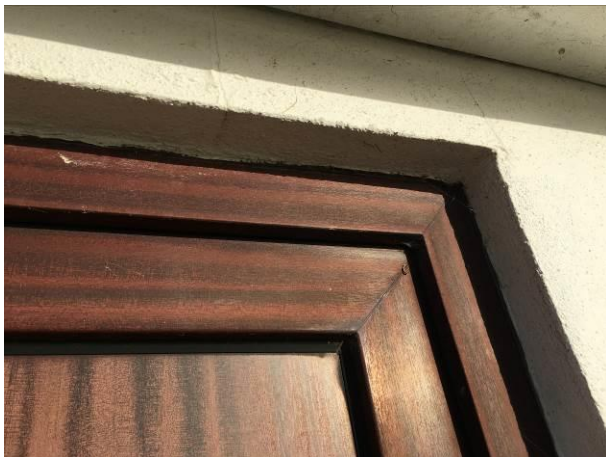
Photograph 3: Showing well-fitted uPVC door frame – this is illustrative of the condition of window and door frames associated with the property.

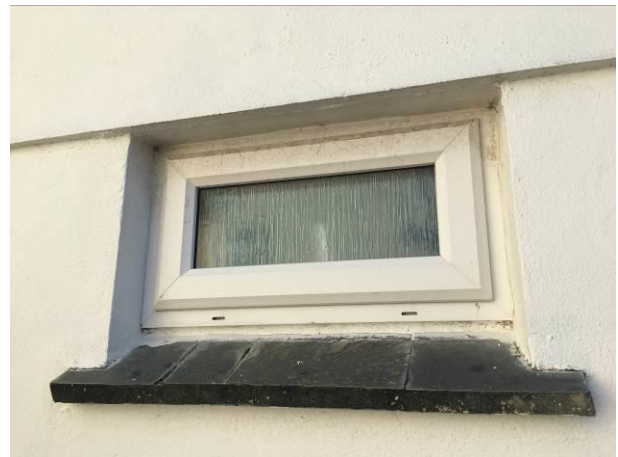
Photograph 4: Showing the porch window – the uPVC frame is well-fitted and the slate sill is well sealed.

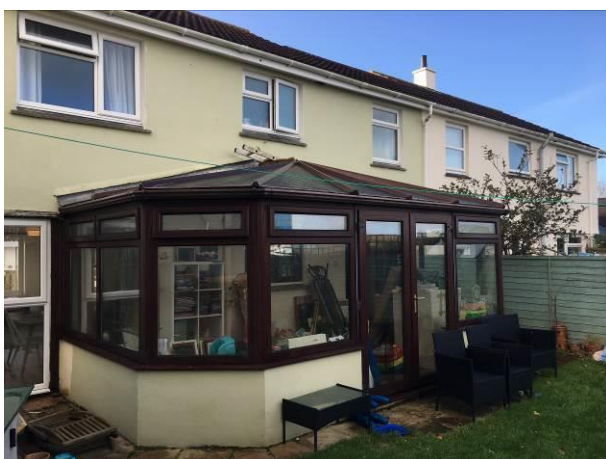
The conservatory has a rendered lower wall supporting a uPVC structure above. The structure is in good condition with no suitable features for use by roosting bats. The interior of the conservatory is light and used as part of the residential property – no suitable roosting habitat for bats is identified internally.

Photograph 5: Showing the conservatory situated to the rear of the property.

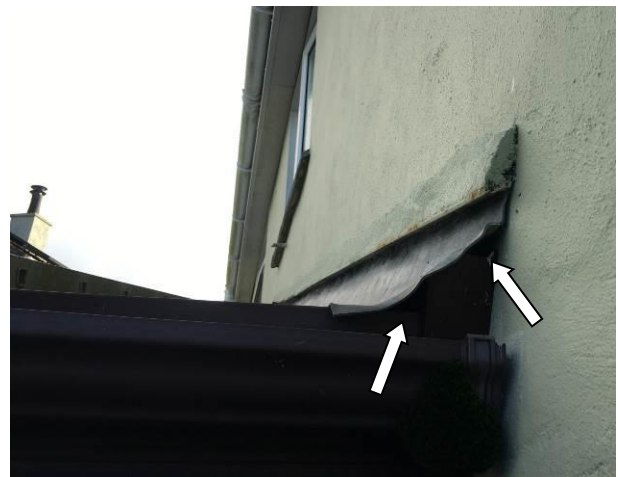
Lead flashing lines the union between the conservatory roof and the adjacent main dwelling – there are small gaps at the eaves but these were inspected fully with a video-endoscope and found to be blocked with dense cobwebs and debris indicating no current or recent use by bats. This sole element of the construction offers negligible potential for use by roosting bats.

It is considered that the lead flashing where the conservatory joins the main dwelling provides

negligible potential for use by roosting bats – however an inspection using a video endoscope provides sufficient confidence to confirm a lack of current or recent use.

Photograph 6: Showing the lead flashing at the joint between the conservatory roof to the adjacent building – there are minor gaps present where indicated.

Standard good practice and vigilance should be observed during the removal of the lead flashing between the conservatory and the main dwelling in acknowledgement that bats are transient in their use of roosting opportunities and may explore potential locations. The flashing should be removed carefully and by hand in order to ensure that, in the unlikely event of bats utilising this potential feature, they would not be harmed or killed. Recommended measures to achieve this recommendation and ensure legislative compliance are provided in Appendix 1.

This flashing should be removed carefully and by hand in such a way that if any bats are present beneath, they are not crushed or otherwise injured by the action. Once this location has been exposed and it has been confirmed that no bats are present, works can proceed.
