PRELIMINARY ECOLOGICAL APPRAISAL OF:

PENOLD CHURCH STREET ST MARY'S ISLES OF SCILLY TR21 0NA

Our reference: BS44-2021

Report date: 29th April 2021

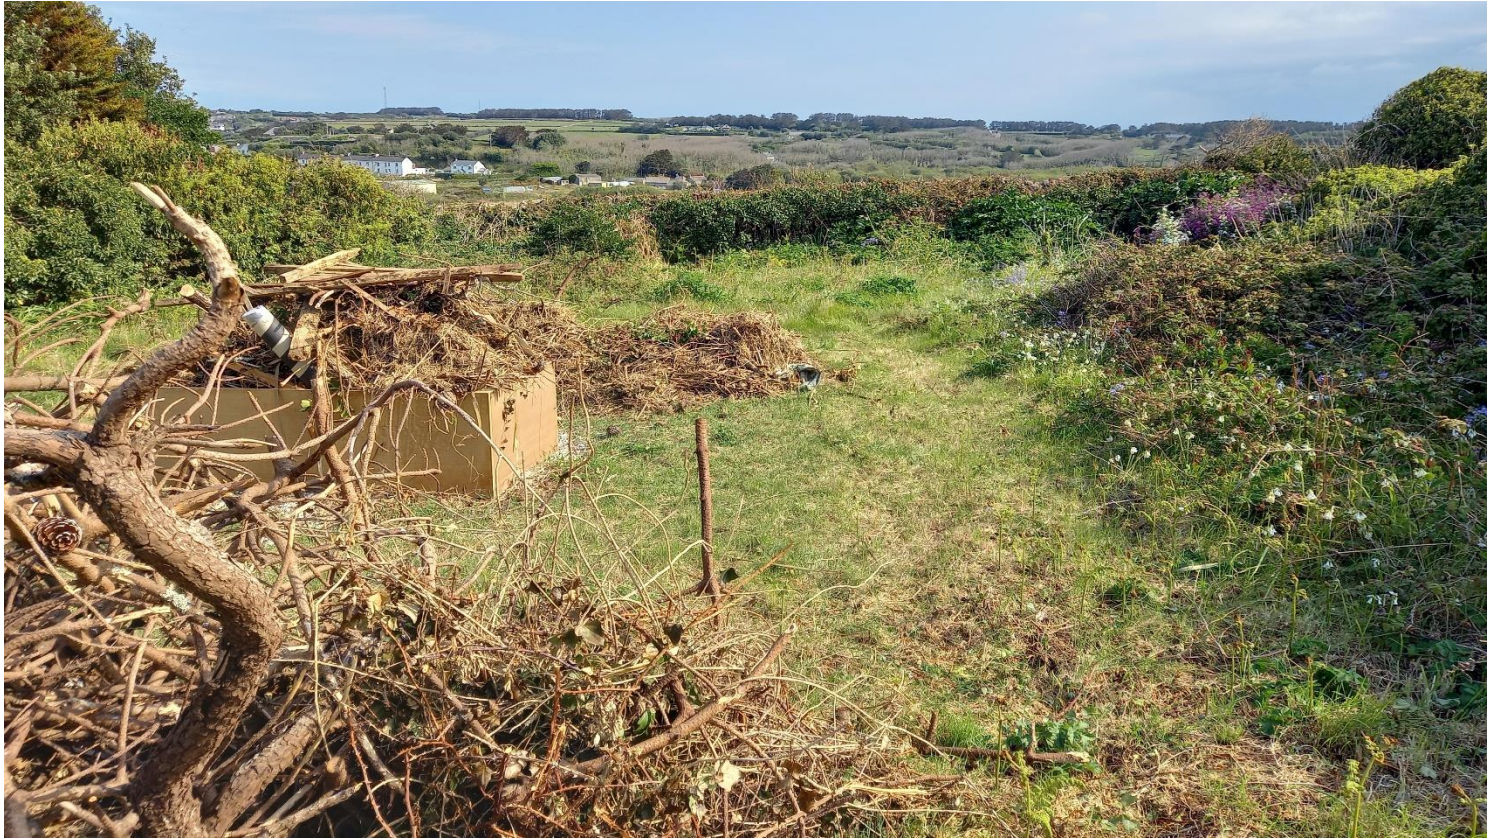
Photo 1. Other neutral grassland and drystone walls

Two small fields immediately to the north-east (rear) of the property contained species consistent with under-managed neutral grassland (see Photo 1.). Grass species included frequent Red Fescue (*Festuca rubra*) and Cock's-foot (*Dactylis glomerata*), with occasional Common Bent (*Agrostis capillaris*) and Sweet Vernal-grass (*Anthoxanthum odoratum*). Wildflowers included rare Bulbous Buttercup (*Ranunculus bulbosus*) and Yarrow (*Achillea millefolium*), with occasional Ribwort Plantain (*Plantago lanceolata*) and Common Cat's-ear (*Hypochaeris radicata*). Signs of under management included encroachment by species such as Hogweed (*Heracleum sphondylium*), Bracken (*Pteridium aquilinum*), Bramble (*Rubus fruticosus* agg.) and Narcissi (*narcissi* sp.), suggesting possible previous cultivation or consistent with being used as areas to compost garden waste as other non-native and naturalised species including Bear's-breeches (*Acanthus mollis*), Hybrid Bluebell (*Hyacinthoides hispanica* x *non-scripta*) and Three-cornered Leek (*Allium triquetrum*) were also present. Species typical of disturbed ground or increased nutrient status were also present and included Perennial Sow Thistle (*Sonchus arvensis*), Spotted Medick (*Medicago arabica*), Scarlet Pimpernel (*Anagallis arvensis*), Common Nettle (*Urtica dioica*), Cleavers (*Galium aparine*) and Bindweed (*Convolvulus arvensis*) rare Common Vetch (*Vicia sativa*) and a Tare species (*Vicia* sp.).

The northern, eastern and part of the western boundaries of the development consist of drystone wall, along with 2 further internal drystone walls, the first separating the formal rear garden from the fields to the north-east and the second being the boundary that creates the two smaller fields. These walls are predominantly covered in vegetation in particular Ivy (*Hedera helix*), Honeysuckle (*Lonicera periclymenon*) and Bracken (see Photo 1.). Some of the exposed granite blocks are covered with saxicolous lichens including *Flavoparmelia caperata*, *Parmotrema perlatum* and *Parmelia saxatilis*.

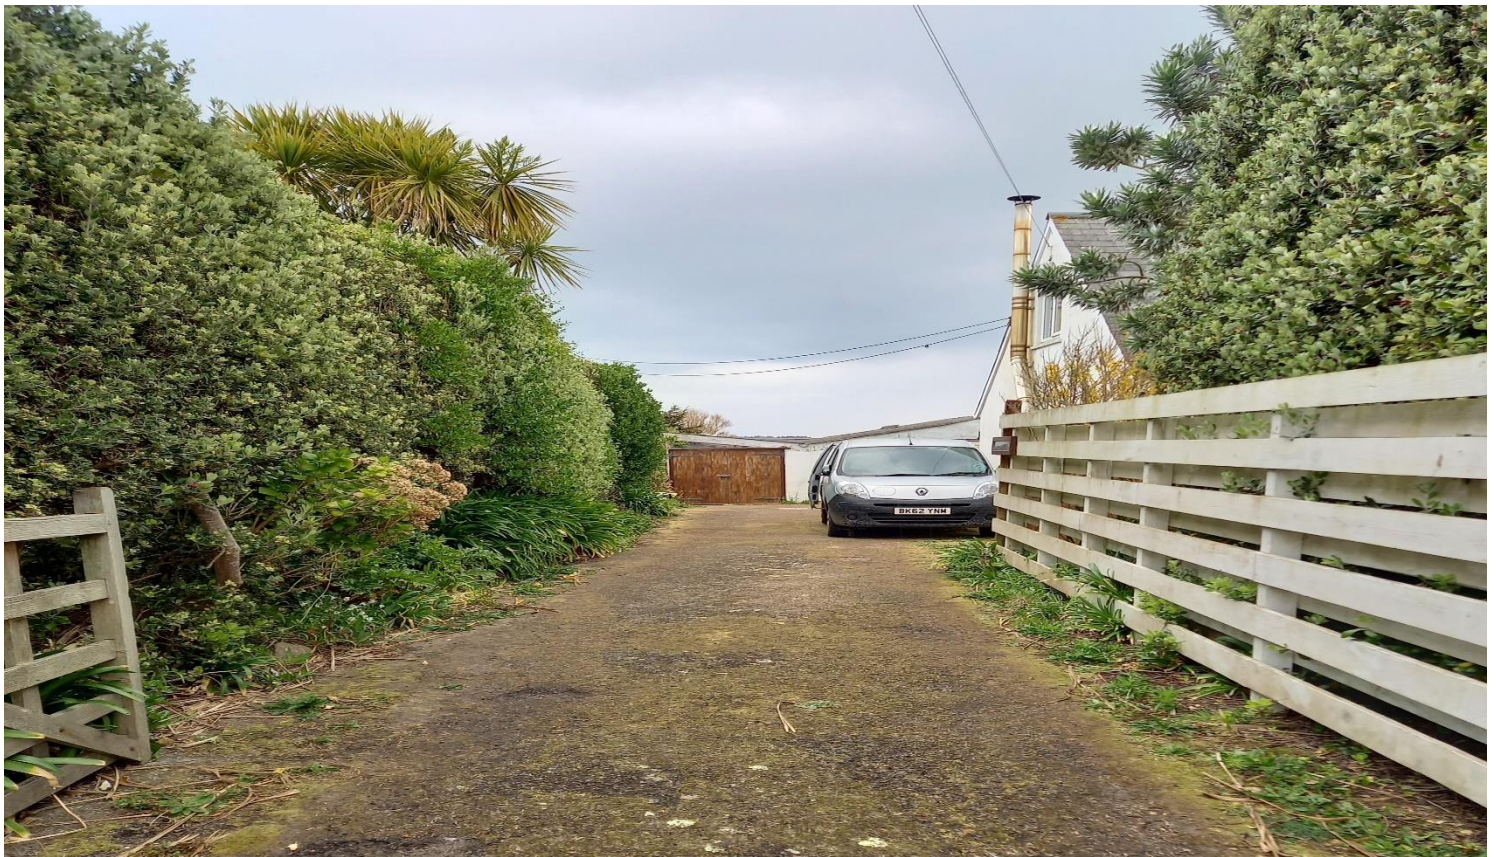
Photo 2. Other hedgerow

A mature, non-native hedgerow is present along north-west boundary separating the driveway of the development with the adjacent property (see Photo 2.). The hedge is well-maintained and consists predominantly of Karo (*Pittosporum crassifolium*) with rare Tree Bedstraw (*Coprosma repens*). The hedge has a small border dominated by African Lily (*Agapanthus africanus*), with rare Bigleaf hydrangea (*Hydrangea macrophylla*), African Daisy (*Osteospermum* sp.) and Tutsan (*Hypericum androsaemum*).

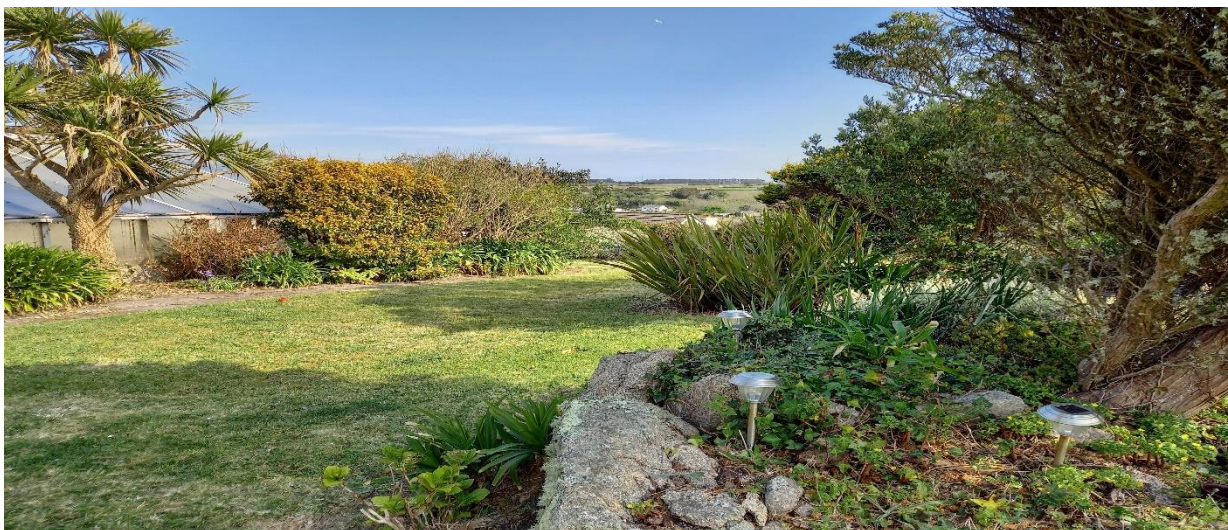
Photo 3. rear garden

The garden is situated to the rear of the development and is laid predominantly to lawn, dominated by *Hypnum* and *Eurhynchium* sp. of moss, with occasional tussocks of Cock's-foot, Broad-leaved Plantain (*Plantago major*), White Clover (*Trifolium repens*), Daisy (*Bellis perennis*), Common Dog-violet (*Viola riviniana*) and rare Creeping Cinquefoil (*Potentilla reptans*). One mature Monterey Cypress (*Cupressus macrocarpa*) and Monterey Pine (*Pinus radiata*) are present at the south-east and north-east corners of the property, along with two small standards of Apple (*Malus* sp.) which are found along the north-east boundary with smaller shrub species including Karo, Cabbage Palm (*Cordyline australis*), Castor Oil Plant (*Ricinus communis*), Silver-bush Everlastingflower (*Helichrysum petiolare*), African Lily (*Agapanthus africanus*), Buddleia (*Buddleia davidii*) Giant Herb Robert (*Geranium maderense*), Bamboo (*Bambusoideae* sp.) French Lavender (*Lavandula stoechas*) the latter three planted within a large 'rockery' adjacent to the boundary wall separating the garden from the smaller fields immediately to the east (see Photos 3.).

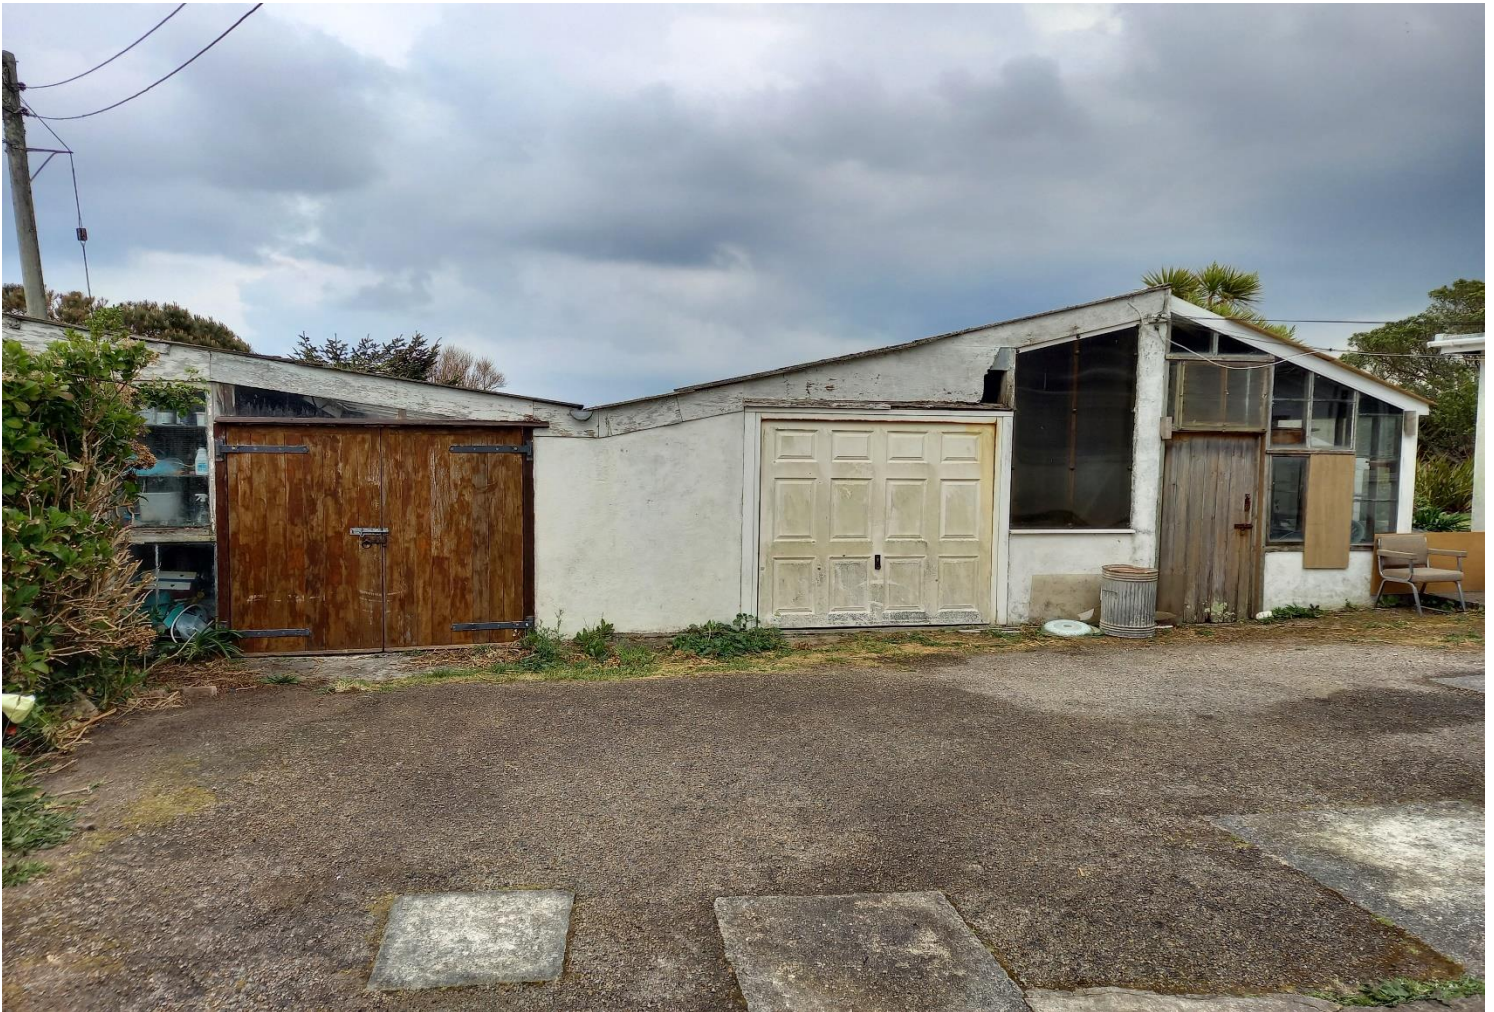
Photo 4. outbuildings

The buildings comprise the main semi-detached dwelling (described in section 3.4) and a group of outbuildings immediately north-west of the property. These buildings comprise of two single garages and associated storage along with an old flower store. Block built in construction with pent style roofs in a combination of corrugated roof sheeting and opaque plastic sheeting of varying pitch and aspect (see Photo 4.).

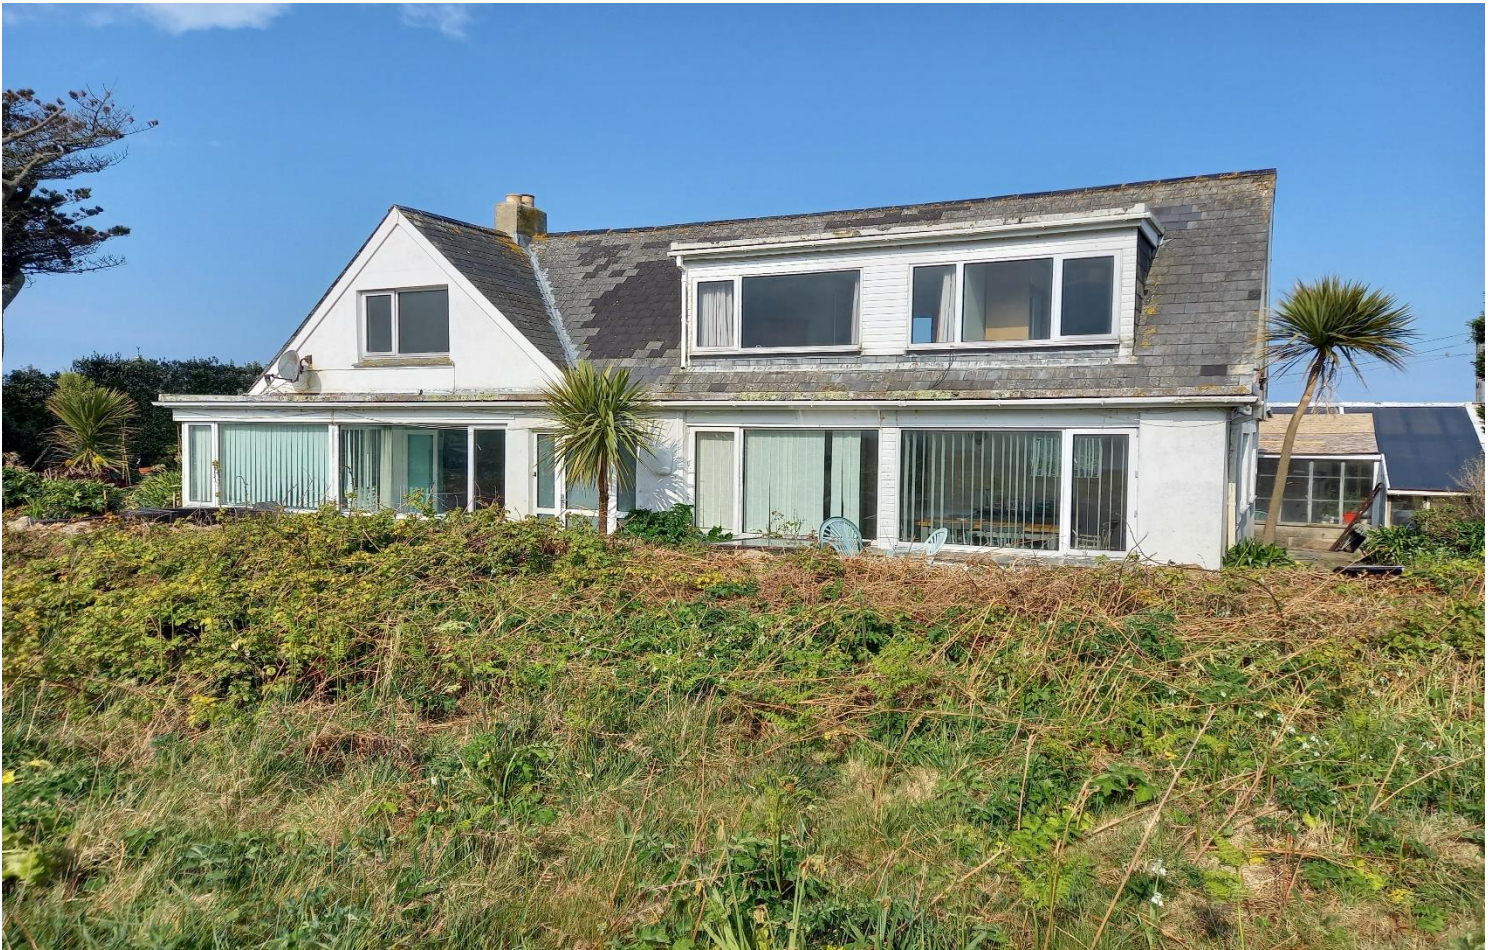
Photo 5. North-east elevation

The work proposed is to re-roof the building, including the re-roofing of the two flat, fibre-glassed roof extensions and the refurbishment of two large, flat-roofed dormer windows. Throughout, the building presented with little, or no gaps, crevices or holes in the areas of the proposed works. None of the fibre cement tiles were missing and were tightly bound to each other; the glazed concrete ridge tiles were well attached with no obvious mortar missing. The flashing around the base of dormer windows and the chimney was well fitting and not raised. The vertical hanging fibre cement tiles on each aspect of the dormer windows were in the same condition as those of the roof. The fenestration presented with no gaps between the window frames and the buildings structure and the modern UPVc fascia and soffit boards were tightly bound to the eaves and their respective elevations. The modern fibre-glass roof presented with no cracks or holes, as did the render on the chimney (See photo 5.).

In summary, the building and the proposed development has negligible features suitable for use by roosting bats, in particular crevice-dwelling species of the pipistrellus genus. In contrast, the outbuildings provide numerous features that bats could use to roost or utilise as a night roost, but these buildings do not form part of the current proposed works. Beyond the proposed development the habitat becomes more favourable for foraging and commuting bats, providing links to the wider countryside. Overall, the site is assessed as being of **negligible roost potential**.

- Undertake enhancement measures to meet NPPF net gain in biodiversity principles by installing 1 stand-alone bat box at the apex of the south-east gable end of the property.
