PRELIMINARY ECOLOGICAL ASSESSMENT (PEA) 2023 UPDATE of 2021 REPORT BS44-2021

PENOLD, CHURCH STREET,
HUGH TOWN, ST MARY'S, ISLES OF SCILLY

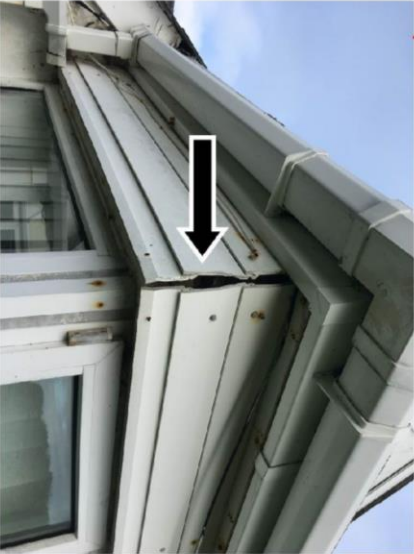
Gap behind fascia on south-eastern corner

There is a gap where the uPVC fascias meet on the south-eastern corner of the flat-roof component of the property. This could potentially provide access for bats to roosting opportunities behind the fascia which runs along the southern aspect towards the main dwelling at this location.

Feature A - Gaps behind fascia on south-eastern corner of flat roof section

These fascias should be unscrewed and removed carefully by hand to expose the location behind. Any void present should be carefully inspected for the potential presence of bats. The reverse of the fascia should also be checked carefully after removal before it is disposed of.

It is critical that this feature is exposed carefully such that if any bats were present, they would not be crushed or otherwise injured by the operation. Contractors should satisfy themselves that no bats are present before proceeding with works in these areas.

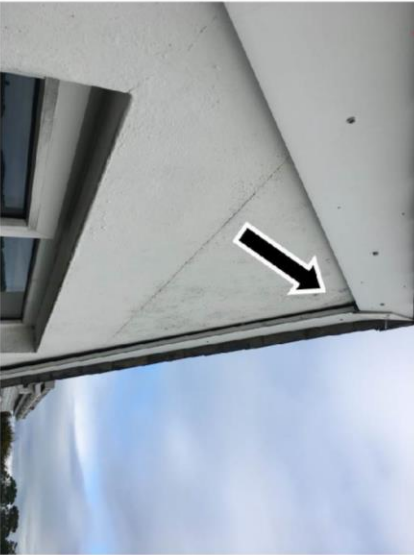
Gaps behind fascia on dormer windows and east-facing gable

There are minor gaps where the uPVC fascias meet the wall in the on dormer windows and east-facing gable. Bats such as common pipistrelle can often be found in small crevices between the wall and fascia features. In this instance, the dimensions and depth are not considered to be optimal for roosting but a precautionary approach is essential to ensure legislative compliance.

Feature B - Minor gap behind fascia on east-facing gable.

The majority of these gaps behind fascias are sufficiently open and shallow that they can be inspected prior to the commencement of works to check for the presence of bats. A torch can be used to aid this inspection. Once contractors have completed this non-destructive visual check for bats, and confirmed absence, the features should then be carefully removed.

The fascias should be unscrewed and removed carefully by hand to expose the location behind. Any void present should be carefully inspected for the potential presence of bats. The reverse of the fascias should also be checked carefully after removal before it is disposed of.

It is critical that these features are exposed carefully such that if any bats were present, they would not be crushed or otherwise injured by the operation. Contractors should satisfy themselves that no bats are present before proceeding with works in these areas.

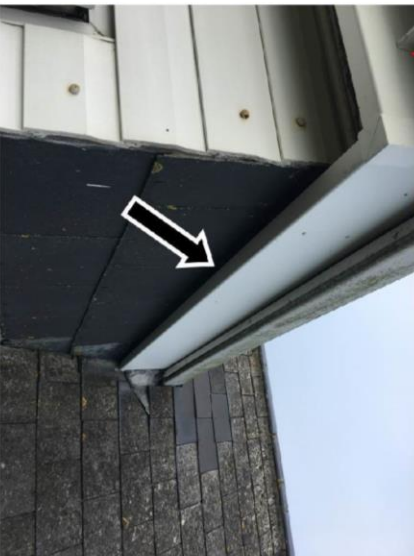
Feature C - Minor gap behind fascia above hanging tiles on dormer (north and south aspects)

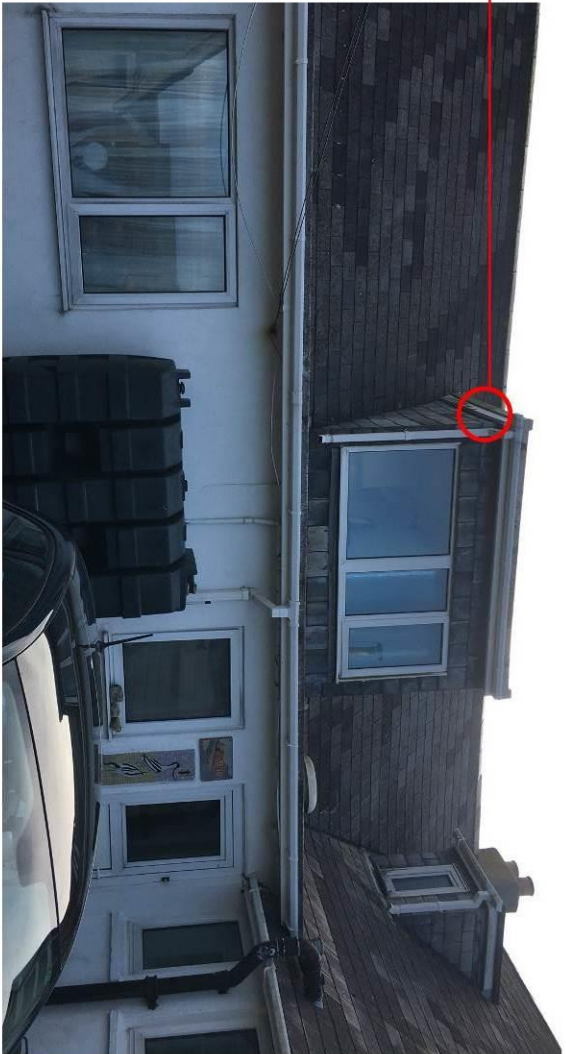
Photograph showing the western aspect of the property.

No other potential features were noted which would require consideration under the MPW - including on the northern gable (not pictured).

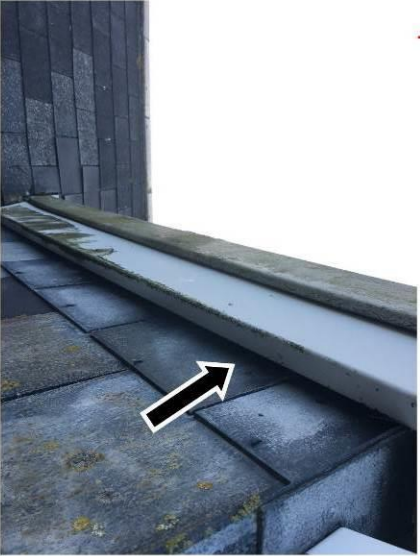
Feature D - Minor gap behind fascia above hanging tiles on dormer (north and south aspects)
