PERMISSION FOR DEVELOPMENT

P/23/007/HH

Removal of chimney.

PRELIMINARY ROOST ASSESSMENT (PRA)

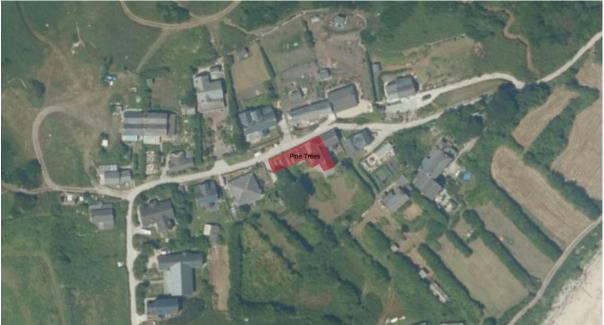
Map 02 – Showing the property highlighted in red. The main 2-storey dwelling is to the east and is attached to a further property on this aspect. The renovated single-storey packing barn which comprises the extension to the property is situated to the west.
