PRELIMINARY ROOST ASSESSMENT (PRA)

BEVERLEY HILLS,
7 PILOTS RETREAT, ST MARY'S, ISLES OF SCILLY

Our reference: 23-5-4

Report date: 19th June 2023

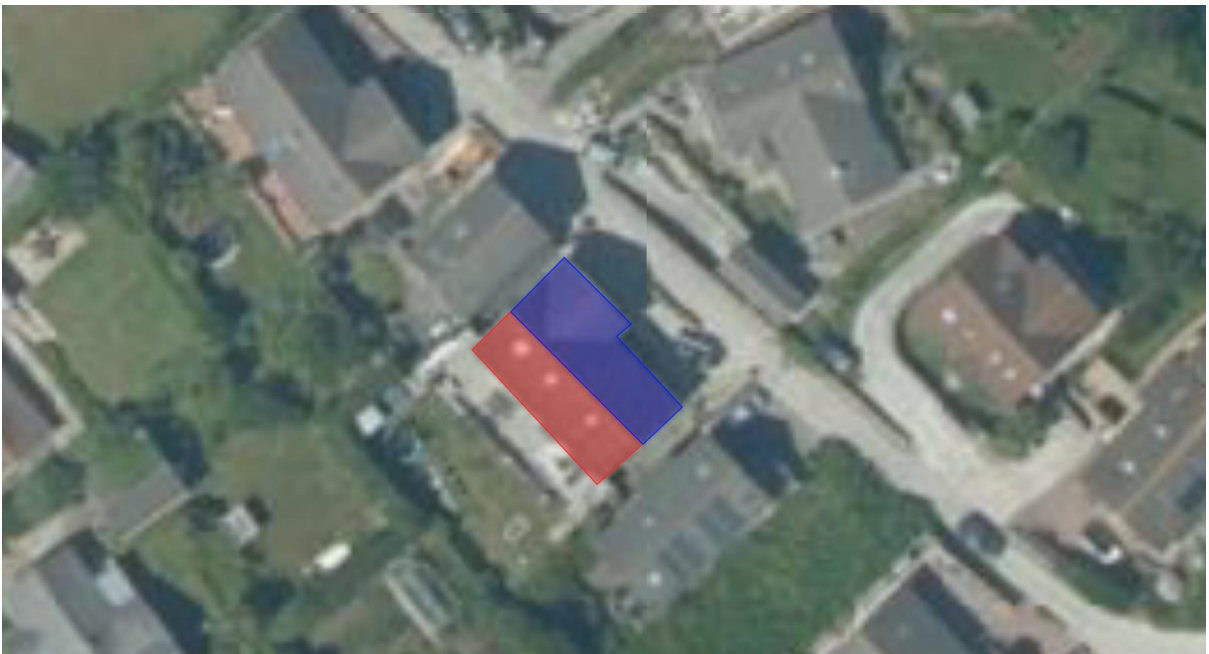
Map 02 – Showing the western pitch of the roof (red wash) on the context of the wider building (blue wash). Reproduced in accordance with Google’s Fair Use Policy.

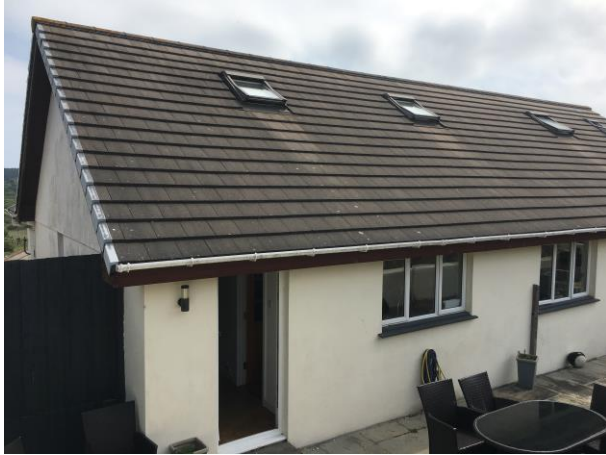
The proposals under consideration in the current Planning Application are restricted to installation of dormer windows in the western roof pitch and the construction of a small flat-roof extension on this aspect – therefore the remainder of this description and assessment will relate to those aspects of the property to be directly and indirectly affected by these works only. This is to ensure clarity and brevity.

Photograph 1: Showing the building viewed from the north-western corner – this is the western pitch of the roof which would be impacted by the proposals.

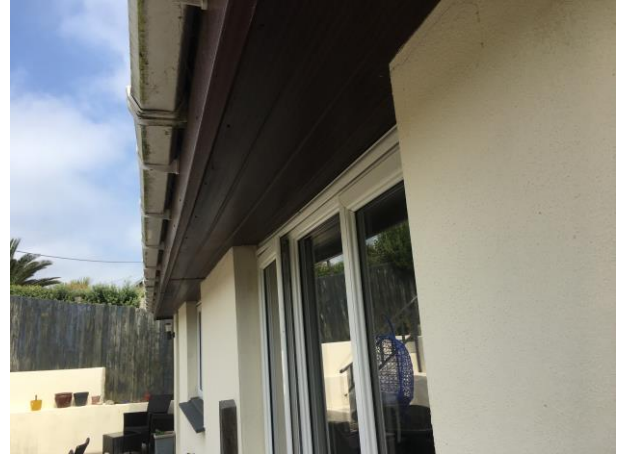
There are uPVC soffits with guttering at the eaves which would preclude direct fly-in access – these were well-fitted and in good condition. The wall below is rendered in good condition, with well-fitted uPVC window and door frames offering no roosting opportunities.

Photograph 2: Showing the tight fit of the uPVC soffits with guttering attached at the eaves of the western pitch. The high quality of the render and tightly fitted windows frame on this aspect can also be seen.

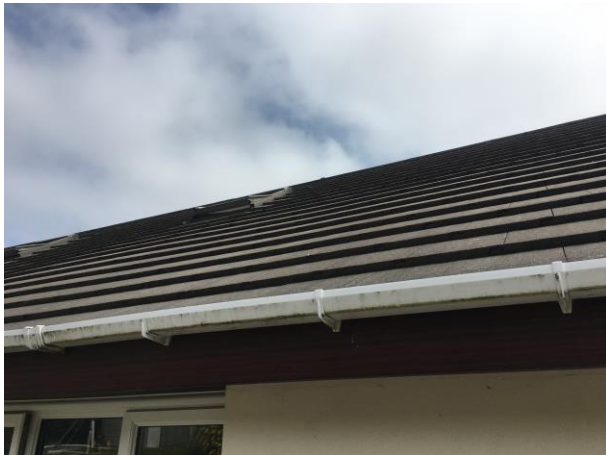
The western pitch of the roof has well-fitted interlocking pre-fab roof and ridge tiles – all are well fitted with no gaps noted. There are existing Velux rooflight windows, some of which would be removed to permit the installation of the new dormers. At the intersection between the roof and the windows there are occasional gaps but these appear large and sealed with battens and are unlikely to provide suitable roosting opportunities for bats. The shallow pitch of the roof would also limit the fly-in at this location. The gables are capped with end-tiles which appear to be well-fitted but would not be directly impacted by the proposals.

Photograph 3: Showing the tightly-fitted interlocking pre-fab roof tiles on the western pitch of the roof.

There are occasional gaps associated with tiles at the junction between the existing Velux rooflight windows and the surrounding tiles. These tiles should be inspected visually and lifted away carefully until any gaps behind them are fully exposed. This should be undertaken by hand and with care in such a way that, in the highly unlikely event that bats are present, they are not injured or killed by the action.

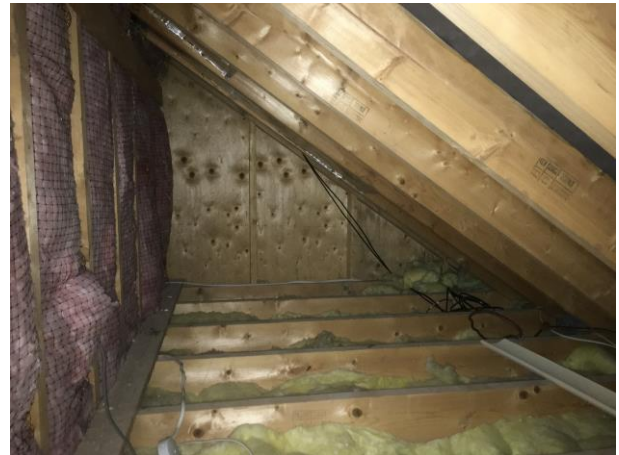
- The void at the apex is sealed but external inspection of the roof indicates no potential access for bats due to the tight fit of the tiles;
- The void associated with the eastern eaves would not be directly or indirectly impacted by the proposals;
- The void associated with the western eaves would be directly impacted by the proposals and was subject to a full internal inspection. The modern timber trusses do not offer roosting opportunities due to their tight fit. Insulation occurs between the joists. The void is tightly under-felted throughout – daylight can be seen at the eaves but any potential fly-in for bats would be significantly obstructed by the positioning of the guttering and conjunction with uPVC soffits. The void was clean and free from obstructing storage – a single mouse dropping was identified but no evidence of bats was found.

Photograph 4: Showing the interior of the void which runs along the western eaves of the roof.
