PERMISSION FOR DEVELOPMENT

Application No:	P/23/046/HH	Date Application Registered:	12th July 2023
Applicant:	Mr Mark Wright Bishop View Porthloo St Mary's Isles of Scilly TR21 0NF	Agent:	Mr Mike Bradbury Mike Bradbury Design Studio St Ives 4 Gabriel Street St Ives TR26 2LU
Site address:	Bishop View Porthloo St Mary's Isles of Scilly TR21 0NF		
Proposal:	Removal of hipped roof and construction of new roof incorporating first floor accommodation and internal alterations (Amended Plans)

BAT PRESENCE/ABSENCE SURVEYS (PAS)

PRELIMINARY ROOST ASSESSMENT (PRA)

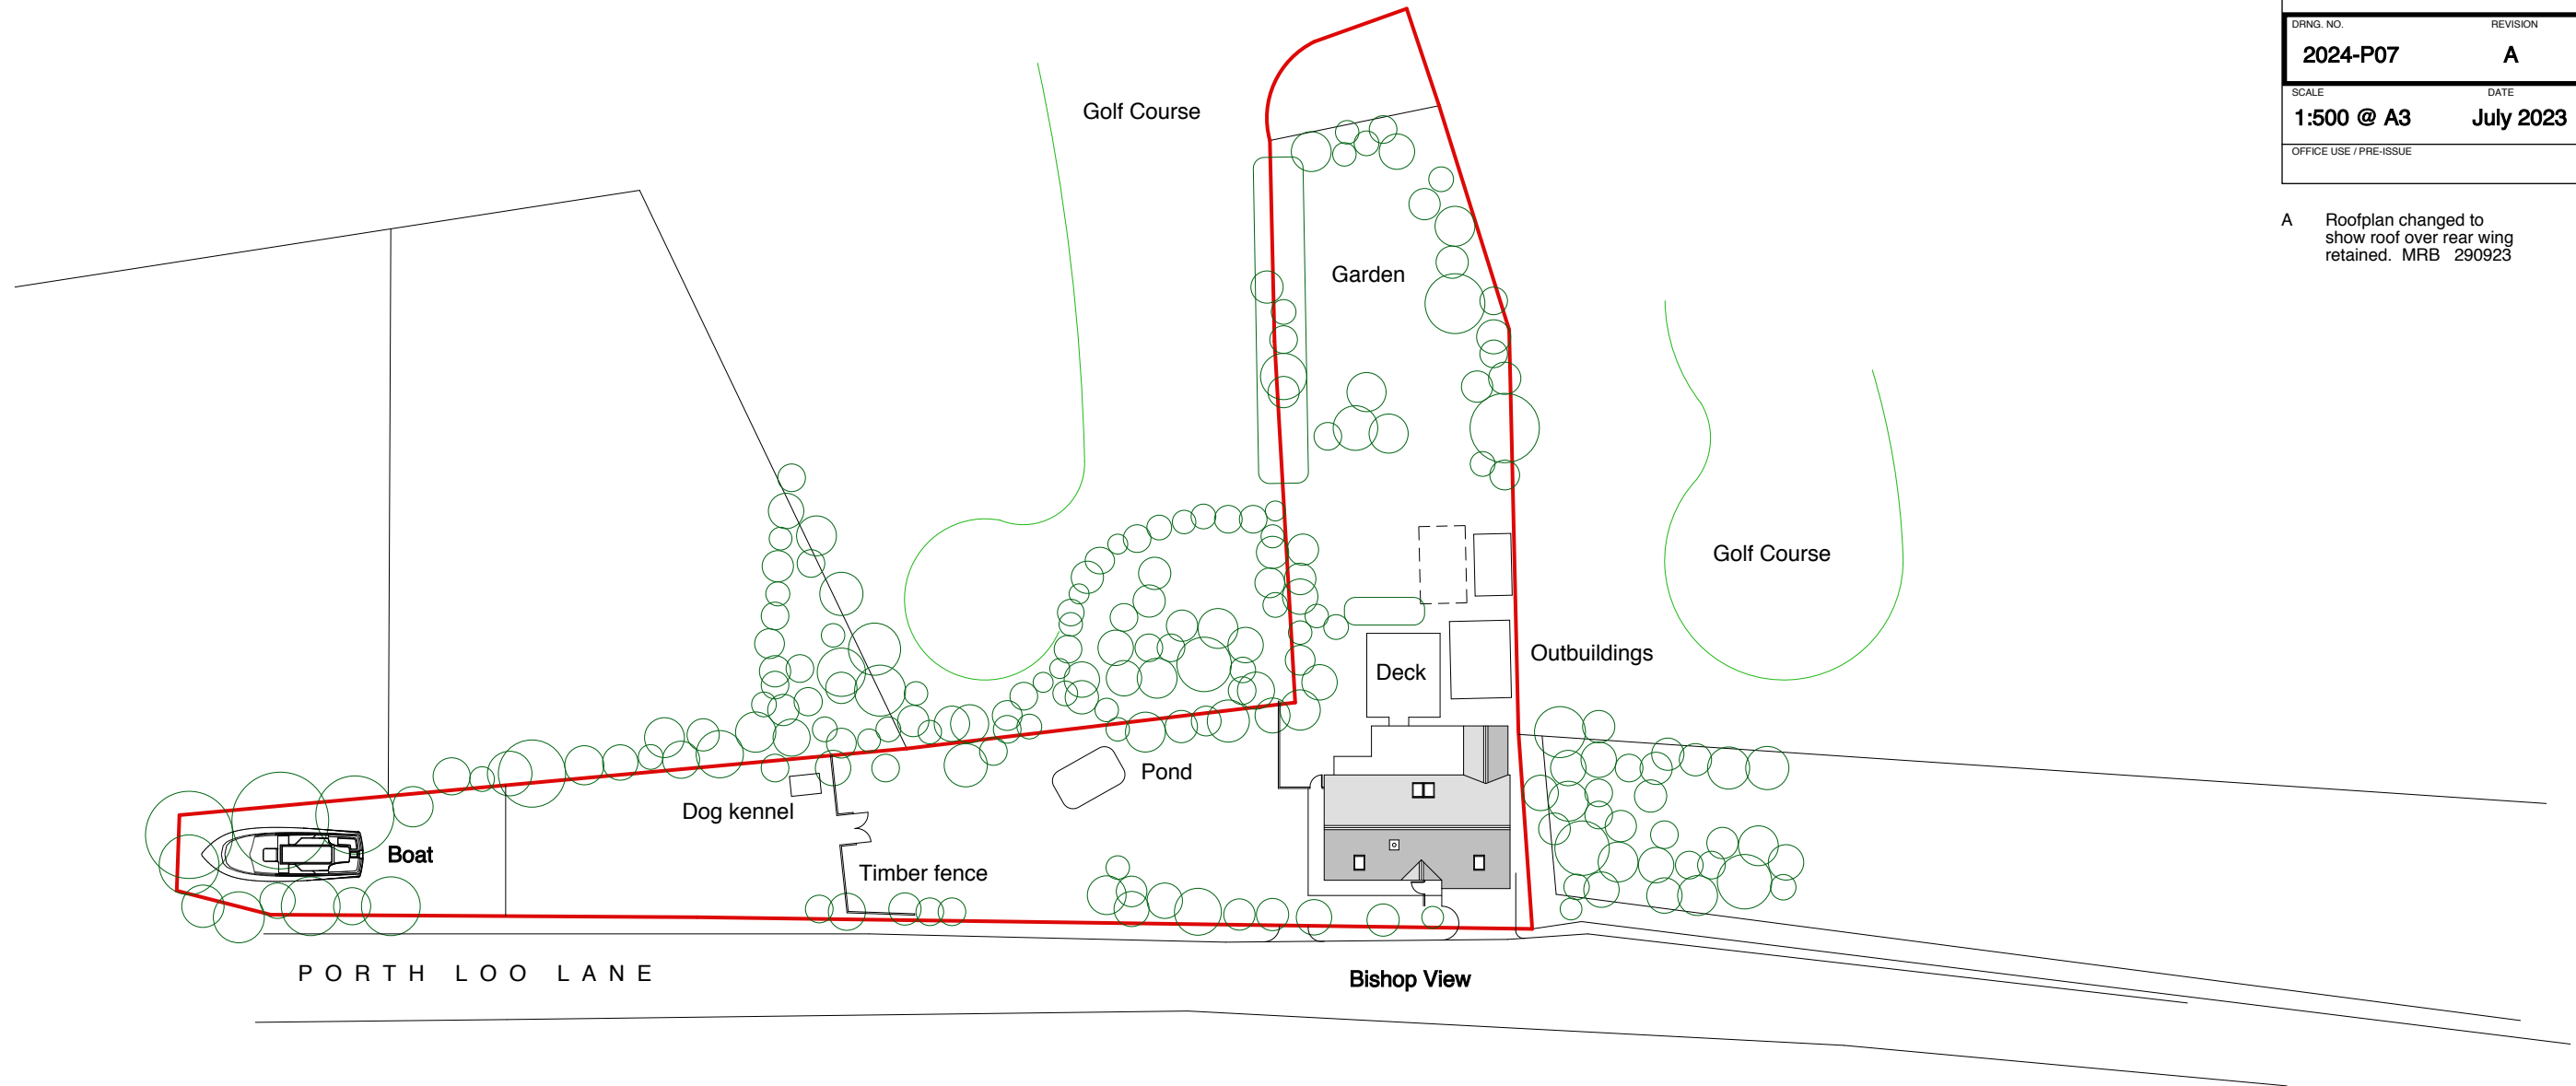
Site Plan

A Roofplan changed to show roof over rear wing retained. MRB 290923

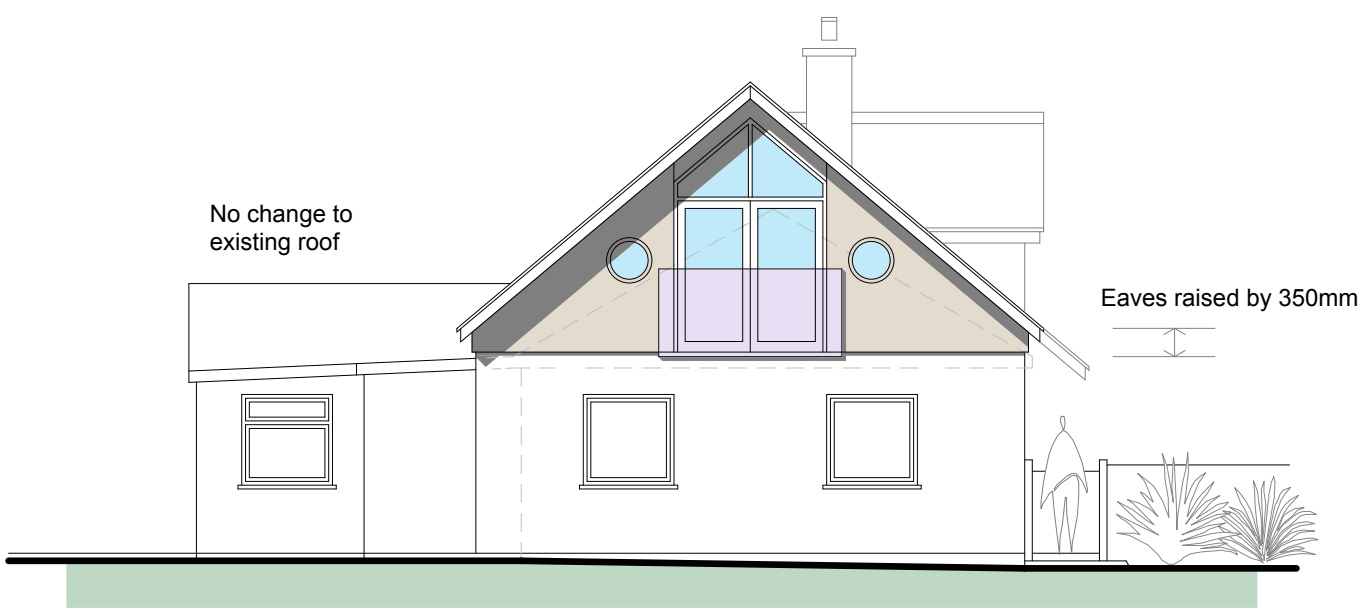
West Elevation

Eaves raised by 350mm

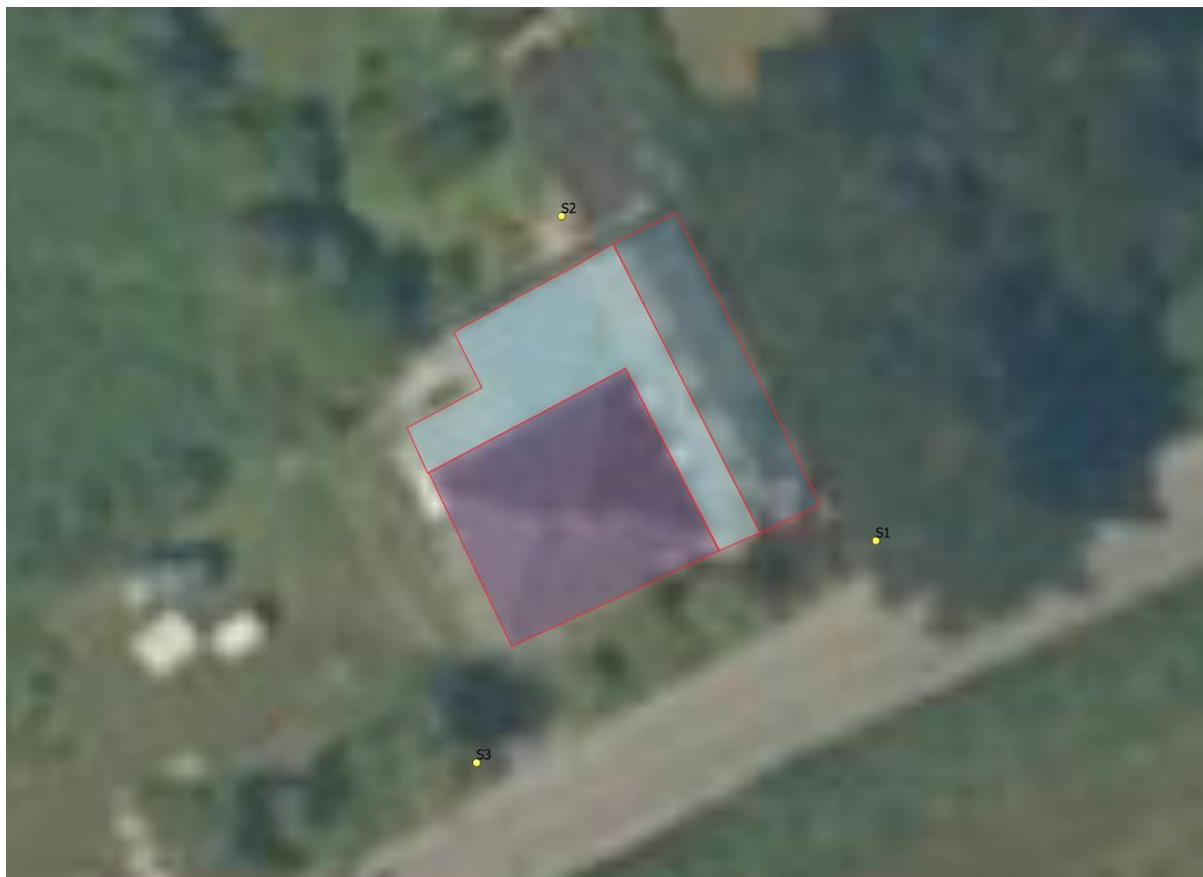
Map 01 – showing surveyor positions around the building. The different shading of the plan reflects different roof structures within the property – these are described in full in the PRA report.

In order to ensure that the different elements of the building were surveyed comprehensively in line with the Best Practice Guidance, a total of three surveyor positions were identified. These are identified in Map 01 below.

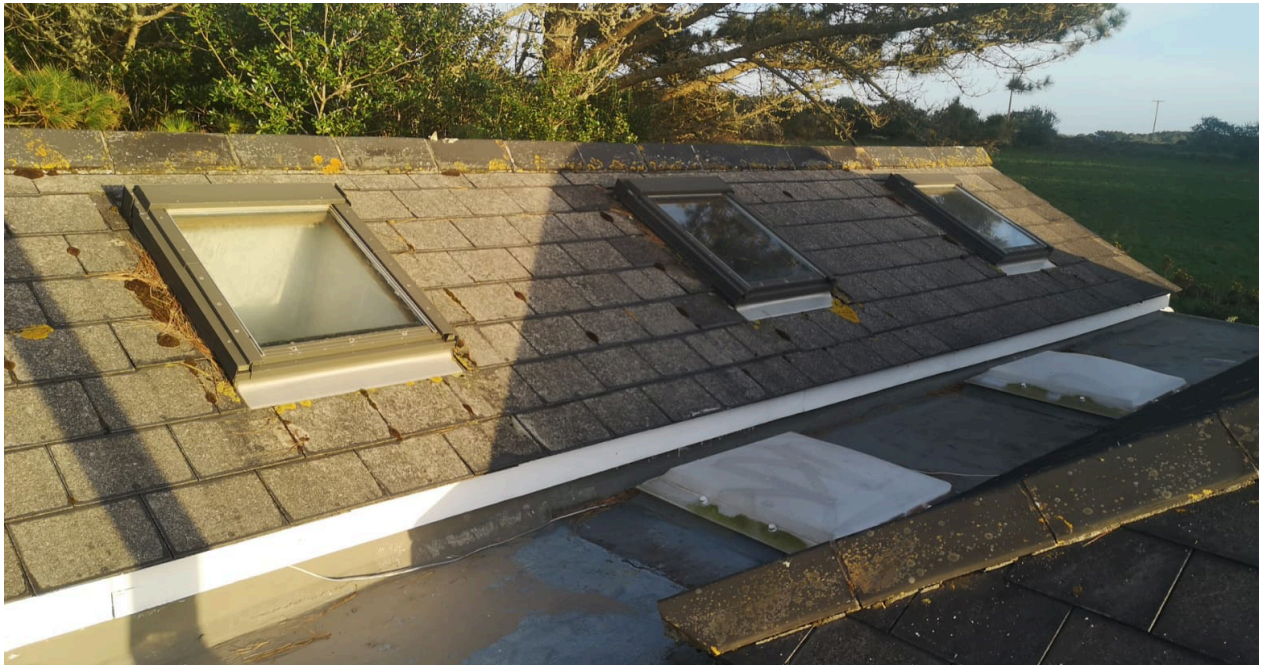
Above: The pitched roof over the garage, corner of the main hipped roof and flat roof connecting link

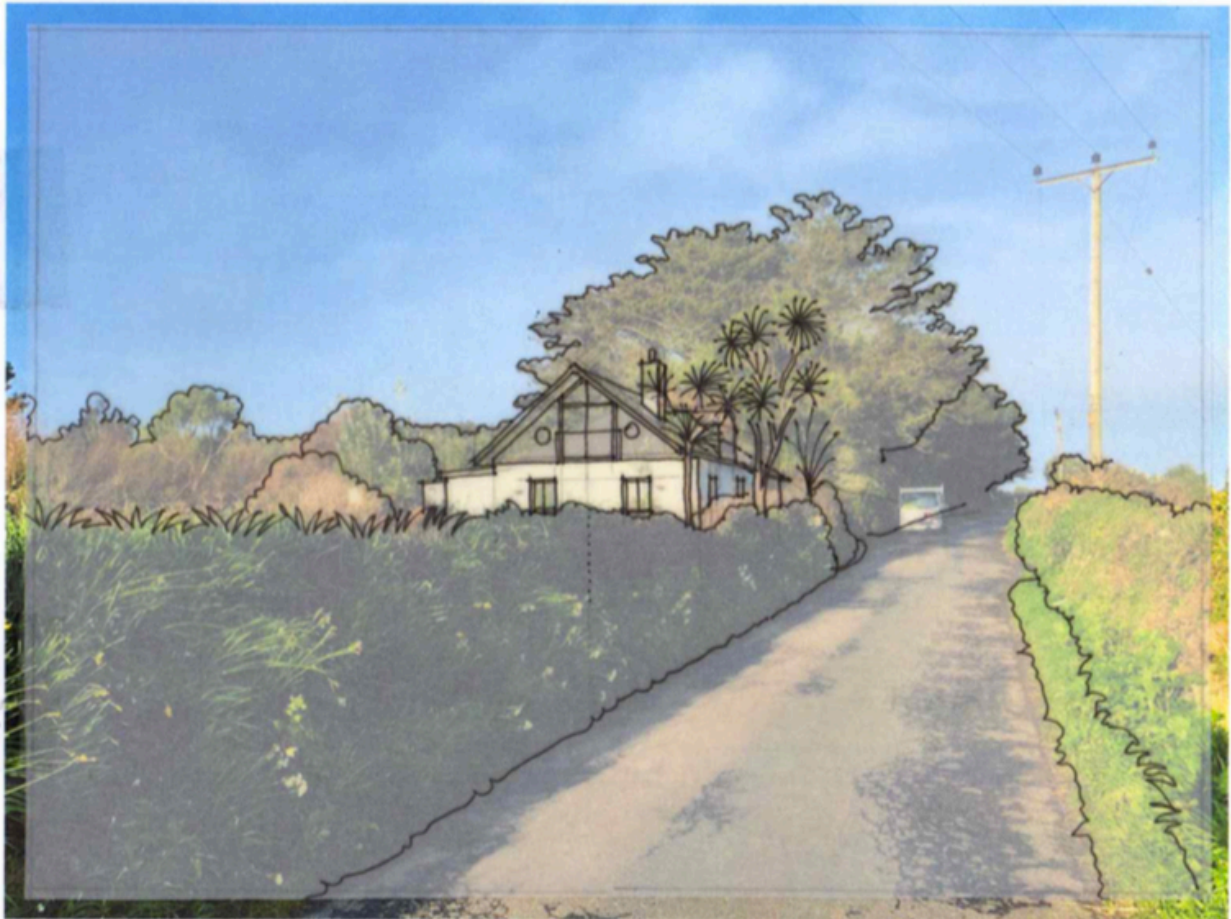
Photo-montage view looking back along Porth Loo Lane towards Bishop View

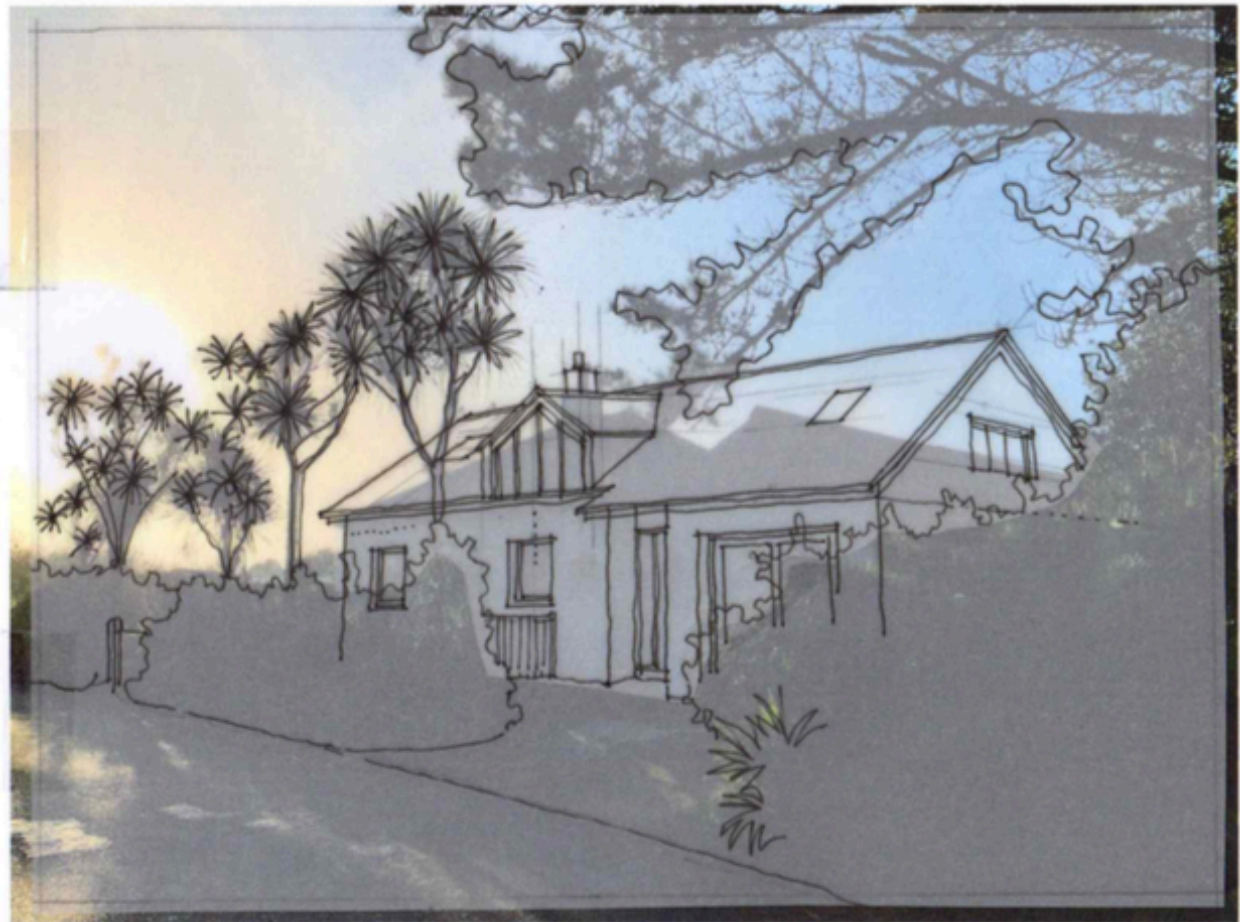
Above: Photomontage proposed view, approaching Bishop View from the East. The existing roof profiles can be seen ghosted behind the freehand overlay

As mentioned above, the proposed designs do not alter the footprint of Bishop View. However, there is a vertical increase in height with the eaves raised by approximately 350mm and the ridge increased by 1.45m. This is the minimum height increase possible to generate reasonable usable first floor space with a canopy internal ceiling profile. Looking at the site as a whole, the most dominant features are mature conifers surrounding the site to the West and North (see photo on previous page). Although these have not been measured accurately, they appear to be in the region of 50ft tall. The relatively small increase in roof height will have little impact in relation to the enveloping landscape. It should also be noted that, from road level, the apparent height of the bungalow is dictated by the line of the eaves. As the height is only being increased by 350mm, the visual impact of this change will be minimal.

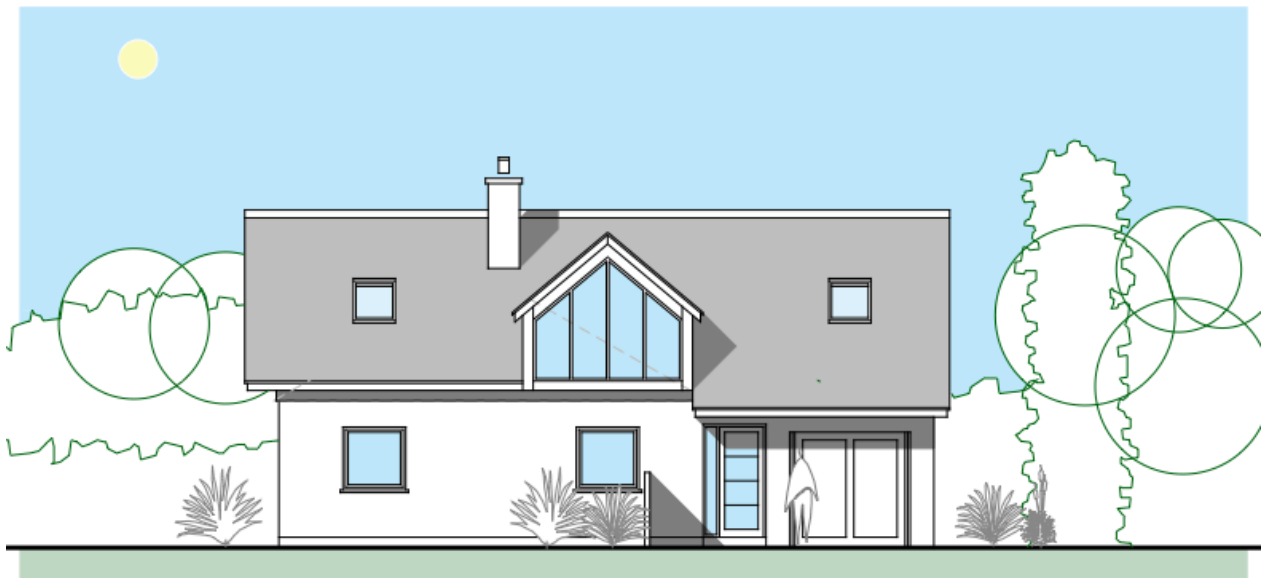
The changes to the roof design and fenestration will transform the appearance of Bishop View. The new gabled roof does change the character of the existing bungalow that has no real architectural merit. Proportions and alignment have been carefully considered. For example, on the front elevation (see below) the new first floor dormer window has been centred on the bedroom window below. Roof windows also align with the window and garage door below. The dragged-down roof over the garage and front door serves a practical purpose, creating shelter – it also introduces a pleasing asymmetrical effect to add interest to the property.

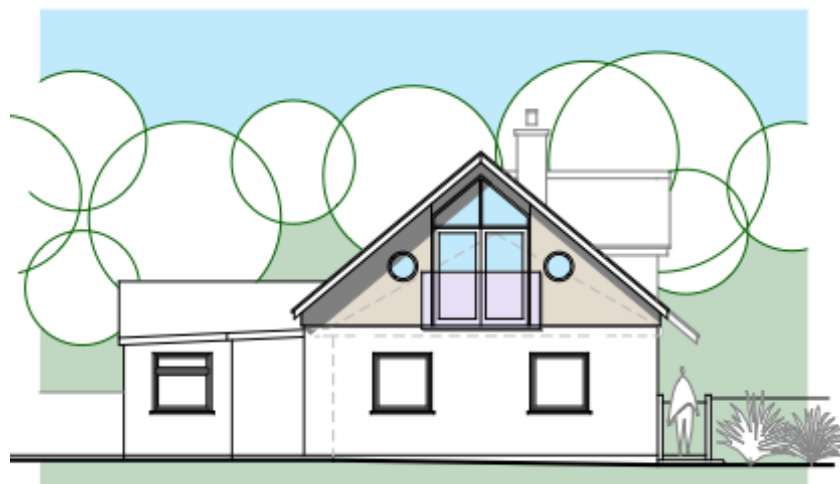
The South facing gable elevation is the other prominent face, seen from Porth Loo Lane when approaching from the Hugh Town direction. Again, care has been taken to achieve the right proportions. The new roof has been centred on the ground floor living room windows. The first floor living room will have an impressive seaward outlook and the glazing will flood the interior with natural light. The two port-hole windows will provide glimpse views from a sitting position. The 40-degree traditional roof pitch will be perfect for a new natural slate roof. Windows will be white to match the new ground floor windows in either upvc or, in the case of the larger feature windows, marine grade aluminium. The earlier rear wing has been omitted from the designs, reducing the impact of the extensions from this angle.
