PRELIMINARY ROOST ASSESSMENT (PRA)

WINGLETANG, ST MARY'S, ISLES OF SCILLY

Report date: 23rd July 2023

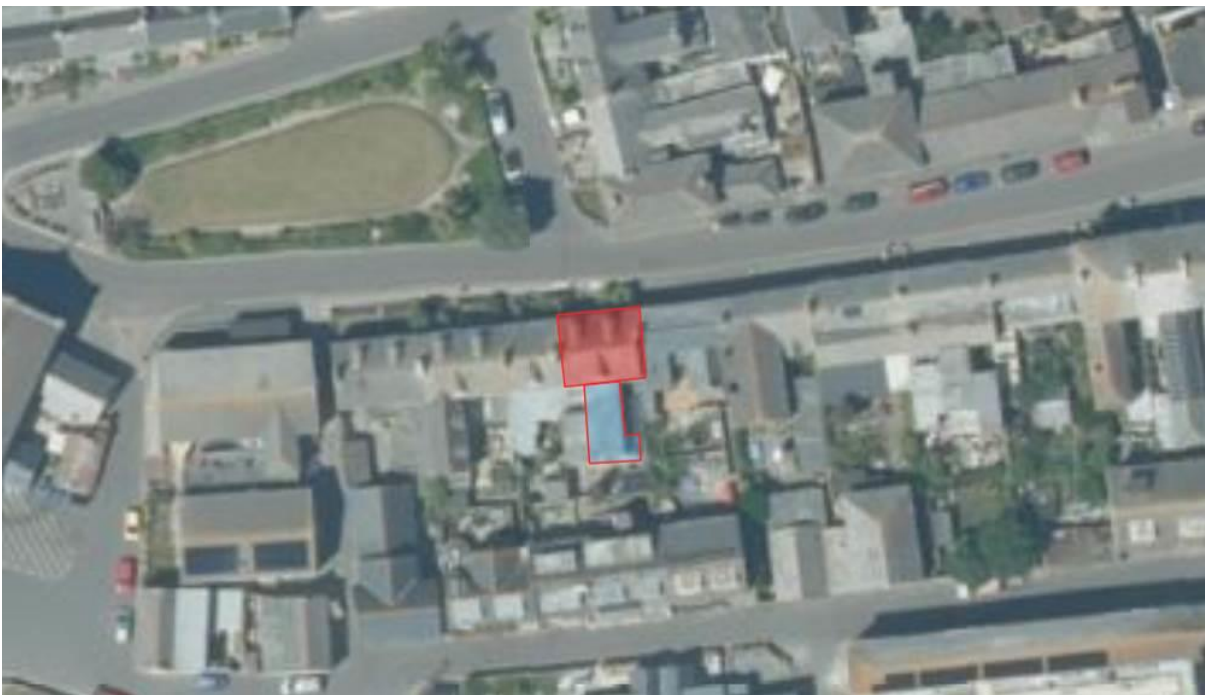
Map 02 – Showing the main pitched roof mid-terrace property (red wash) with the flat-roof extension to the rear (blue wash). Please note boundaries are indicative and illustrative only.

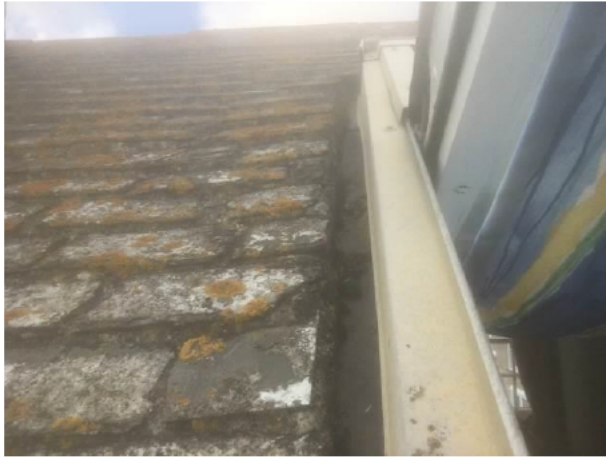
The roof itself is wet-laid scantle tiles and appeared to be in excellent condition, especially around the existing roof-light windows which are to be replaced. The flashing around these windows was tightly sealed and no potential features for use by bats could be identified in these locations. There are occasional examples of missing mortar beneath tiles, though these appear largely superficial.

Photograph 1: Showing the tight fitting of the existing rooflight windows and adjacent wet-laid scantle tiles.

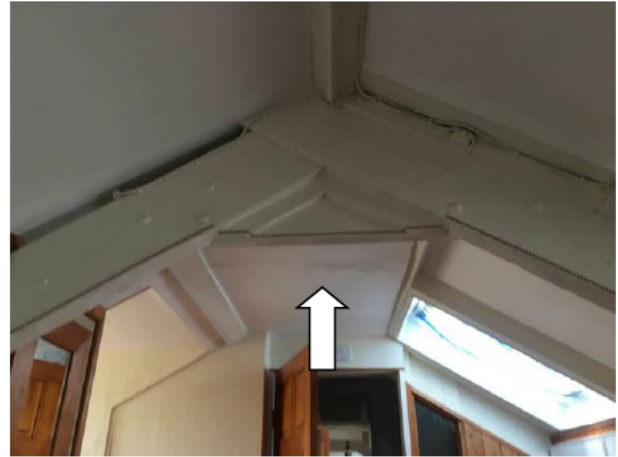
Internally, the majority of the top floor is converted to residential accommodation. There are very minor sealed voids above the ceiling at the apex in places, though these would be too small to allow internal flight by bats. There is eaves storage built into the dormer roof. These voids are accessed by multiple hatches as several physically separated voids are created by the intervening stairways and dormer windows. The voids are well-insulated throughout including insulation between rafters with other minor gaps filled. There is rudimentary under-boardings of the ceilings within these voids using plasterboard sheets. Whilst the voids are not part of the regular residential accommodation, they are carpeted and used for regular storage of various items indicating routine access. No evidence of bats or other species (such as rodents) were identified within these voids and there appeared little or no scope for bats to access these spaces.

Photograph 2: Showing the top floor of the property with some minor apex voids (as indicated) but with the ceiling built to the ridge beam in others.

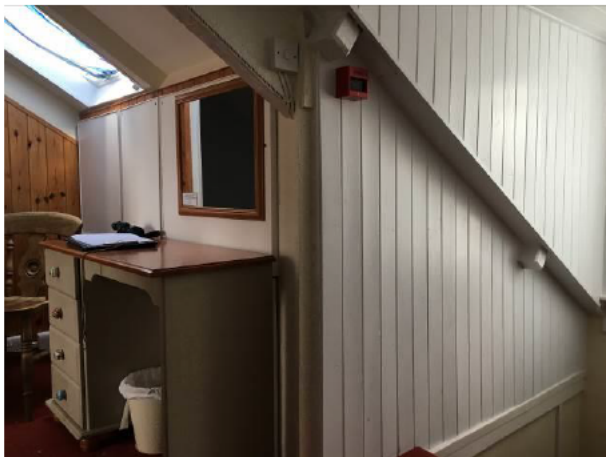
Photograph 3: Showing an example of the eaves storage space, as viewed from the residential accommodation.

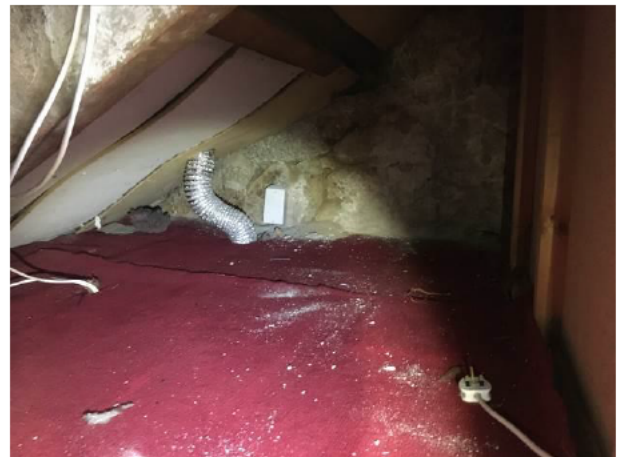
Photograph 4: Showing the typical interior of one of the eaves storage spaces.

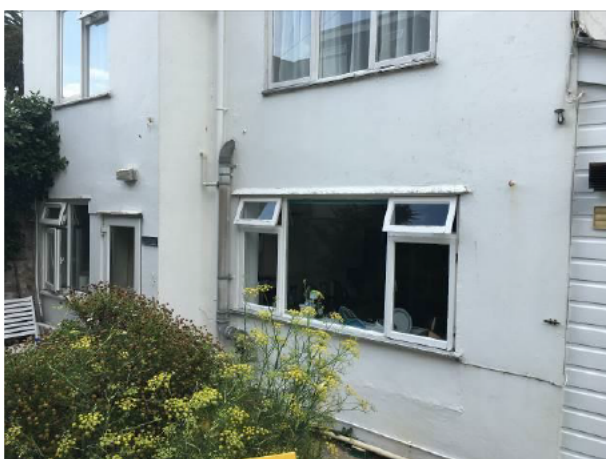
The windows and doors on the southern aspect are uPVC and well-fitted within their frames – no gaps around frames or sills could be identified. There is a lean-to on the eastern edge of the extension which has an access door. This component of the structure is timber-clad but the cladding is tightly fitted with no gaps noted.

Photograph 5: Showing the southern aspect of the property – the tightly fitted uPVC windows and doors are visible.

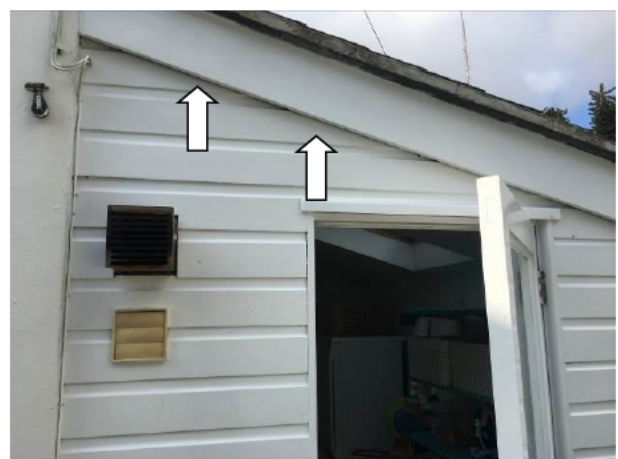
The fascia running along the eaves of the flat-roof building and the lean-to have minor gaps in places – these gaps were inspected with a torch and binoculars but no evidence of bats was

noted. They could however theoretically provide roosting opportunities for bats.

Photograph 6: Showing the access door in the lean-to component – the fascia above is indicated.

There is low potential for individual bats to use transient roosting opportunities behind the fascia which runs along the eaves of the flat-roof extension and the associated lean-to.

The proposed works can approach, but must not impact upon or obstruct, these features in order for the assessment and working methodology outlined in this report to be valid.

Care should be taken during works to ensure that these structures are not disturbed, obstructed, or damaged. This involves careful design of scaffolding installation and may include a contractor briefing to ensure that those working on the project understand the requirement. Other measures such as a temporary sign, tape or physical barrier should be installed if deemed necessary.

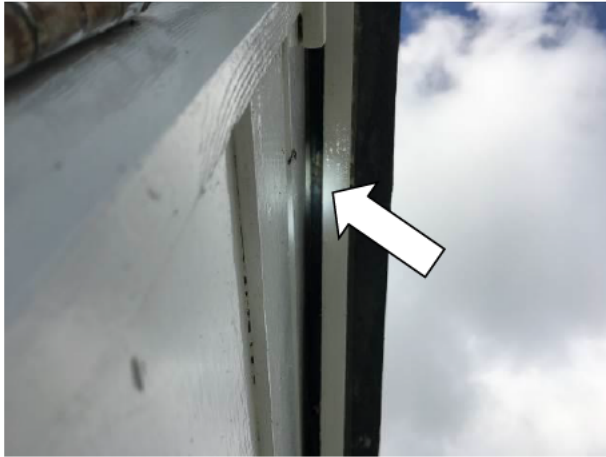
Photograph 7: Showing an example of the gaps behind the fascia on the southern aspect of the flat-roof component.
