## BAT PRESENCE/ABSENCE SURVEYS (PAS)

### THE ATLANTIC, ST MARY'S, ISLES OF SCILLY

**Client:** St Austell Breweries Ltd.

**Report date:** 10<sup>th</sup> September 2023

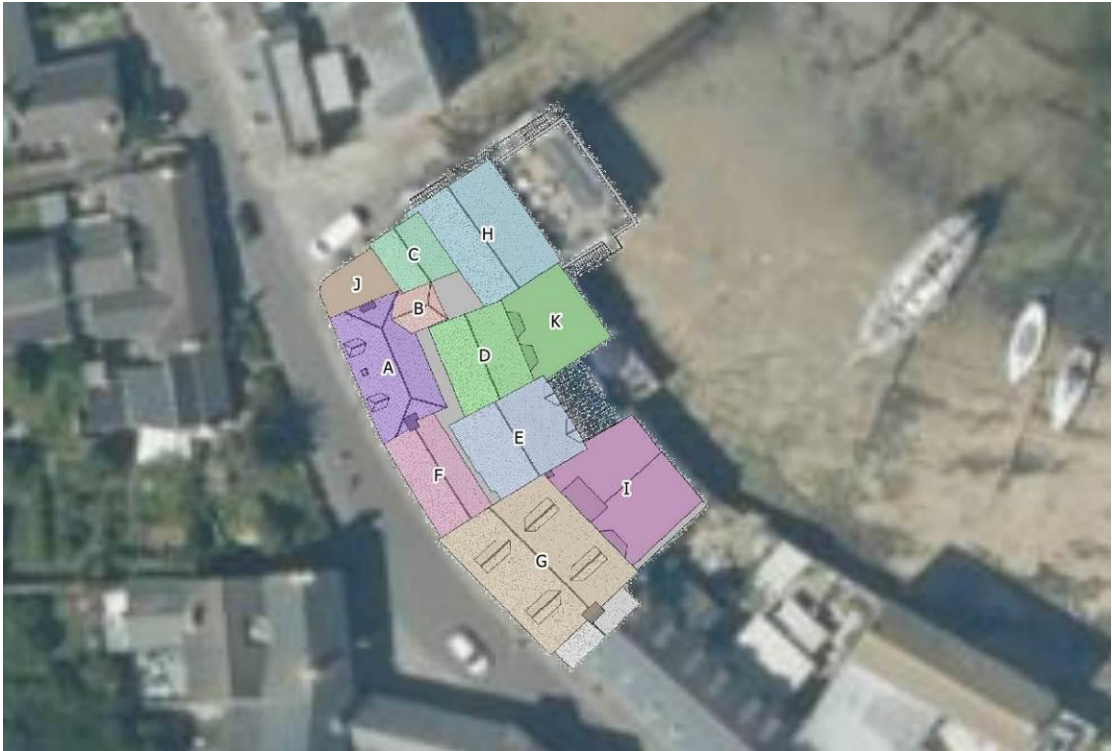
- **Building elements J and K** have negligible potential to support roosting bats;
- **Building elements D, H and I** have low potential to support roosting bats;
- **Building elements A, B, C, E, F and G** have moderate potential to support roosting bats.

**Map 01** – Showing the building comprising multiple different roof pitches. Note that this reflects the area subject to the survey in this assessment – areas within the redline ownership which are not subject to survey are not shown.

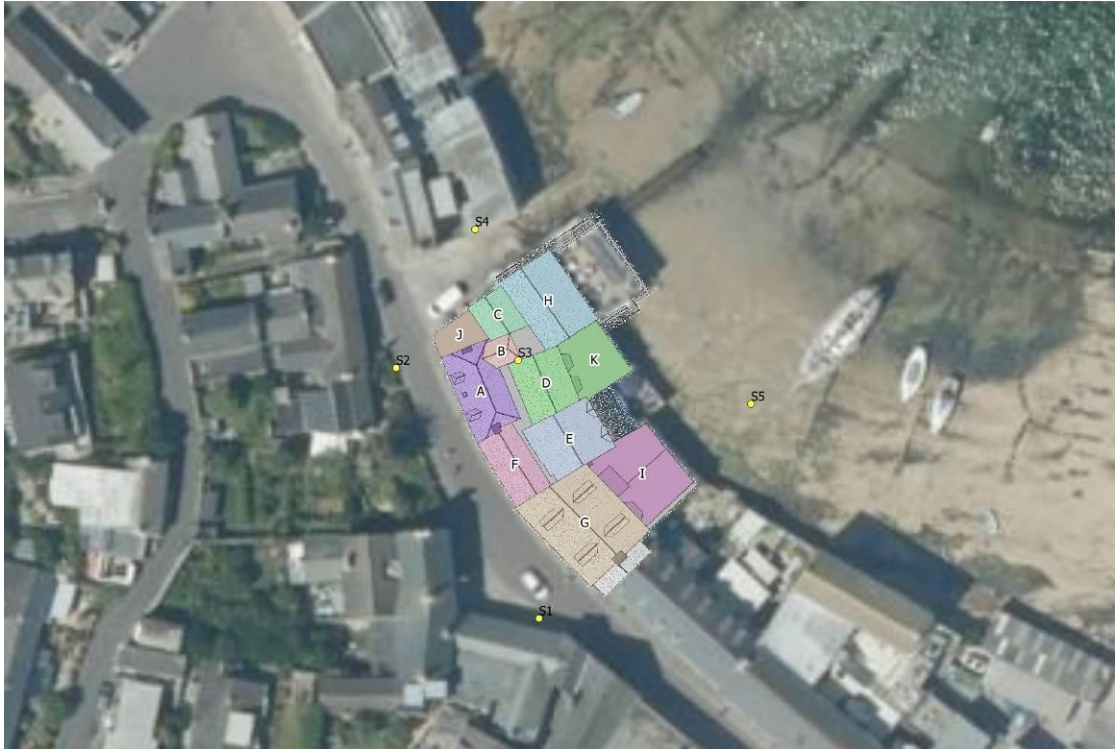
In order to ensure that the different elements of the building received a survey effort in line with the Best Practice Guidance, five surveyor positions were identified. These are identified in Map 02 below.

**Map 02** – showing surveyor positions around the building. The different elements of the building are identified by different colours.

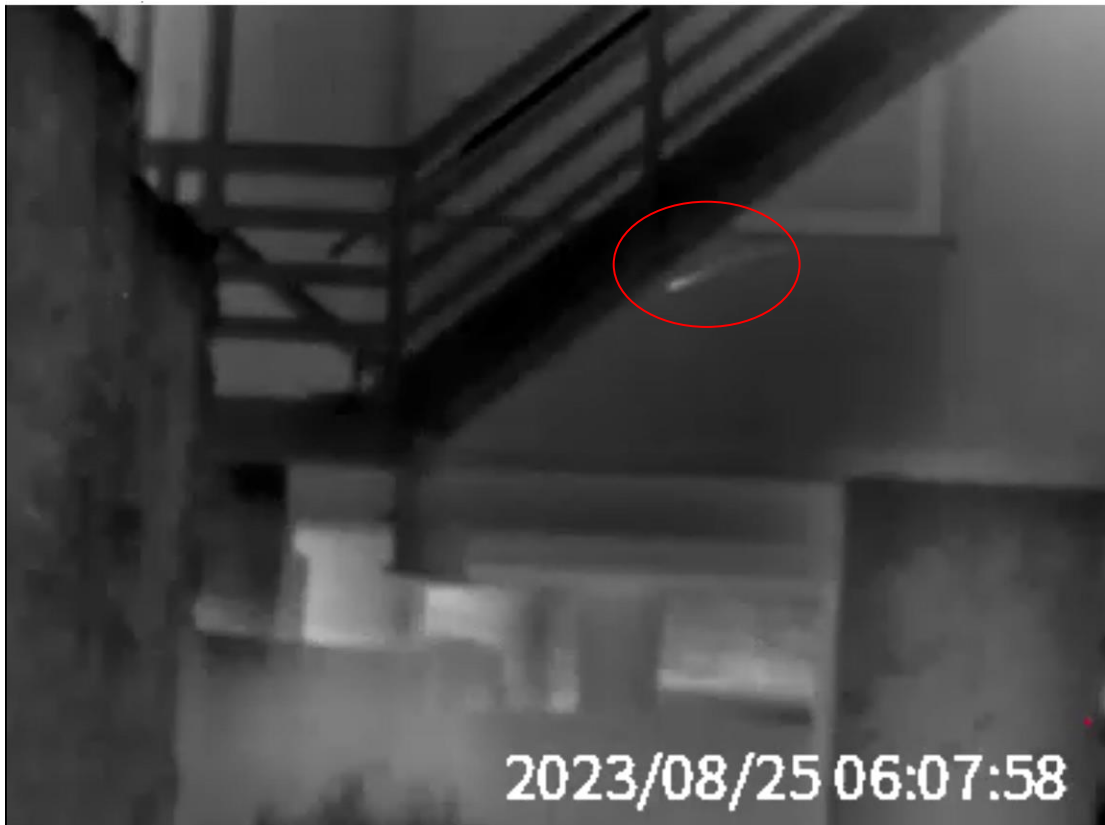
Brief foraging passes were detected between 5:37am and 5:57am, then two common pipistrelle bats were observed foraging intensely from 6:00am until 6:09am at the interface between Building K and the shoreline. Both bats were observed to fly offsite to the north along the beach at the end of this foraging activity.

**Photograph 01** – showing the foraging common pipistrelle beside the steps of the Atlantic on the dawn survey. Screenshot from infra-red video recordings.
