## PERMISSION FOR DEVELOPMENT

- Applicant: Mr And Mrs Woodcock 4 Porthcressa Terrace Hugh Town St Mary's Isles of Scilly TR21 0JW
- Site address:4 Porthcressa Terrace Hugh Town St Mary's Isles of Scilly TR21 0JWProposal:Demolition of existing single storey extension and replace with larger extension<br/>on rear elevation, removal of existing rear dormer window and replace with a<br/>larger rear dormer window, replace scantle roof slates with new dry laid slates.

4 Porthcressa Terrace	
TR21 OJW	
25.01.2024	
Proposed Plans	
Ground Floor	1:50 @A3
DC_XXX_000_02101_P02

## 4 PORTHCRESSA TERRACE, HUGH TOWN, ST MARY'S, ISLES OF SCILLY

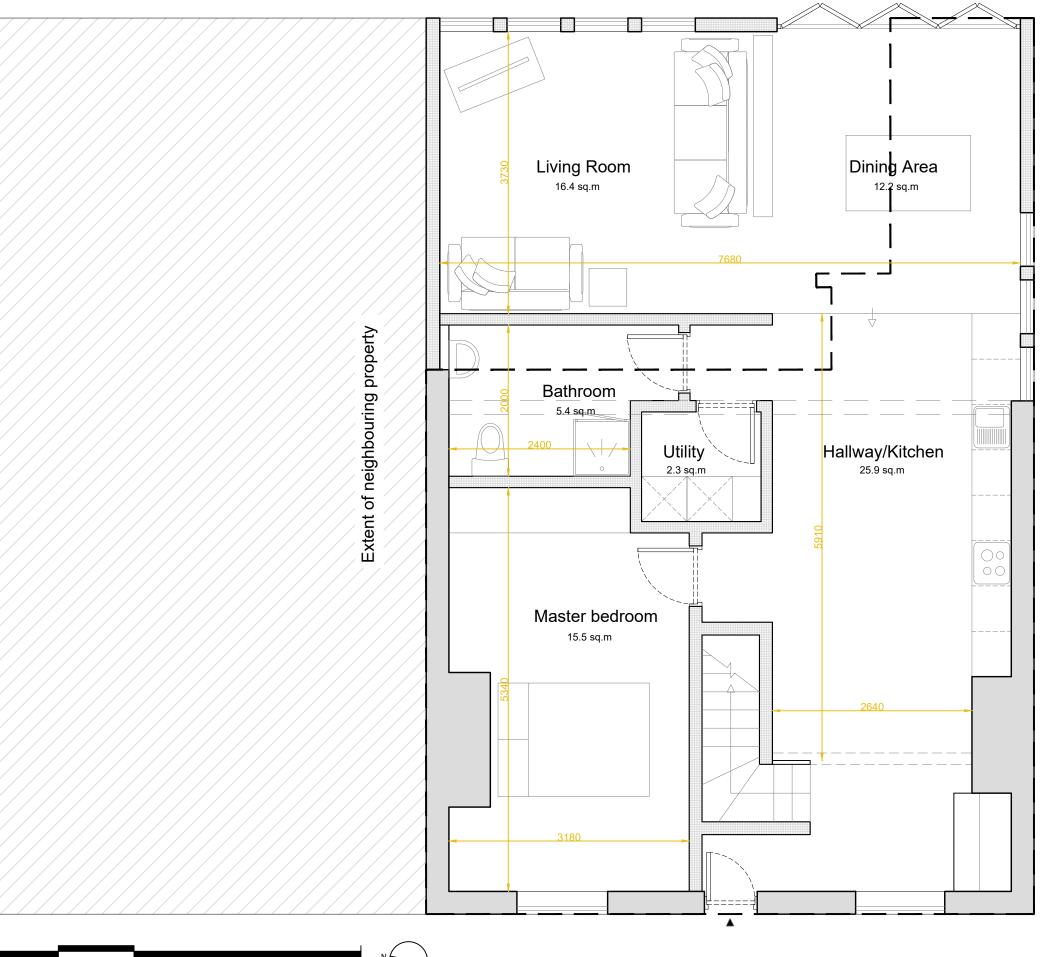
> Line of existing property - -- --

- Plan 2 Proposed Block Plan, drawing no: DC\_XXX\_000\_06101\_P0, received 14.02.2024.
  - Plan 3 Proposed Ground Floor Plans, drawing no: DC\_XXX\_000\_02101\_P02, received 16.02.2024.

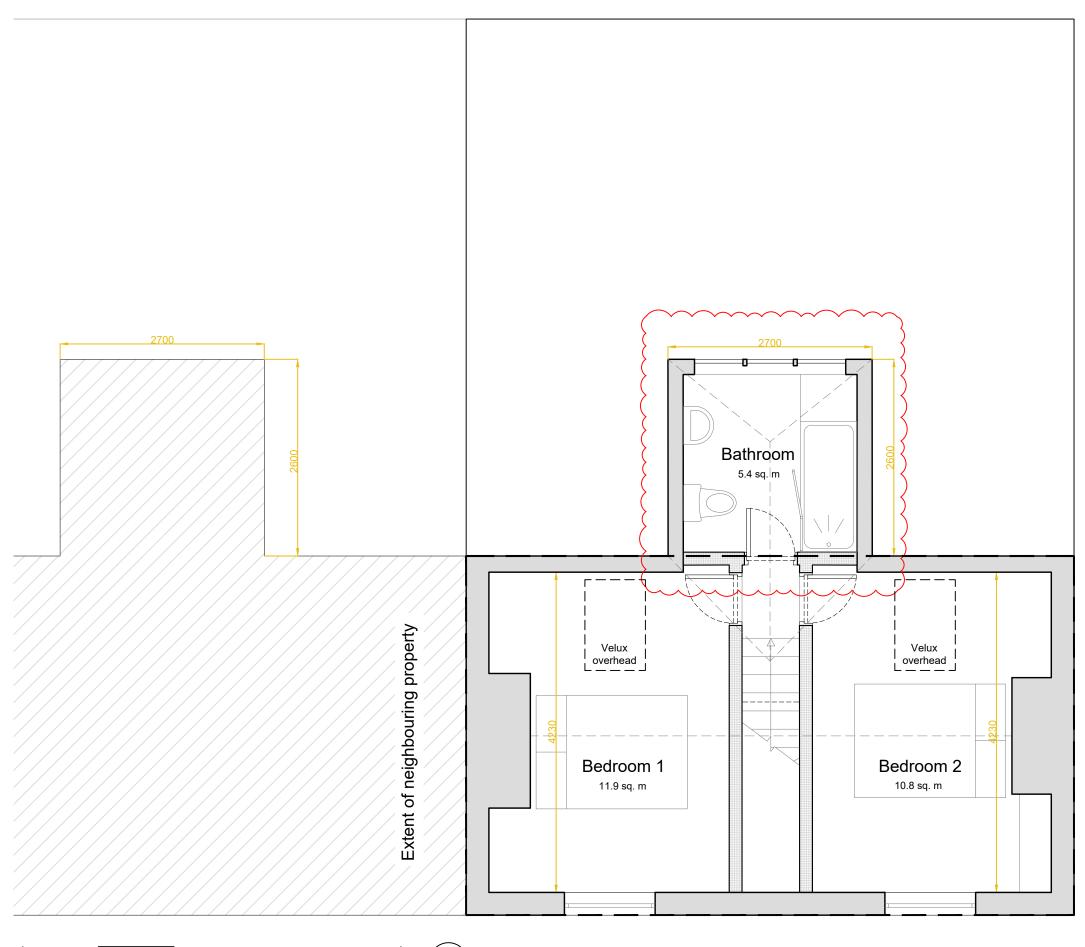
4 Porthcressa Terrace	
TR21 OJW	
25.01.2024	
Proposed Plans	
First Floor	1:50 @A3
DC_XXX_001_02102_P02

---- Line of existing property

- Plan 4 Proposed First Floor Plans, drawing no: C\_XXX\_001\_02102\_P02, received 16.02.2024.
  - Plan 5 Proposed Roof Plan, drawing no: DC\_XXX\_R1\_02103\_P01, received 16.02.2024.

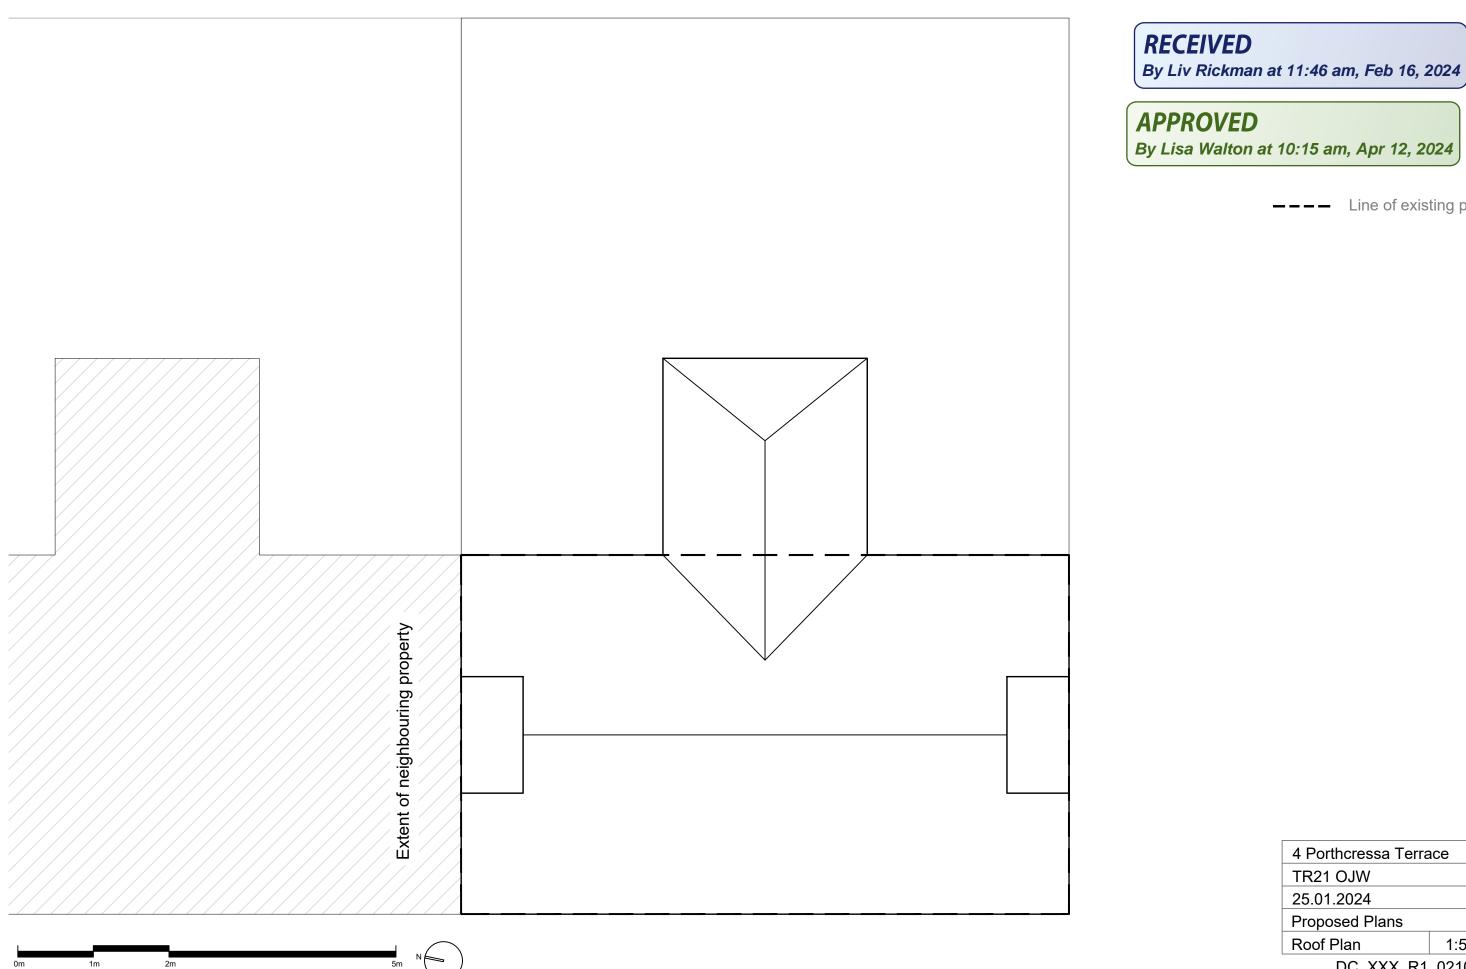
4 Porthcressa Terrace	
TR21 OJW	
25.01.2024	
Proposed Plans	
Roof Plan	1:50 @A3
DC_XXX_R1_02103_P01

--- Line of existing property

To replace wet laid scantle slate roof on rear elevation with dry laid 10x20 Spanish slate secured with stainless steel clips. This will match in with the remaining properties in the terrace. The extended rear 1<sup>st</sup> floor dormer will create a much-needed 1<sup>st</sup> floor bathroom the service the 2 bedrooms on the 1<sup>st</sup> floor.

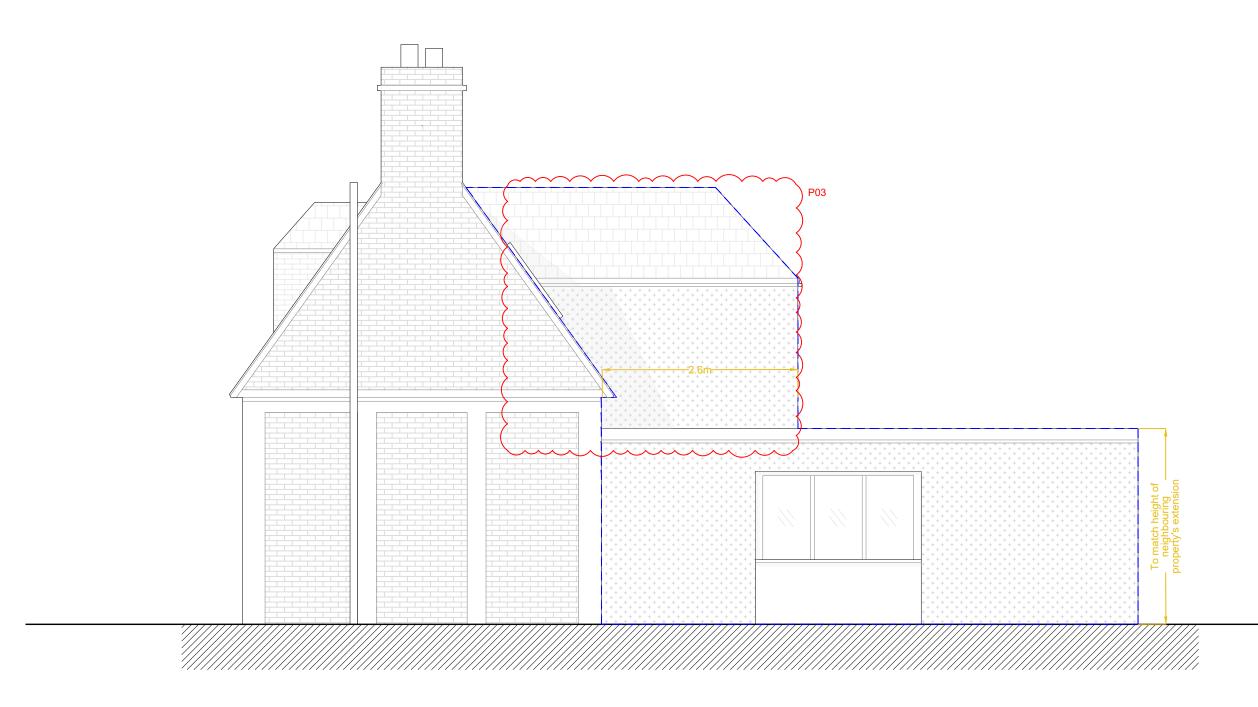
4 Porthcressa Terrace		
TR21 OJW		
05.04.2024		
Proposed Elevation		
Side Elevation	1:50 @A3	
DC ZZZ XXX 04102 P03

---- New proposal

- Plan 6 Proposed Rear Elevation Amended, drawing no: DC\_ZZZ\_XXX\_04101\_P03, received 08.04.2024.
  - Plan 7 Proposed Side Elevation Amended, drawing no: DC\_ZZZ\_XXX\_04102\_P03, received 08.04.2024.

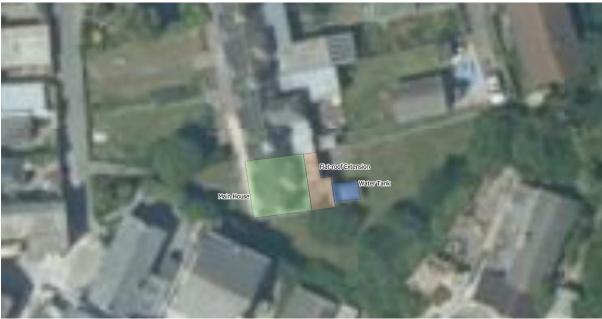
Map 02 – Showing the different elements of the buildings.

The structures under assessment comprise three distinct elements:

- Main House;
- Flat-roof extension;
- Water Tank enclosure.
