## PRELIMINARY ROOST ASSESSMENT (PRA)

### GARAGE ASSOCIATED WITH SYLINA, MCFARLANDS DOWN, ST MARY'S, ISLES OF SCILLY

*Report date: 3<sup>rd</sup> December 2023*

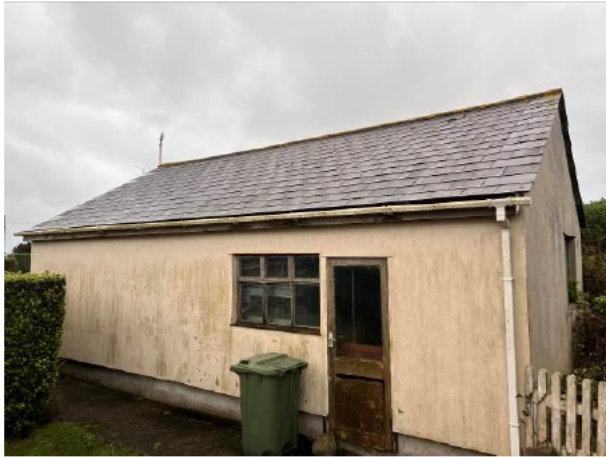
**Photograph 1:** Showing the northern and western (gable) aspects of the garage.

The garage is a single-storey structure built around a timber frame atop a breeze block base. The exterior is rendered and in good condition throughout. The window and door frames are tightly fitted with no gaps noted.

The pitched roof is covered by flat-slate with ridge tiles – the roof is in good condition with no gaps or other roosting opportunities noted. The roof verge is well sealed on the gables with no gaps noted.

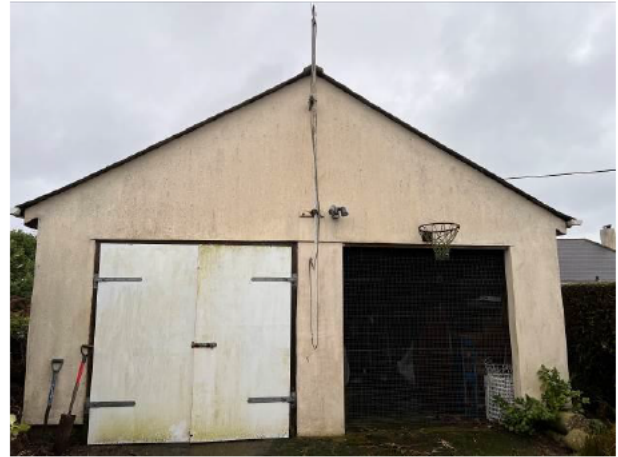
**Photograph 2:** Showing the front of the garage facing east – the mesh-sealed opening can be seen to the right of the double doors.

The windows and doors are in good condition – the main access includes double-doors on one side, and a further opening sealed with wire mesh allowing air flow but precluding fly-in access by bats.

Access to the interior of the garage by birds including swallows can be prevented by keeping doors and windows closed during the breeding season.

If all access features are sealed before the end of February, this would ensure that breeding birds do not have opportunity to establish nests. Utmost care must be taken to ensure that no birds are present in the garage at the time that the access features are sealed to prevent birds from being trapped. This would require a careful walkover of the garage. Upon completion of this inspection, windows and doors should be closed and sealed.

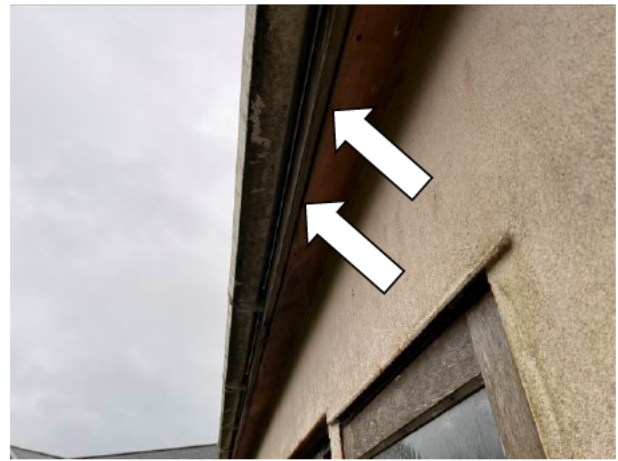
**Photograph 4:** Showing the soffits on the northern aspect – the minor gap between timbers is indicated.

There are boxed soffits running along the eaves with guttering attached – this guttering would obstruct any potential access to features beneath the flat tiles, if present. The soffits themselves are in relatively poor condition with gaps between the timbers – these are not sufficiently wide to provide access for roosting bats in their current condition but this could develop in time with ongoing deterioration in condition. A minor gap in the soffit at the north-eastern gable has debris indicating historic nesting – an inspection with a video endoscope revealed that this debris blocks the cavity and therefore precludes access for bats.

There are occasional gaps between timbers of the boxed soffits. Where these are to be removed or impacted as part of the proposed works, the soffits should be carefully removed and the void behind them exposed in such a way that, in the highly unlikely event that bats are present, they are not injured or killed by the action.

Once these areas are fully exposed, they can be visually inspected by contractors. If any bats are present, or suspected, works should pause and a Licenced Bat Worker contacted to review the situation. If no bats are present, the remaining materials can be removed and works can continue.

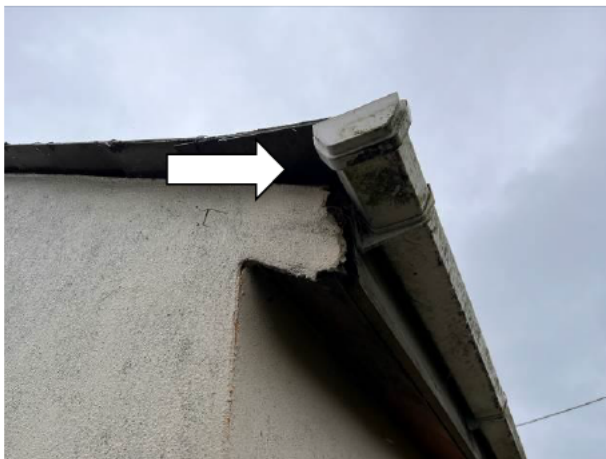
**Photograph 5:** Showing the minor cavity at the north-eastern corner of the building where a historic nest is present.

The historic nest present in the north-eastern corner of the soffit represents a feature associated with deterioration in the condition of the structure – similarly, routine repairs might be expected to remove this feature regardless of conversion works.

Excluding access to the soffit could also be undertaken with care outside of the breeding season. The old nest should be carefully removed by hand and confirmed not to be in active use before the feature is sealed. The presence of the dense nesting material and lack of access to further voids within the soffits would currently prevent use of these features by bats.

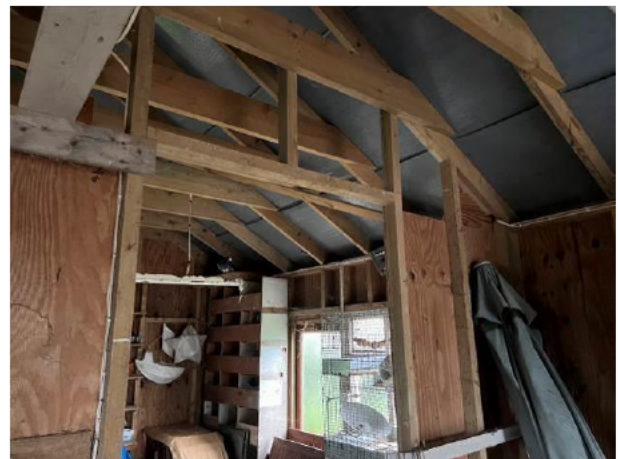
**Photograph 6:** Showing the interior of the property - the exposed studwork walls and well-sealed membrane above the rafters can be seen.

Internally, the building is used for routine storage and historically for housing rescued racing pigeons. The timber studwork walls are exposed internally and are tightly fitted to ply on the exterior providing no gaps or other roosting opportunities. The concrete floor was relatively clean and a full inspection of interior surfaces did not reveal any evidence of droppings or urine staining. The timber roof frame does not have a ridge beam. The underlay membrane is in good condition throughout preventing access between the interior of the garage and cavities beneath the tiles.
