Land to the south of Pungies Lane St Mary's, Isles of Scilly

HERITAGE IMPACT ASSESSMENT

Charlie Johns | Report No 2024/3 | 12 February 2024

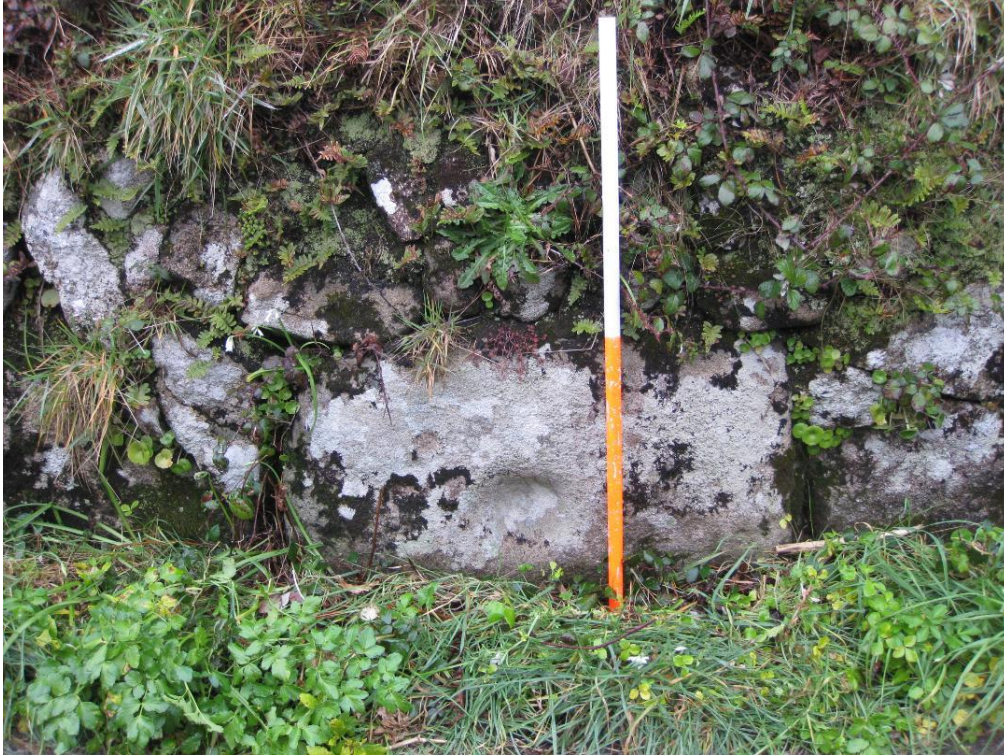
Figure 5 The undated cup-marked stone incorporated in the drystone hedge on the south side of Pungies Lane, (MCO58413 (photo: Katharine Sawyer).

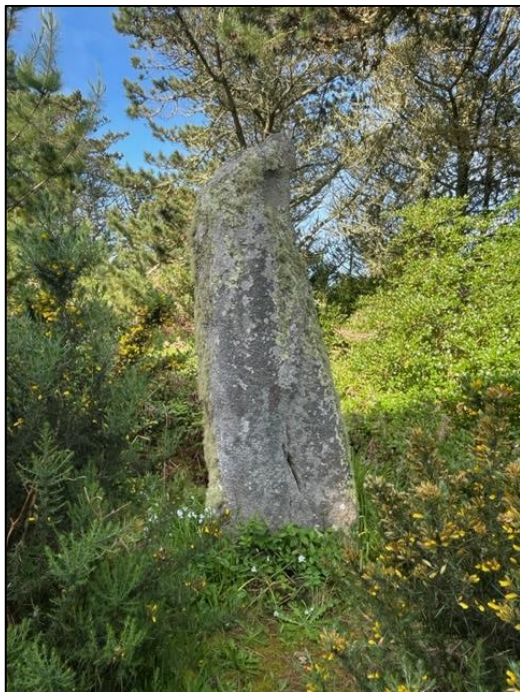
Figure 6 The Long Rock standing stone (NHLE 1013276) (photo: Clive Sibley).

The Long Rock standing stone has survived well with no recorded disturbance from its present location. A concentration of flint artefacts recorded near this stone provides evidence for this site having formed a focus for prehistoric activity. The relatively close grouping of standing stones known on this part of the island is also unusual, while the wider relationship between the monument, its topographical setting and the settlements and field systems on the slopes of Halangy Down demonstrates the organisation and development of ritual and settlement activity among prehistoric and Romano-British communities.

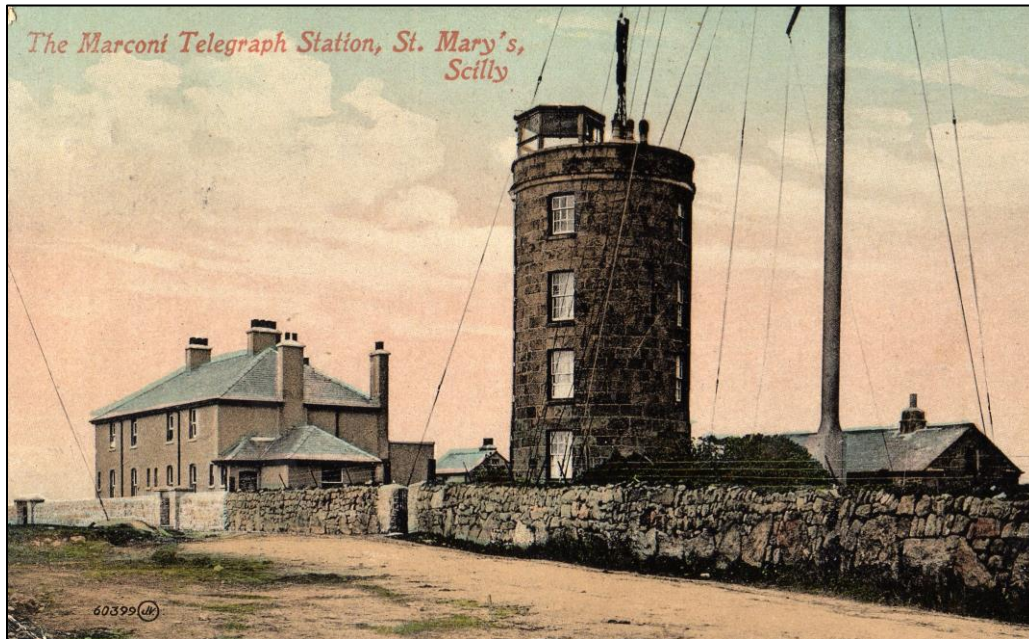
Figure 8 Postcard of the Telegraph Tower in c1898.

The tower is circular in plan, stands four storeys (12m) high and is built of coursed, shaped, granite blocks. There are four four/four-pane sash windows with sills to each face and gabled wooden porch. One of the ground-floor window openings is sealed in granite, and probably marks a former door opening. To the right of the opening, a downpipe with hopper is attached below parapet level. The granite surrounds of the window openings show signs of disturbance, and some heads are scored vertically to give the appearance of decorative, flat arches. The upper floors are slightly set back from the projecting ground floor. There are string courses beneath the parapet surrounding a flat roof on which the early-20th century timber telegraph house stands (Goodwin 1993).

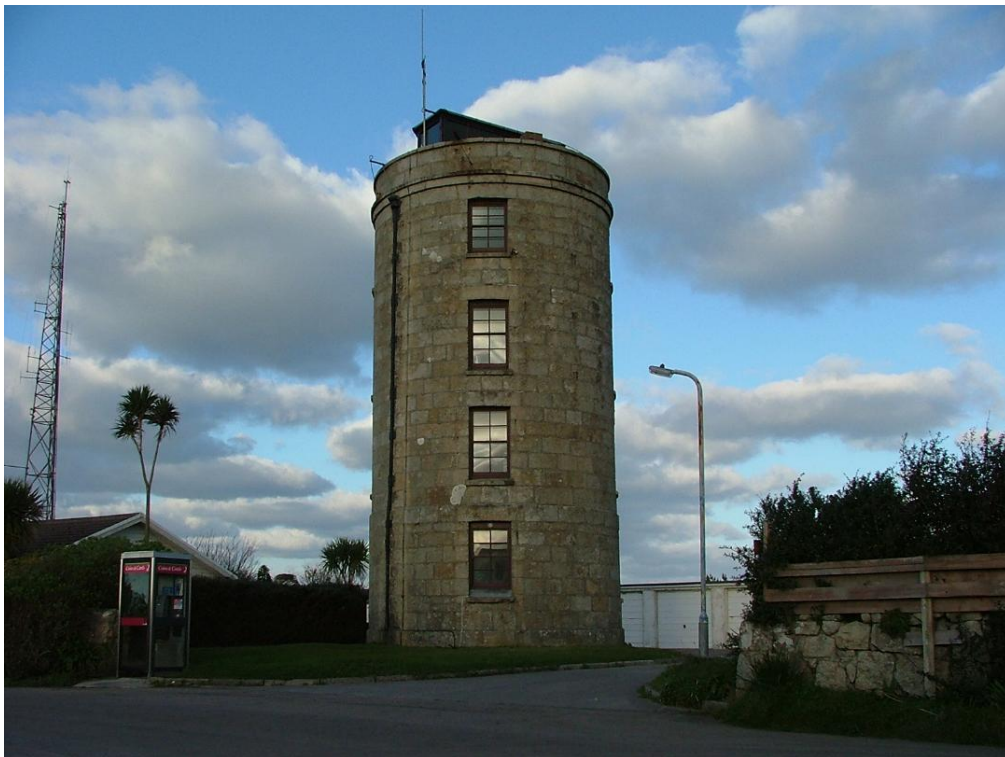
Figure 11 The Grade II Listed Coastguard Lookout Tower today, note the row of garages behind the tower (photo: Katharine Sawyer).

Most of the development around the Telegraph Tower dates to the mid- and late-20th century, including a new row of garages between the tower and the site (Figure 11), the linear development of McFarland's Down to the north and Telegraph Bungalows to the south west. There is a new telecommunications mast to the north and a Repeater Station (telecommunications) with mast and what looks like sewage treatment works to the south.

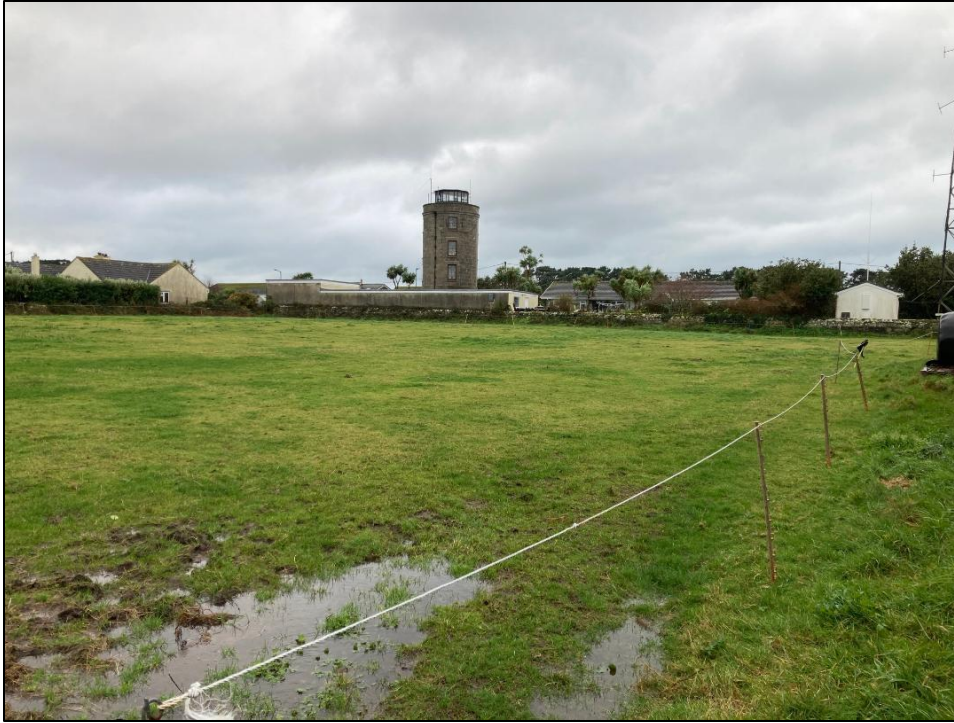
Figure 12 The northern boundary of the site showing development around the Coastguard's Lookout Tower (photo: Nathan Dean).

However, the setting of the Coastguard Lookout Tower has already been compromised by the miscellaneous modern development around it such as a row of garages, bungalows, transmitter masts and a sewage treatment plant (Figures 11, 12 and 13). The visual impact of the proposed development on the Coastguard Lookout Tower is therefore assessed as **Neutral**.

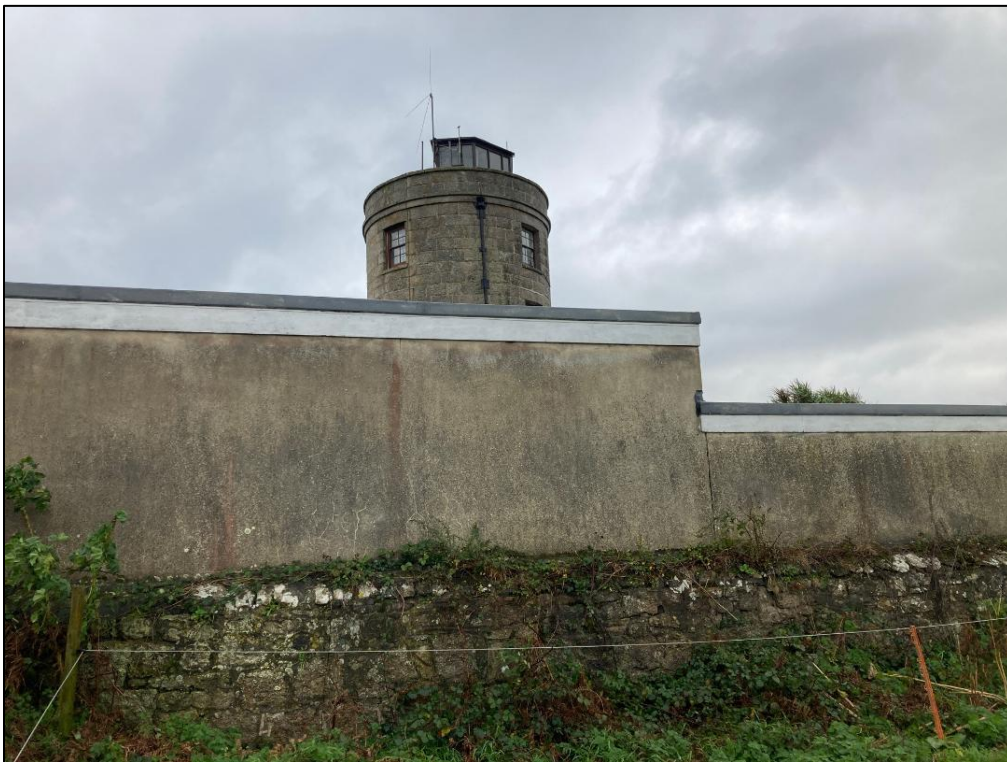
Figure 13 The back of the row of garages between the site and the Coastguard's Lookout Tower (photo: Nathan Dean).
