BAT PRESENCE/ABSENCE SURVEYS (PAS)

THE DOWNS and LITTLE DOWNS,
TRENOWETH, ST MARY'S, ISLES OF SCILLY

Report date: 11th September 2024

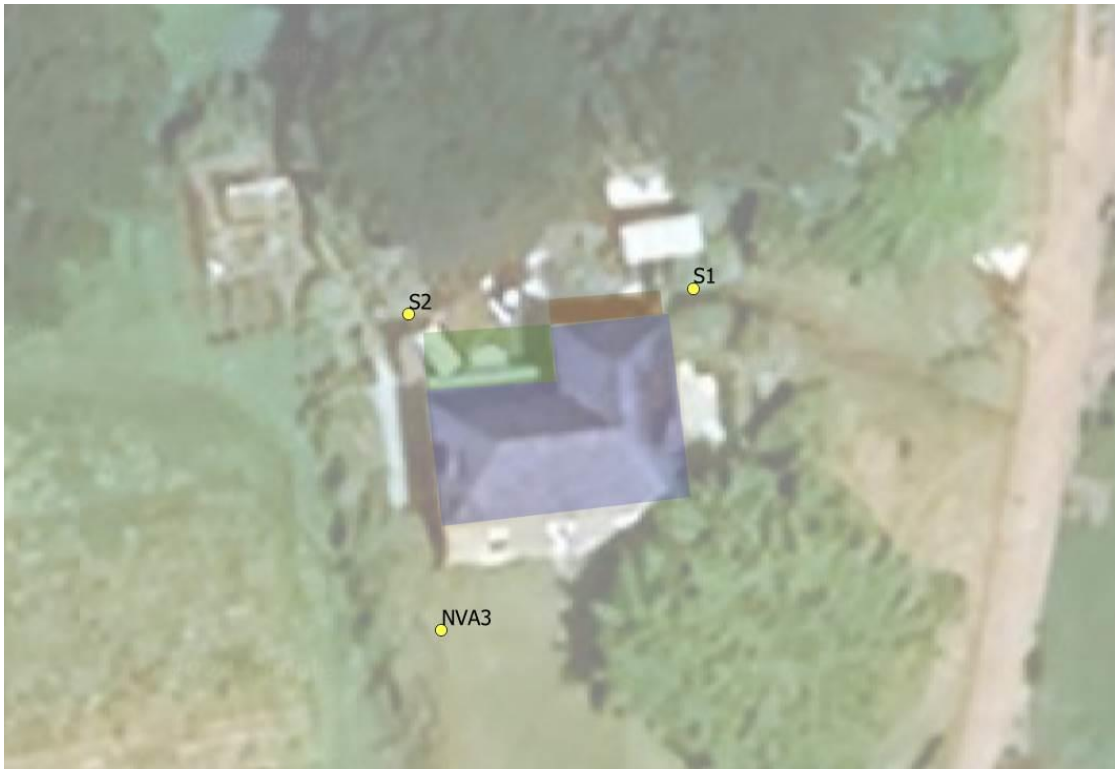
In order to ensure that the survey was comprehensive with regards to coverage and vantage points, two surveyor positions (S1 – S2) with corresponding NVAs, and an additional unmanned NVA (NVA3) were used. These are identified in Map 01 below.

Map 01 – showing surveyor positions around the buildings. See the PRA report for full details of the different structures indicated by the various colour washes.

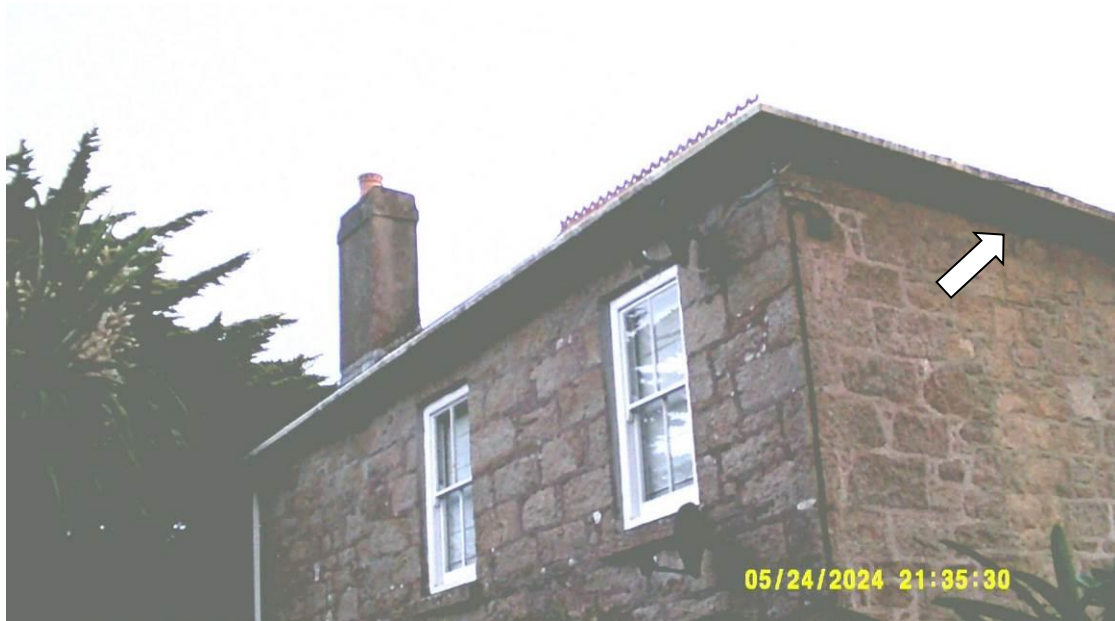
The emergence survey identified two common pipistrelle bats emerging from two separate roosting sites behind fascias on the northern and eastern aspects of the property at 9:35pm and 9:45pm. These locations are indicated in Photo 01 and 02 below.

Photo 01 – showing the location where 1x common pipistrelle bat was recorded emerging from a roosting location on the northern aspect of the property at 21:35.

- Key elements of the works should be undertaken under a 'soft strip' methodology whereby the fascia boards are removed by hand, as well as tiles on the eastern aspect; and all tiles within 1m of the eaves on other aspects under the ecological oversight of a Licensed Bat Worker. If bats are identified, they would be captured by hand and moved to a place of safety.

- Following completion of the works, the roost would be restored in situ. This would involve the retention/replacement of existing soffits, or the incorporation of a cavity 100mm wide and 25mm deep behind the soffits boards in the locations of confirmed access features to permit continued access for bats. This would be completed under the direction of the Licensed Bat Worker who would confirm and sign off the restored roosting feature at the end of works.

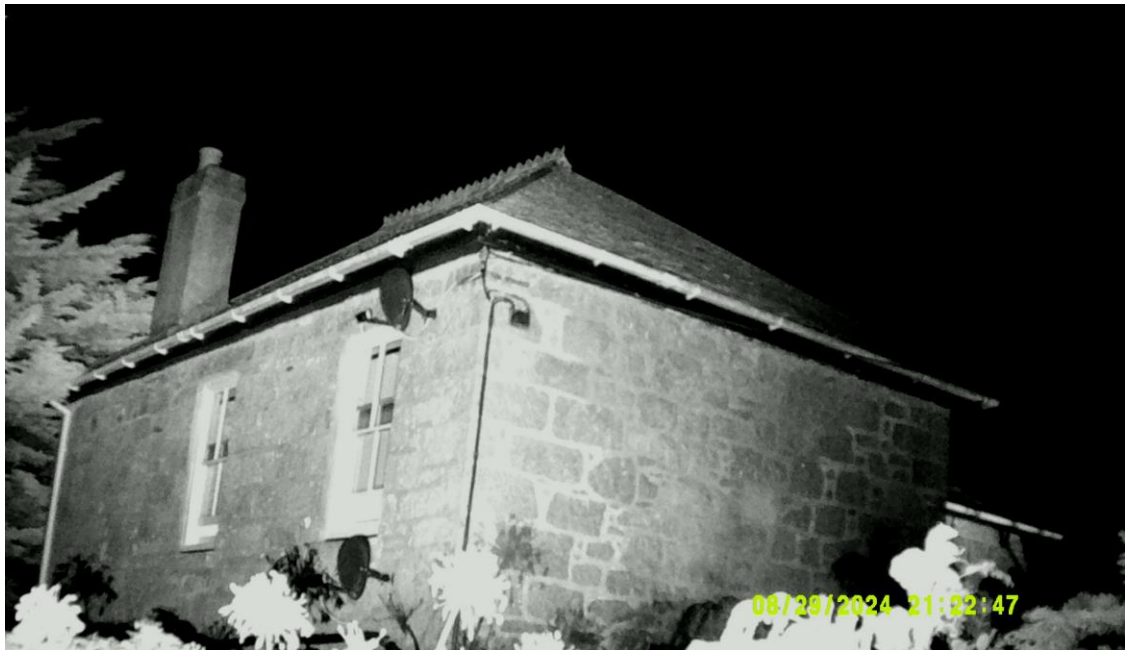
NVA1 – showing footage from the Nightfox Whisker at survey position S1 – this covers the eastern and part of the northern aspects of the property.

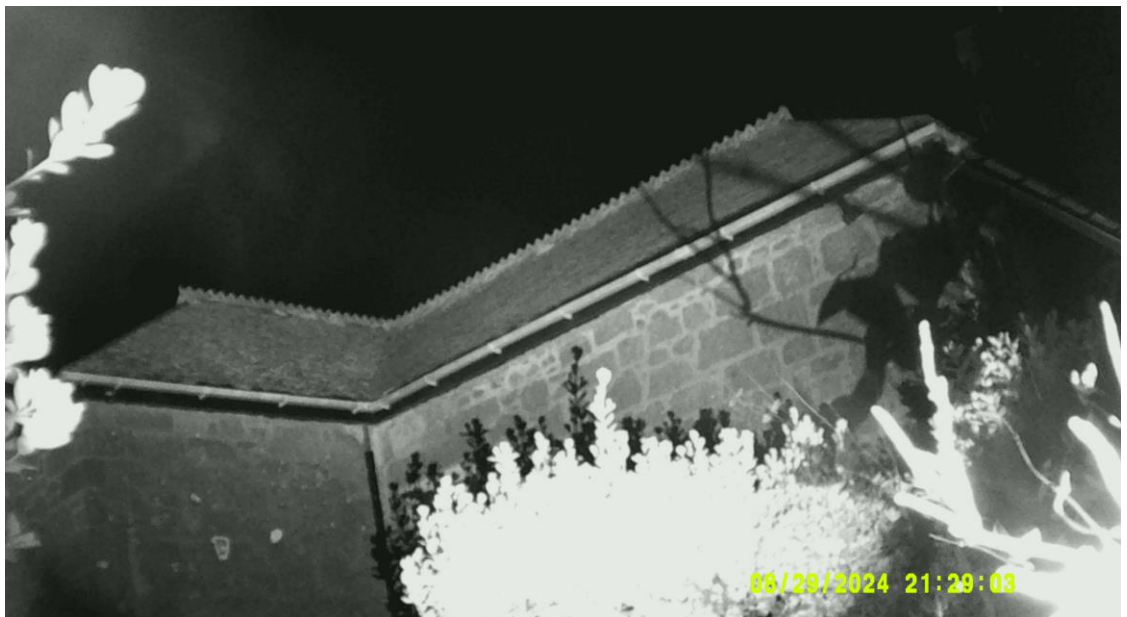
NVA2 – showing footage from the Nightfox Whisker at survey position S2 – this covers the western and part of the northern aspects of the property.

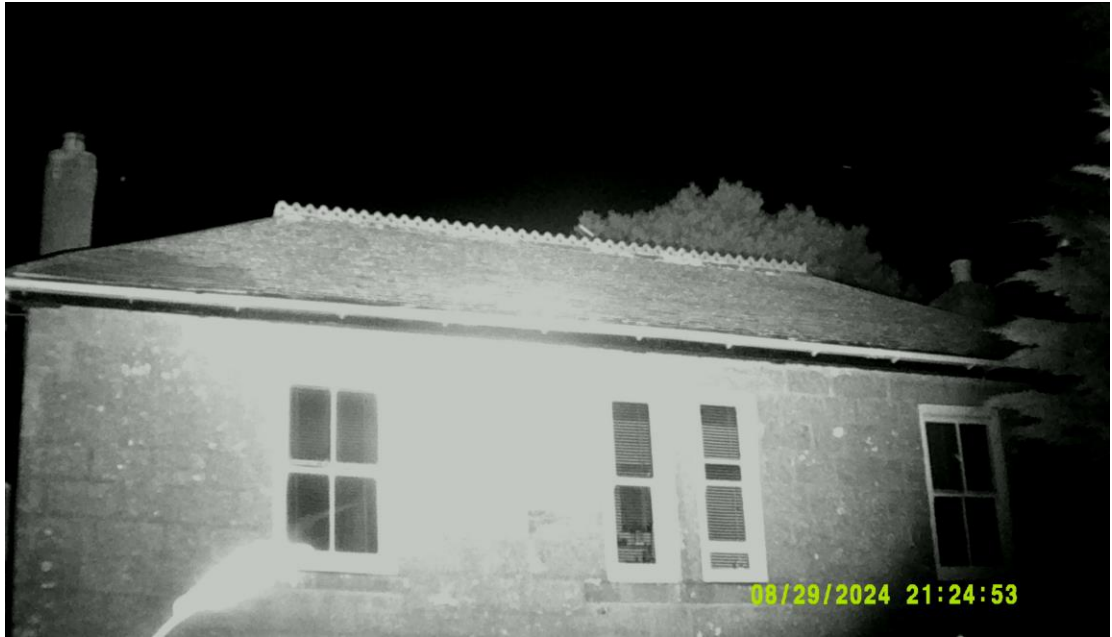
NVA3 – showing footage from the Nightfox Whisker at survey position NVA3 – this covers the southern aspect of the property.
