**RESULTS OF FURTHER SURVEY WORK ON
THE DOWNS, TRENOWETH, ST MARY'S,
ISLES OF SCILLY**

July to September 2019

Report No: 18-211T/DofC/The Downs, St Marys/Further bats 1

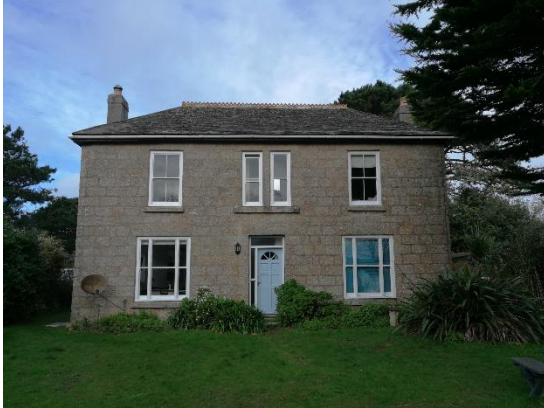
Photo 1. Showing the front of the house

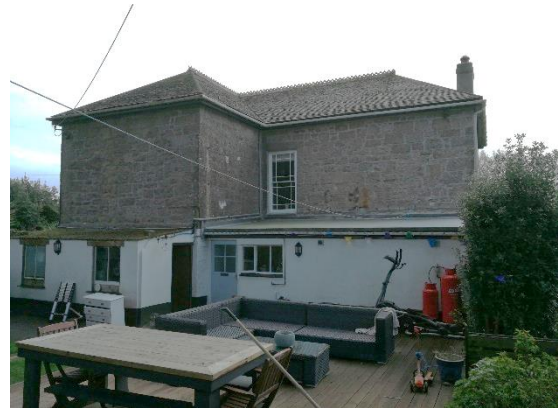
Photo 2. Showing the rear of the house
