PERMISSION FOR DEVELOPMENT

Application No: P/24/013/FUL **Date Application Registered:** 2nd September 2024

Site address: The Downs Trenoweth St Mary's Isles of Scilly TR21 0NS
Proposal: Replacement of scantle slate roof covering with natural slate and insertion of 3 no. roof lights

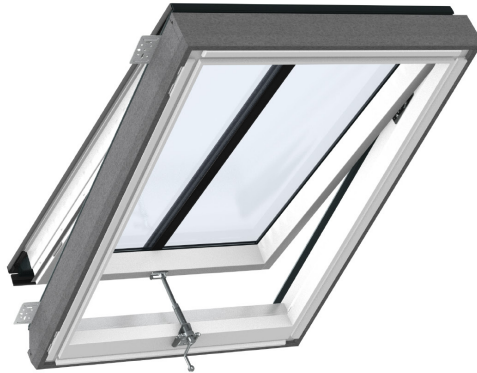
The VELUX Heritage conservation roof window is designed to be in keeping with historic façade aesthetics. Slim and elegant and sitting flush to the tiles, it blends beautifully into historic roofs.

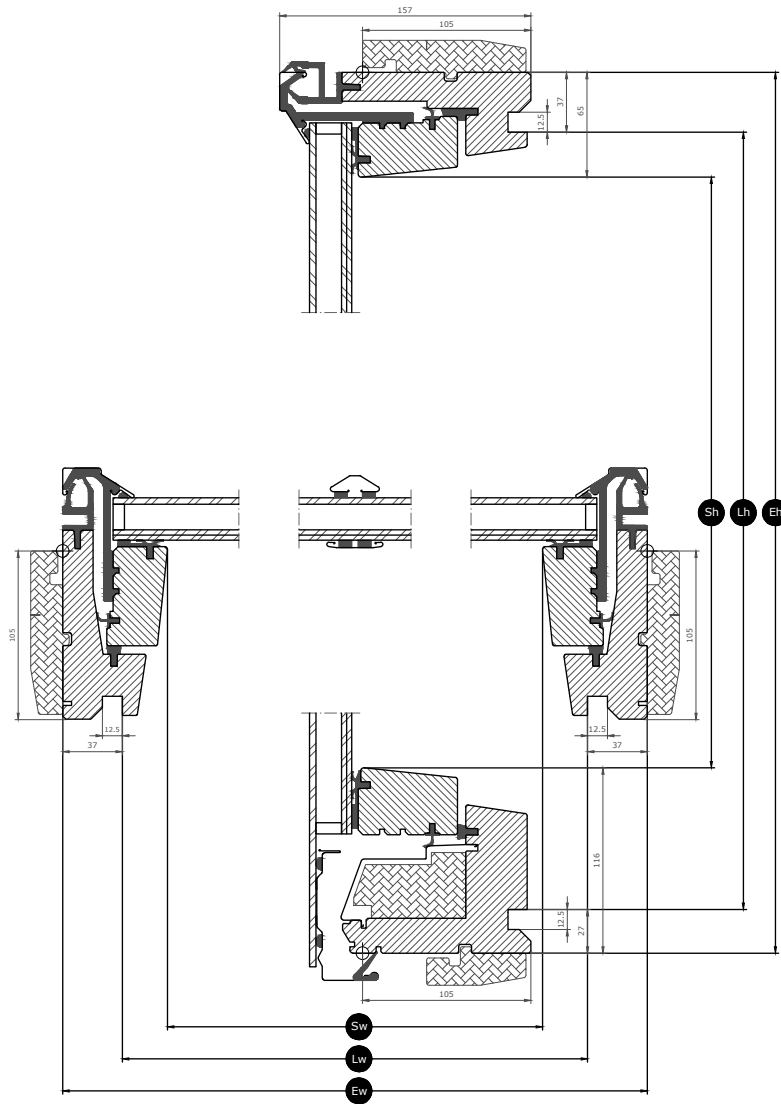
Cross section dimensions

Width		CC--	FC--	MC--	PC--	SC--
Sw	Sash aperture width	419	529	649	811	1009
Lw	Distance between lining grooves, width	475	585	705	867	1065
Ew	External frame width	550	660	780	942	1140

Height		--04	--06	--08	--10
Sh	Sash aperture height	797	997	1217	1419
Lh	Distance between lining grooves, height	913	1113	1333	1535
Eh	External frame height	978	1178	1398	1600

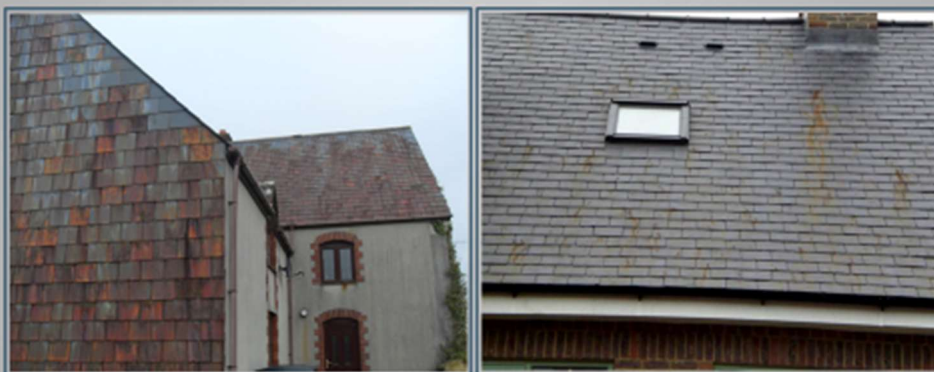
Severe rusting – from reactive pyrite

The slate installation above demonstrates the consequences of installing Spanish slates with high levels of reactive pyrite and high water absorption slate in a sever exposure coastal Environment.

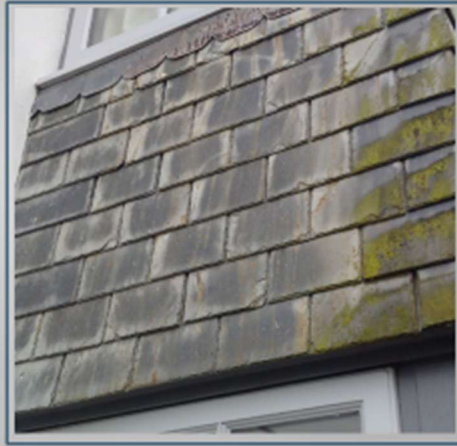
Moss is also likely to flourish in wet environments

The photo above demonstrates the calcifications failure of light colored high water absorption slates in Falmouth Cornwall sourced from the Lugo region of Spain. In this specific example the water absorption rates exceeded .4% where a Spanish slate has been installed with excessive calcium carbonate content. The high levels of salt water exposure and the absorption of that water into the calcium carbonate content of the slate will ultimately lead to the failure of the installation before the minimum life expectancy of the slate in this case the Spanish slate was guaranteed 30 – 40 years.

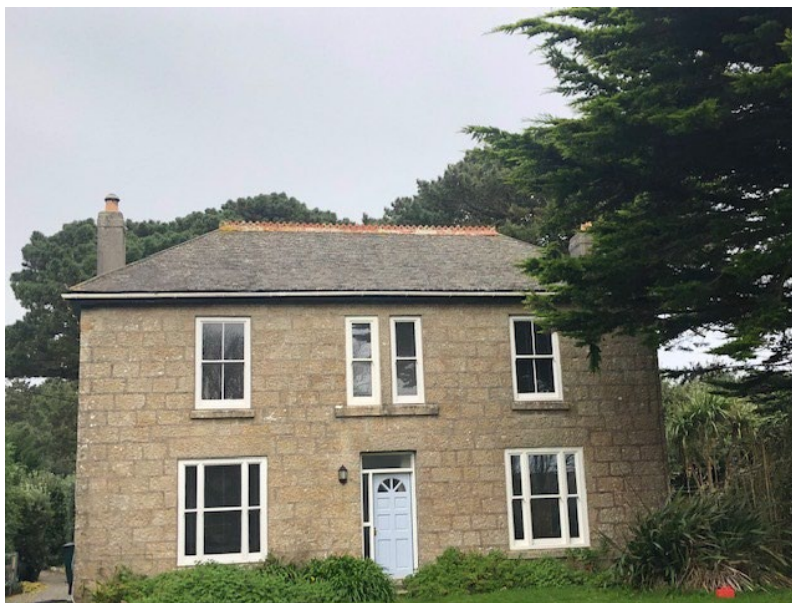
The Downs is a 3 bedroom dwelling with self contained ground floor Annex used as holiday accommodation found in a cluster of dwellings and agricultural buildings at Higher Trenoweth. The property is constructed of coursed granite with a Cornish scantling wet bedded roof finish of slate with clay cockscomb ridge tiles, lead valleys and shaped in situ cement mortar as a caping to hips.

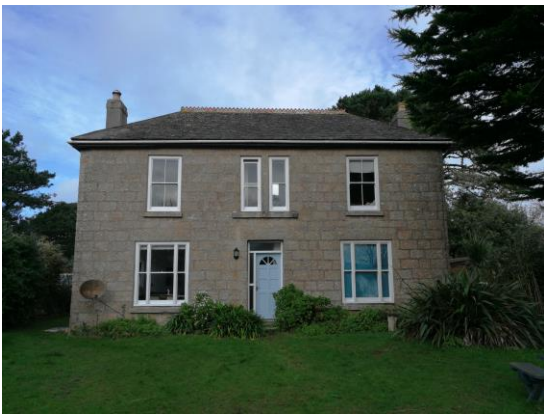
Photo 1. Showing the front of the house

The property subject to this survey is a detached two storey stone house which is divided into two dwellings, there is a small flat on the ground floor and a larger dwelling occupying the remainder of the ground and all of the 1st floor. The house is L-shaped with a hipped slate covered roof, clay ridge tiles and deep soffits with cavities and gaps giving access to the roof void, see photos 1 and 2. At the rear of the building is a single storey lean-to containing the kitchen with another small lean-to on the end of the return on the rear of the building.

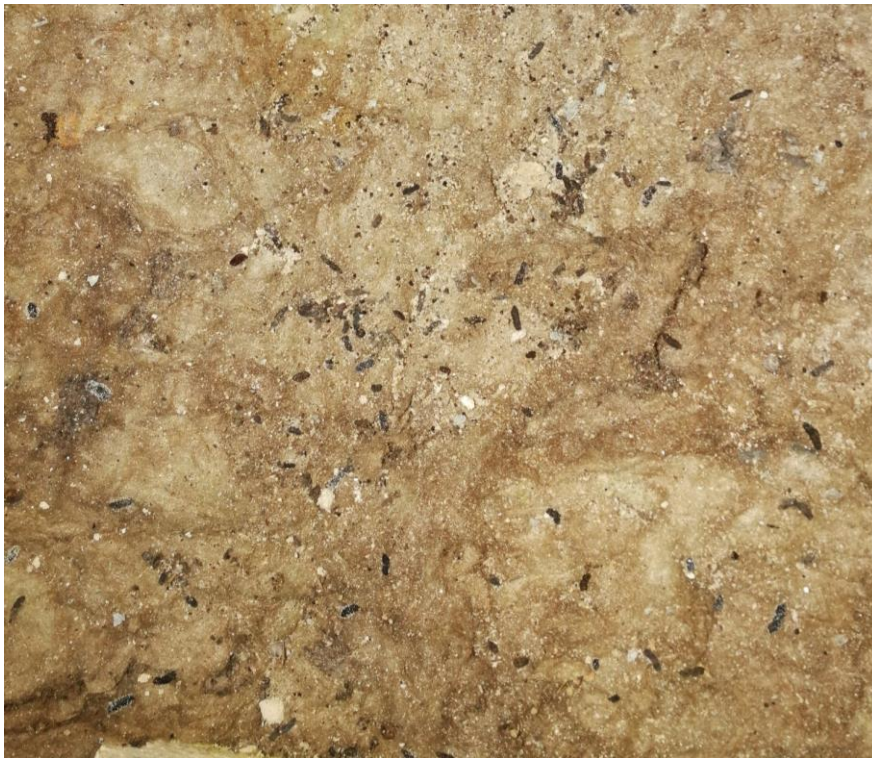
Within the roof void over the house an accumulation of scattered bat droppings belonging to Common Pipistrelles on top of the insulation (approximately 40 to 60 droppings) was found on the floor below the ridge close to the junction where the two arms of the roof meet, see photo 5. In addition directly above this there were droppings caught in cobwebs below the ridge beam which is where it is near certain the bats roost, see photo 6.

Photo 5. Showing a scattering of Common Pipistrelle droppings on the insulation

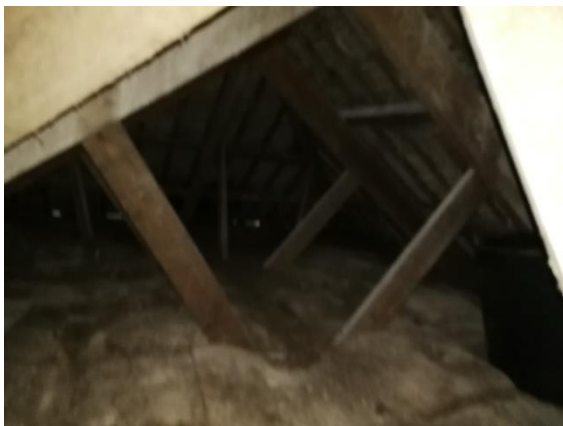
The roof void is a single open L-shaped space with the roof being supported on timber trusses. The underside of the roof is unlined with the roof being covered with wet laid scantle slate but has started leaking, see photo 3. In an attempt to prevent water ingress into the property from leaks in the roof the tenants have started tacking modern roofing membrane to the underside of the rafters, see photo 4. This is not ideal as if bats are using the roof space this could obstruct access to roosting sites and bring bats into contact with modern roofing membrane which is known to cause bat fatalities through bats becoming entangled with the microfibres which coat such membranes. The floor is covered with fibreglass insulation and the tenants have now started boarding out the floor.

Photo 3. Showing roof void in return arm

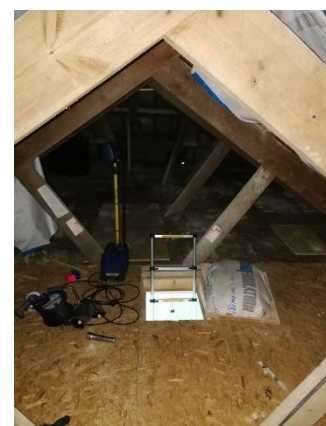
Photo 4. Showing roof void over main part of the house where works have been done

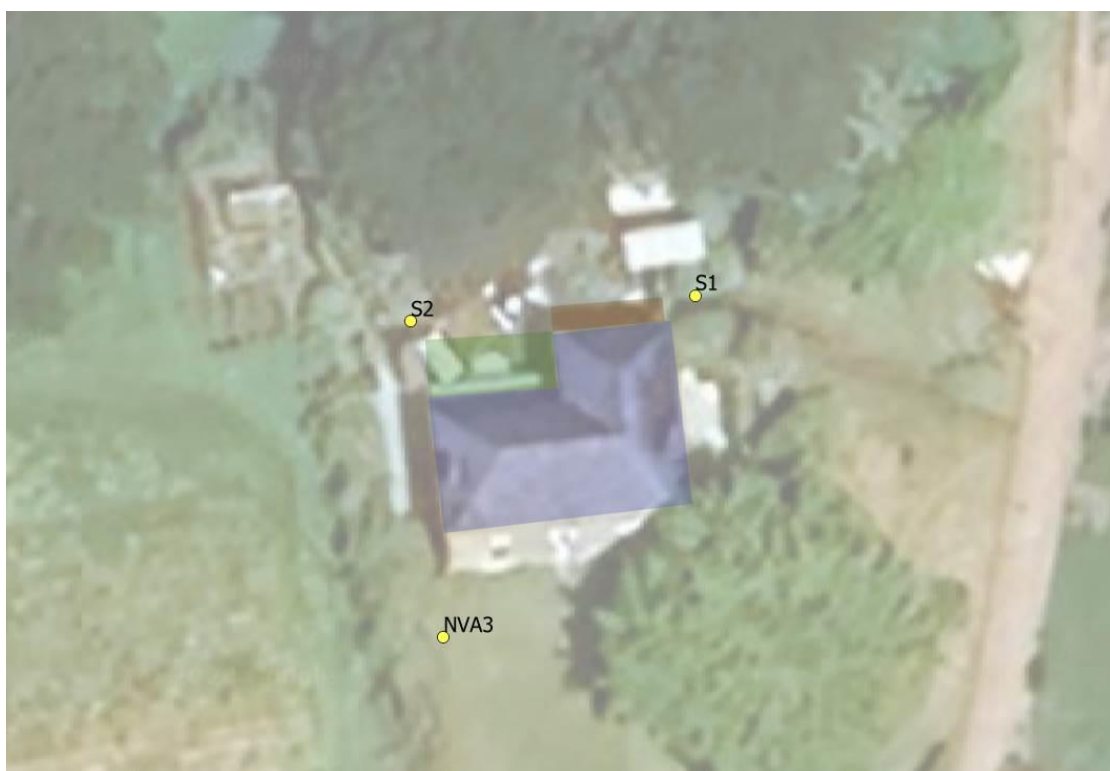
Map 01 – showing surveyor positions around the buildings. See the PRA report for full details of the different structures indicated by the various colour washes.

In order to ensure that the survey was comprehensive with regards to coverage and vantage points, two surveyor positions (S1 – S2) with corresponding NVAs, and an additional unmanned NVA (NVA3) were used. These are identified in Map 01 below.

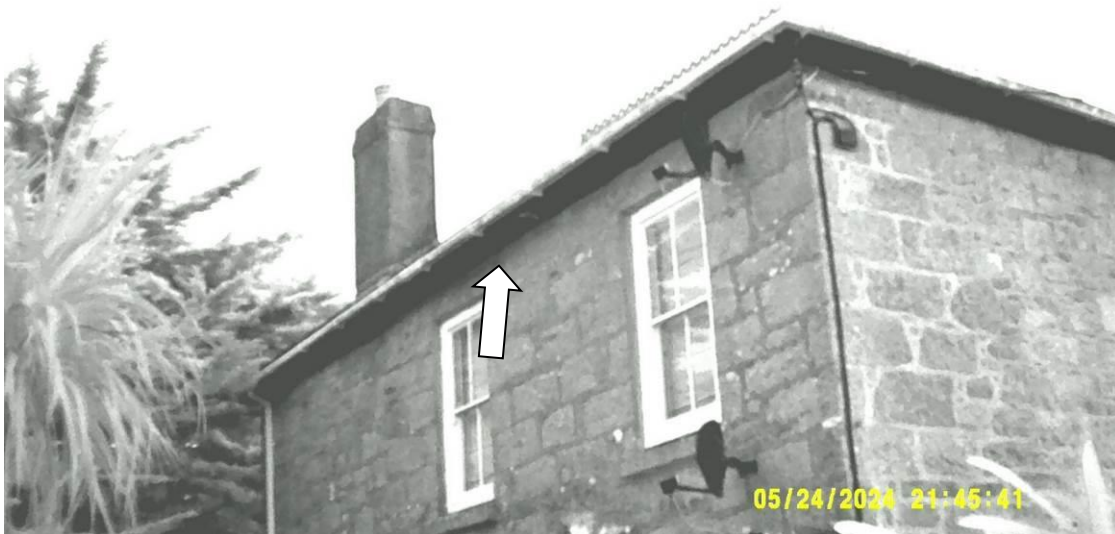
Photo 02 – showing the location where 1x common pipistrelle bat was recorded emerging from a roosting location on the eastern aspect of the property at 21:46.

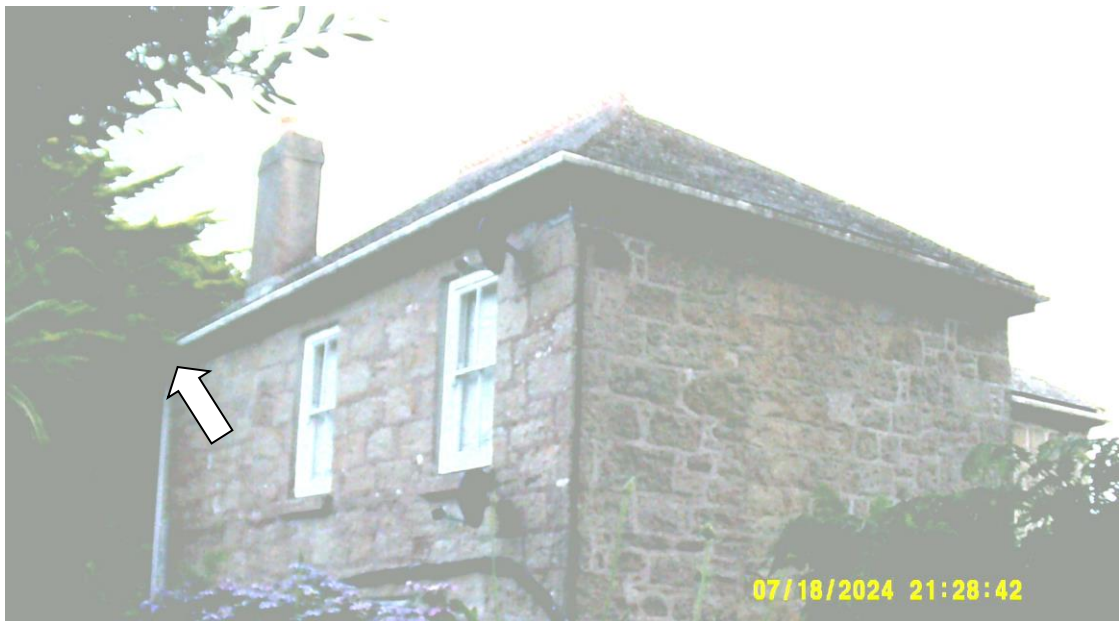
The emergence survey identified two common pipistrelle bats emerging from two separate roosting sites behind fascias on the northern and eastern aspects of the property at 9:28pm and 9:46pm. These locations are indicated in Photo 03 and 04 below. The roost location on the northern aspect corresponds with the location confirmed in PAS1 - the location on the eastern aspect utilised a different feature closer to the southern corner of the property.

Photo 03 – showing the location where 1x common pipistrelle bat was recorded emerging from a roosting location on the eastern aspect of the property at 21:28.

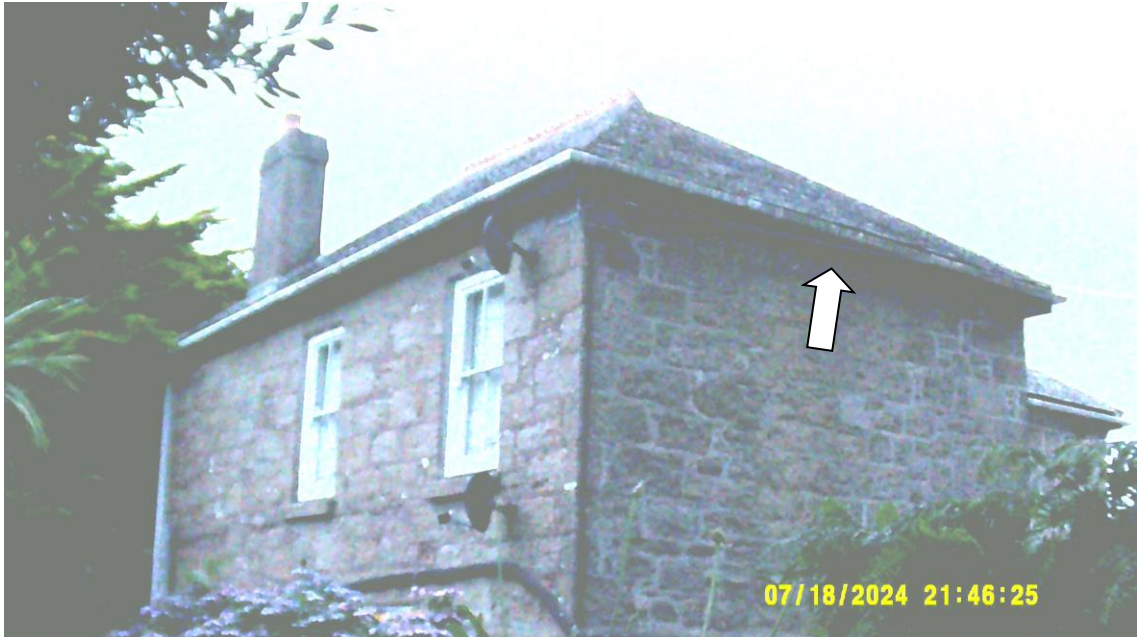
Photo 04 – showing the location where 1x common pipistrelle bat was recorded emerging from a roosting location on the northern aspect of the property at 21:46.

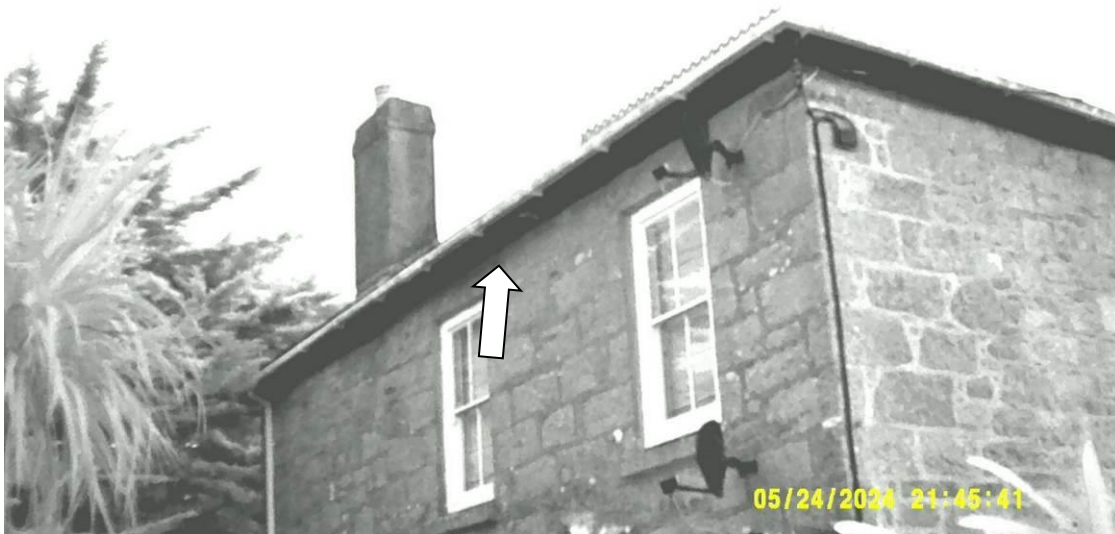
Photo 02 – showing the location where 1x common pipistrelle bat was recorded emerging from a roosting location on the eastern aspect of the property at 21:46.

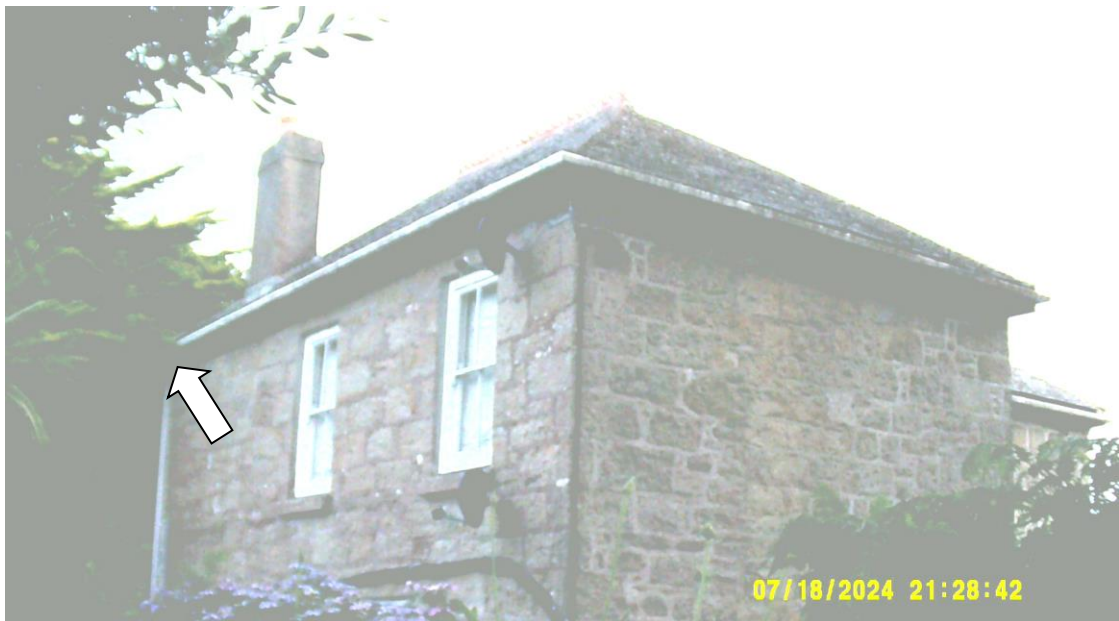
The emergence survey identified two common pipistrelle bats emerging from two separate roosting sites behind fascias on the northern and eastern aspects of the property at 9:28pm and 9:46pm. These locations are indicated in Photo 03 and 04 below. The roost location on the northern aspect corresponds with the location confirmed in PAS1 - the location on the eastern aspect utilised a different feature closer to the southern corner of the property.

Photo 03 – showing the location where 1x common pipistrelle bat was recorded emerging from a roosting location on the eastern aspect of the property at 21:28.

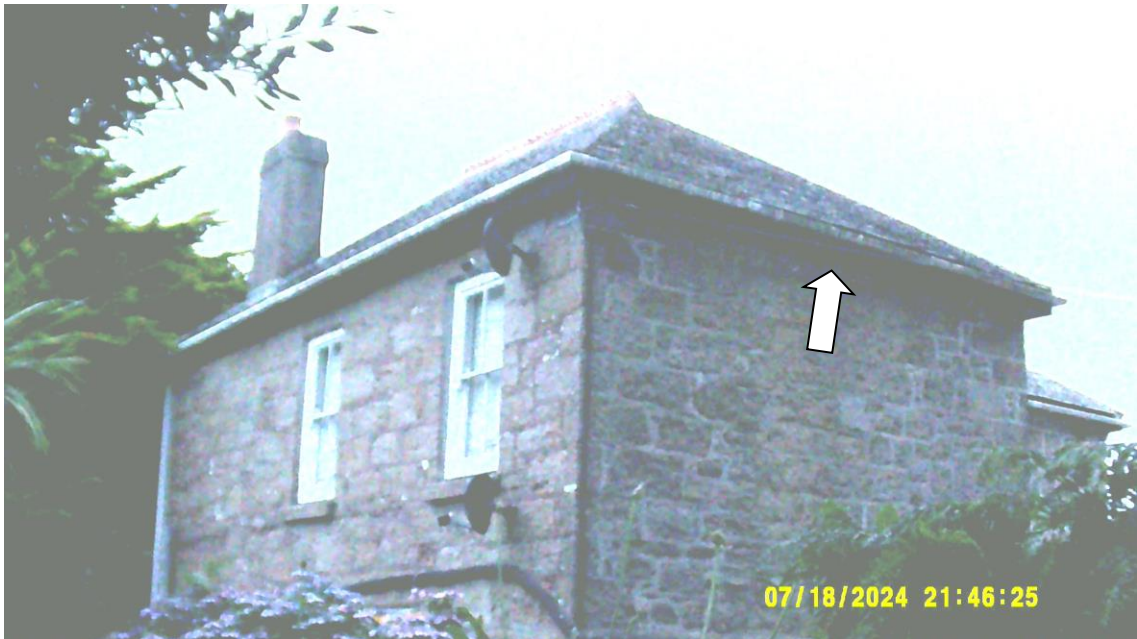
Photo 04 – showing the location where 1x common pipistrelle bat was recorded emerging from a roosting location on the northern aspect of the property at 21:46.
