Specification for mitigation and compensation
Site Name: Racket Town, Tresco, Isles of Scilly
Grid Reference: SV 89286 14924
Date: 2024.07.18

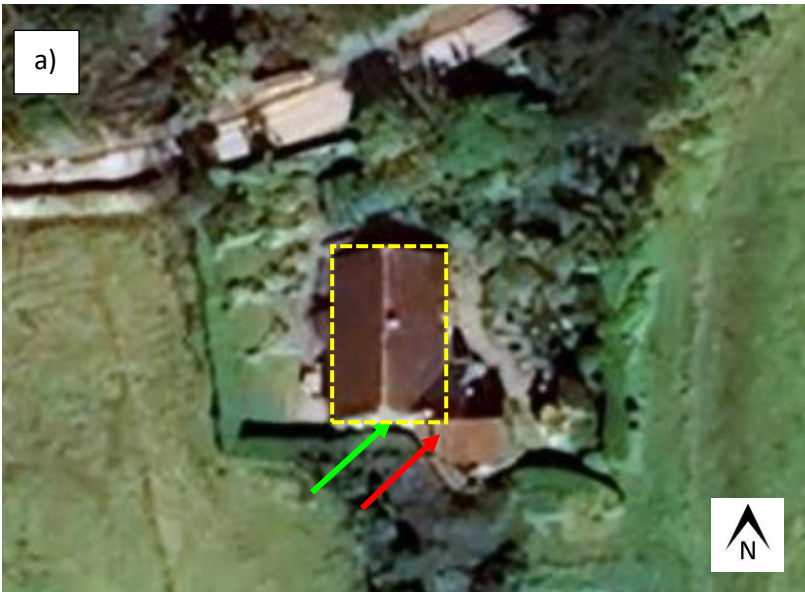
a). Aerial view of Racket Town showing location of bat roosts:

- The brown long-eared bat occasional day roost (dashed yellow line) will be retained. New access points will be installed.
- The common pipistrelle day roost within the south-eastern projection will be lost due to demolition (red arrow). Loss of the roost site will be compensated by either a). spacing off of the fascia board on the south elevation of the new south-east wing by 25mm to create a gap behind for bats to roost within; or b). installation of a raised ridge tile or bat slate over bitumen type 1F on the south-facing roof of the new south-east wing. NB. whilst installation of a single Schwegler Bat Access panel with back plate within the fabric of the building post-development was considered as a mitigation option, the proposed new south-east wing will not be tall enough to provide a suitable location.

- The common pipistrelle day roost located between roof/ridge tiles and the bitumen membrane at the southern gable end will be retained or re-created post-development. The existing access point (green arrow) will be protected, or re-instated post-development through installation of a bat slate and/or raised ridge tile in this location (over bitumen type 1F).

The common pipistrelle day roost located between roof/ridge tiles and the bitumen membrane at the southern gable end will be retained or re-created post-development. The access point (gap beneath end roof tile) will be protected, or re-instated post-development through installation of a bat slate (<https://www.leadworx.co.uk/product-tag/bat-access-slate>) and/or raised ridge tile in this location, featuring a 20mm x 50mm gap to allow the bats between the roof tiles and bat safe membrane (bitumen type 1F).

The common pipistrelle day roost behind the soffit on the west elevation of the south-eastern projection will be lost to allow for the development. Loss of this roost will be compensated by creation of a new roost feature within the new south-east wing. This could either take the form of spacing off of fascia boards by 25mm to create a gap behind for bats to roost within, ; or installation of a raised ridge tile or bat slate over bitumen type 1F on the south-facing roof of the new south-east wing.

The brown long-eared bat day roost within the roof void will be retained. The existing brown long-eared bat access points are unknown; but existing gaps at the wall tops that provide the potential access point(s) will likely be lost. Suitable bat access into the retained roof void will be created by spacing off the fascia boards by 25mm to create a gap behind for bats to access at the wall tops, or installation of two bat slates, one onto each of the eastern and western aspects of the roof with a corresponding slit created in the bitumen felt underneath to enable brown long-eared bats to access the roof void below.

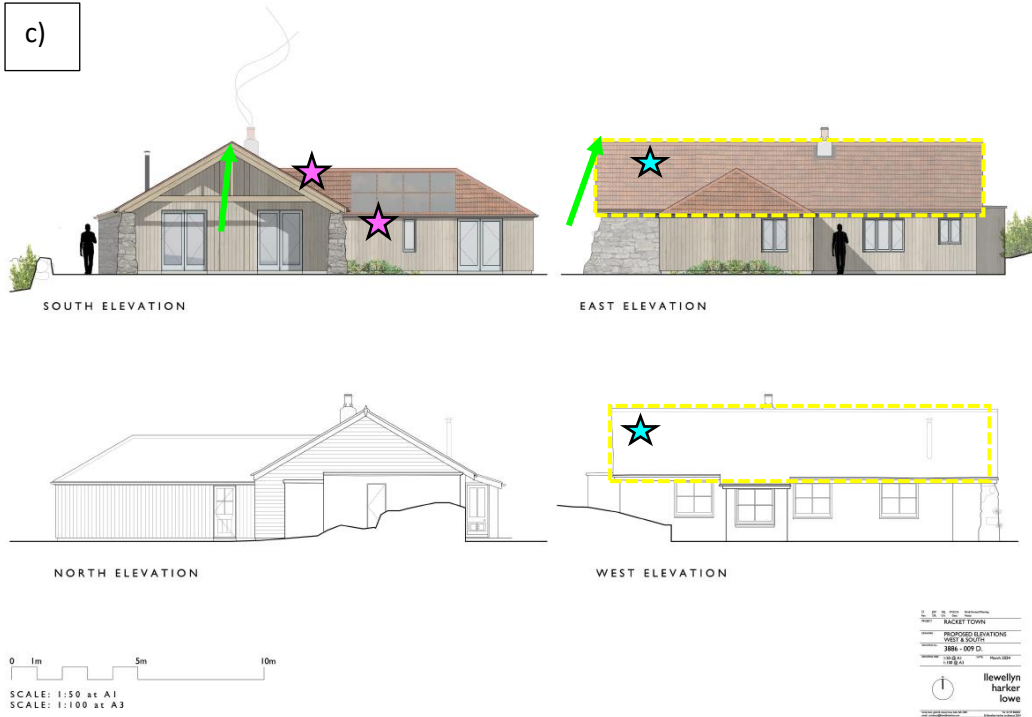
c)

c). Proposed elevations showing location of proposed fabric works and location of mitigation features:

- Retained brown long-eared bat occasional day roost is shown by dashed yellow line. Suitable bat access into the retained roof void will be created by spacing off the fascia boards by 25mm to create a gap behind for bats to access at the wall tops, or installation of two bat slates onto each of the eastern and western aspects of the roof with a corresponding slit created in the bitumen felt underneath to enable brown long-eared bats to access the roof void below (blue stars).

- The common pipistrelle bat day roost at the south gable end will be retained. The existing access point (green arrow) will be retained and protected or re-instated once works are complete.

- The common pipistrelle day roost within the south-east projection will be lost. Loss of this roost will be compensated by creation of one new roost feature within the new south-east wing on the south elevation (pink stars show potential locations of new roost feature).
