## BAT PRESENCE/ABSENCE SURVEYS (PAS)

RIVIERA HOUSE,  
ST MARY'S, ISLES OF SCILLY

*Report date:* 9<sup>th</sup> June 2024

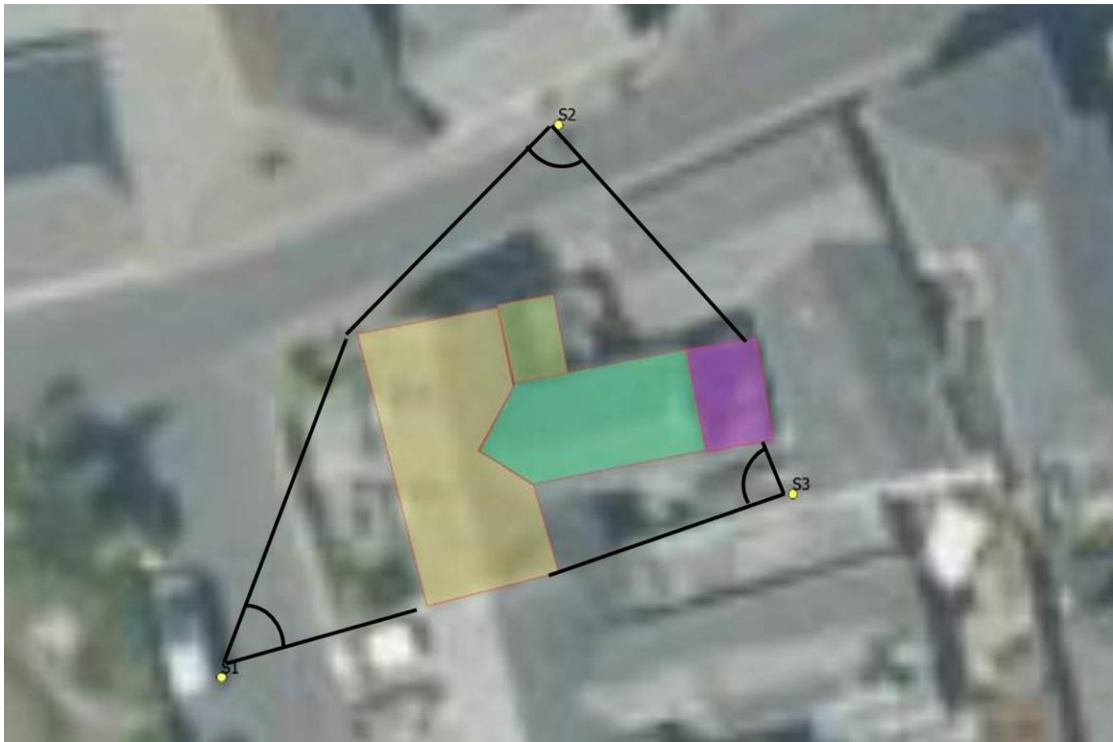
**Map 01** – showing surveyor positions around the buildings. See the PRA report for full details of the different structures indicated by the various colour washes.

In order to ensure that the different elements of the buildings received a survey effort of a single bat survey for a Moderate Potential building (in line with the Best Practice Guidance), three surveyor positions were used. These are identified in Map 01 below.

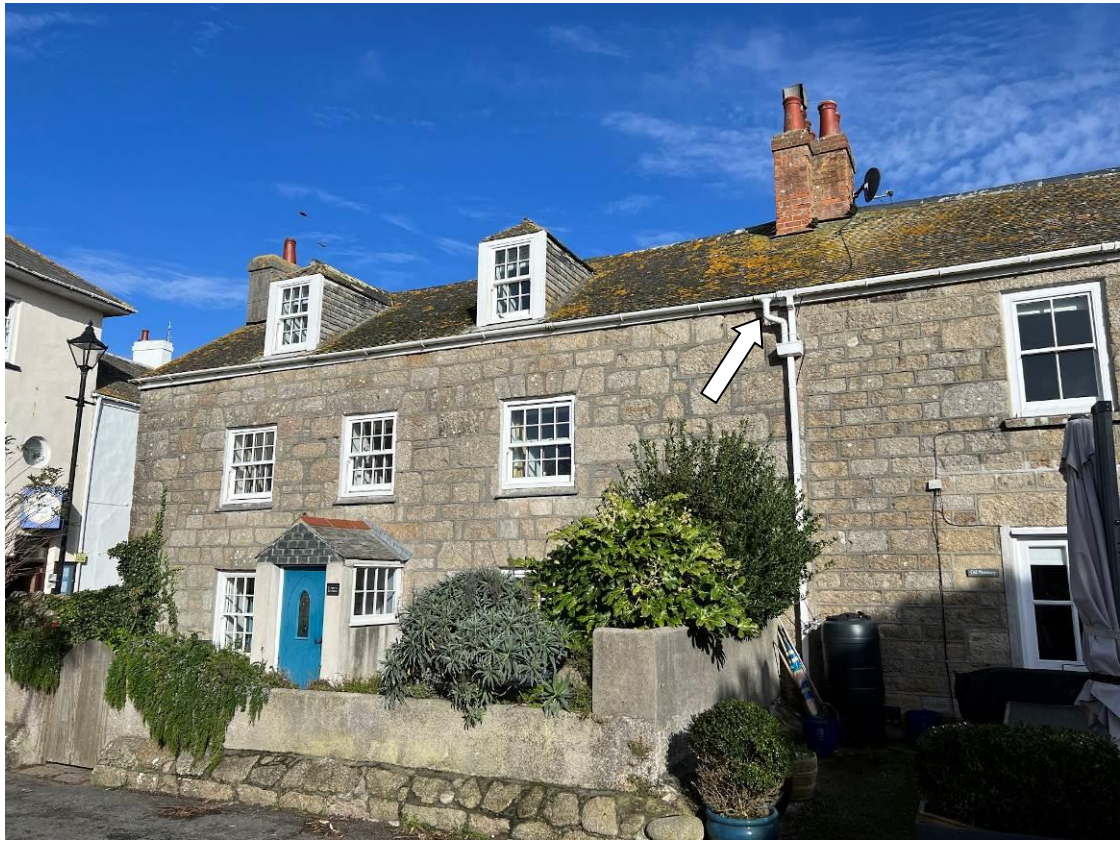
The emergence survey identified two common pipistrelle bats entering a roosting site behind the fascia on the front of the property at the location identified in Photo 01 below. This entry behaviour during a dusk survey has been observed on previous surveys undertaken in Hugh Town.

**Photo 01** – showing the location where 2x common pipistrelle bats were recorded entering a roosting site behind the fascia board.

The two bats entered the roosting opportunity beneath the fascia behind the gutter hopper towards the southern end of the western aspect of the property at 9:36 and 9:39pm respectively. The NV camera field of view (FOV) on this occasion did not cover this aspect at the junction between Riviera House and the adjoined property to the south; however the following factors in the absence of NV confirmation allow confidence in this assessment:

- The location where the entry was observed corresponds with a clear potential roosting feature in the form of a gap behind the fascia.

- Key elements of the works should be undertaken under a 'soft strip' methodology whereby the fascia boards are removed by hand, as well as tiles within 1m of the eaves (if required) under the ecological oversight of a Licensed Bat Worker. If bats are identified, they would be captured by hand and moved to a place of safety.

- Following completion of the works, the roost would be restored in situ. This would involve the incorporation of a cavity 100mm wide and 25mm deep behind the fascia board to permit continued access for bats. This would be completed under the direction of the Licensed Bat Worker who would confirm and sign off the restored roosting feature at the end of works.

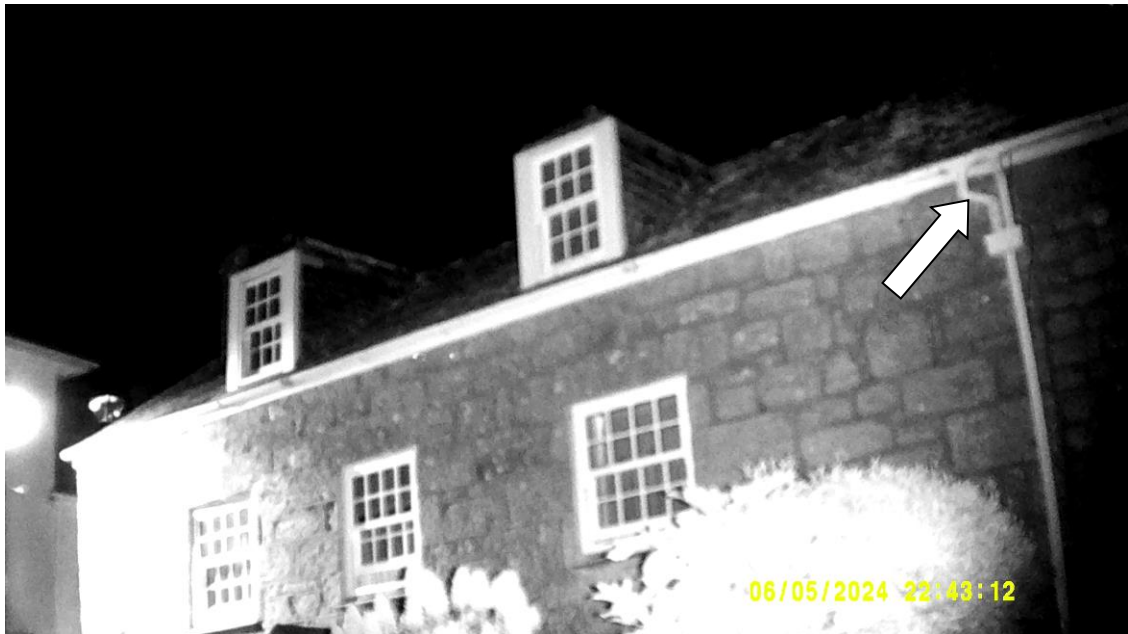
The FOV of the camera in surveyor position S1 did not encompass the roost location point which is at the boundary of the property in PAS 1. This was rectified and the full span of the building as well as a portion of the adjacent property were included in the FOV during PAS 2.

**Surveyor S1** – showing footage from the Nightfox Whisker at surveyor position S1. Note the artificial light on the LHS of the image which provides an elevated level of visibility for the surveyor watching this aspect. The roost site is in the location indicated with the arrow – this illustrative image is taken from the PAS2 survey – the FOV clipped this feature (at the junction between Riviera and the adjacent property) from the recording in PAS1.

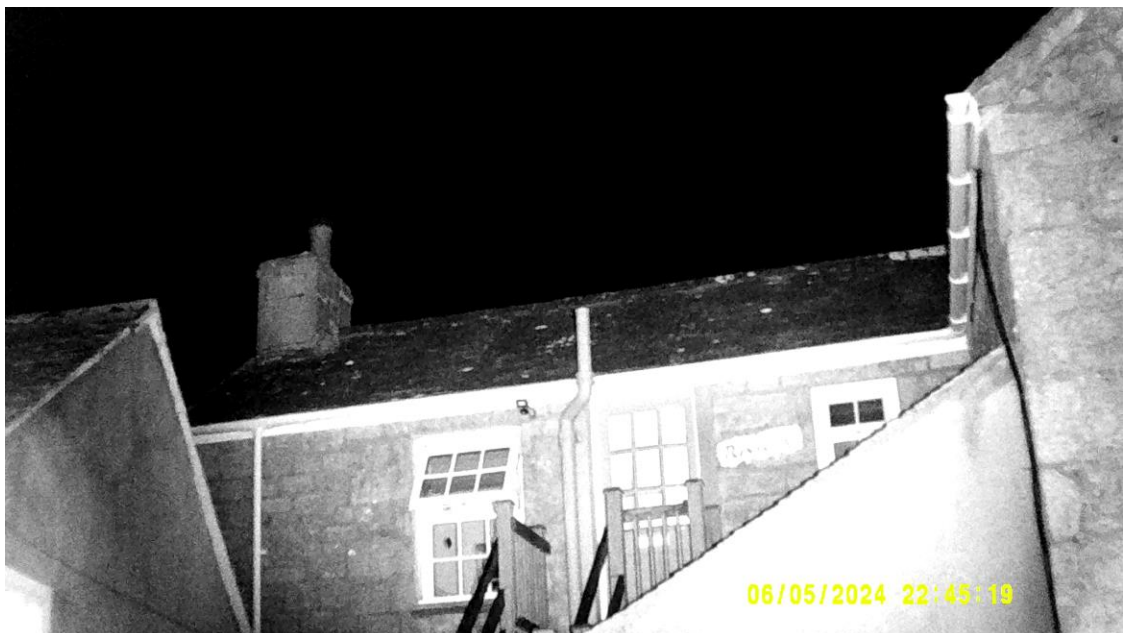
**Surveyor S2** – showing footage from the Nightfox Whisker on surveyor position S2. No potential access features were identified associated with the gable on the RHS of the image – it is also illuminated by the artificial light which provides the surveyor with excellent visibility without requiring IR and NVA; therefore this camera position was focussed on the potential features within the portion of the building on which the camera and IR is focussed.

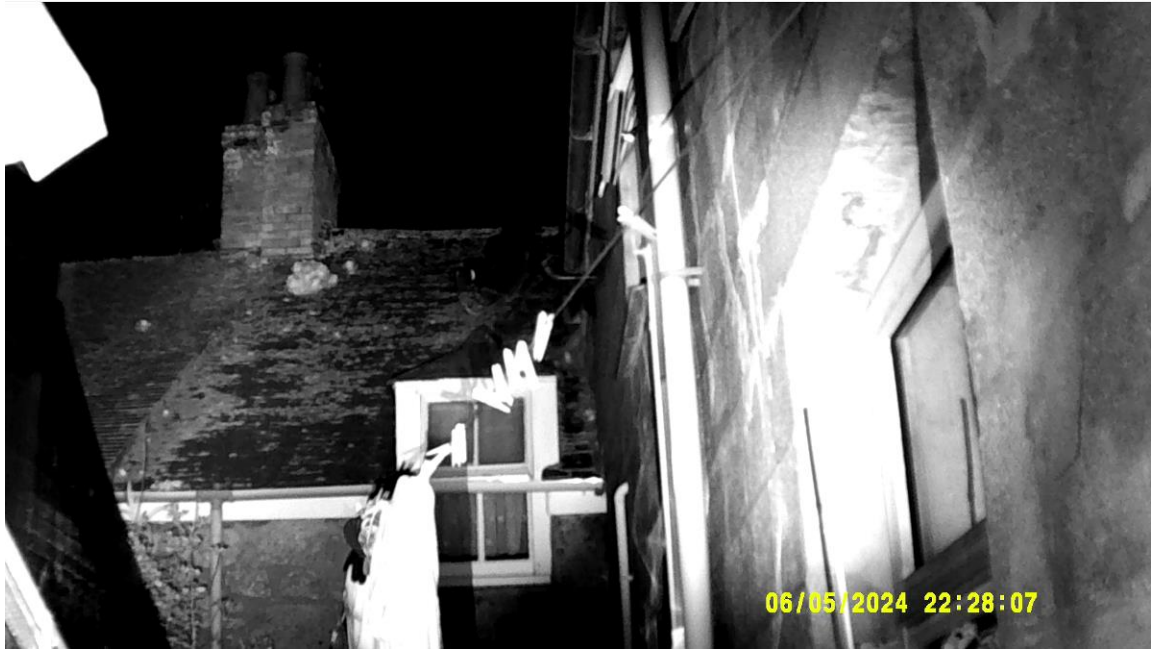
The NV camera FOV could not fully cover all aspects of the buildings due to the presence of intervening or obstructing features around surveyor position S3 in both surveys. However the coverage of the other side of this roof pitch by surveyor position S2; and inspection of the recorded bat activity by surveyor position S3 allow the results to be confirmed with confidence in spite of this constraint.

**Surveyor S3** – showing footage from the Nightfox Whisker on surveyor position S3. The small size of the courtyard restricts the FOV from covering the pitch of the roof on the RHS of the image; this constraint was addressed through positioning of surveyors (including indirect observation by surveyor S2) and careful review and cross-reference of results between surveyors.
