PERMISSION FOR DEVELOPMENT

Application No: P/24/056/HH **Date Application Registered:** 7th August 2024

Site address: Busaverne 1 Buzza Street Hugh Town St Mary's Isles Of Scilly
Proposal: Re-roofing of east facing elevation and hip with dry laid natural slate to match West elevation and removal of leaking chimney

PRELIMINARY ROOST ASSESSMENT (PRA)

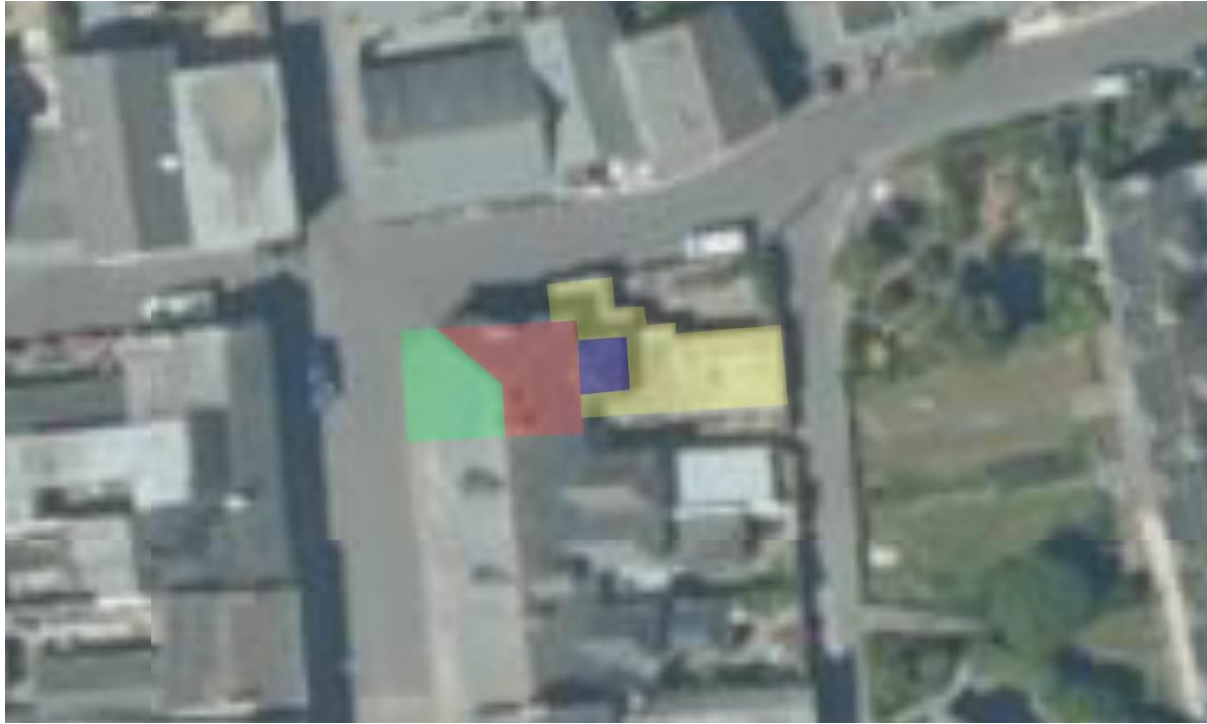
Planning Authority: Isles of Scilly	Location: 90500(E) 10472 (N)	Planning Application ref: Report produced in support of application
Planning application address: 1 Buzza Street, Hugh Town, St Mary's, Isles of Scilly		
Proposed development: The proposed works were identified by the client when instructing the PRA inspection and should accord with the proposals submitted for Planning including: <ol style="list-style-type: none">1) Replacement of the wet-laid scantle tile roof on the eastern and northern pitches;2) Removal of the existing chimney in the northern pitch.		
Building references: The roof sections to be replaced are indicated with the red wash in the aerial image below. For context and reference, the retained section of roof is shown in green. The two-storey hipped roof extension is indicated with the blue wash and the flat-roof single-storey extension is indicated with the yellow wash.

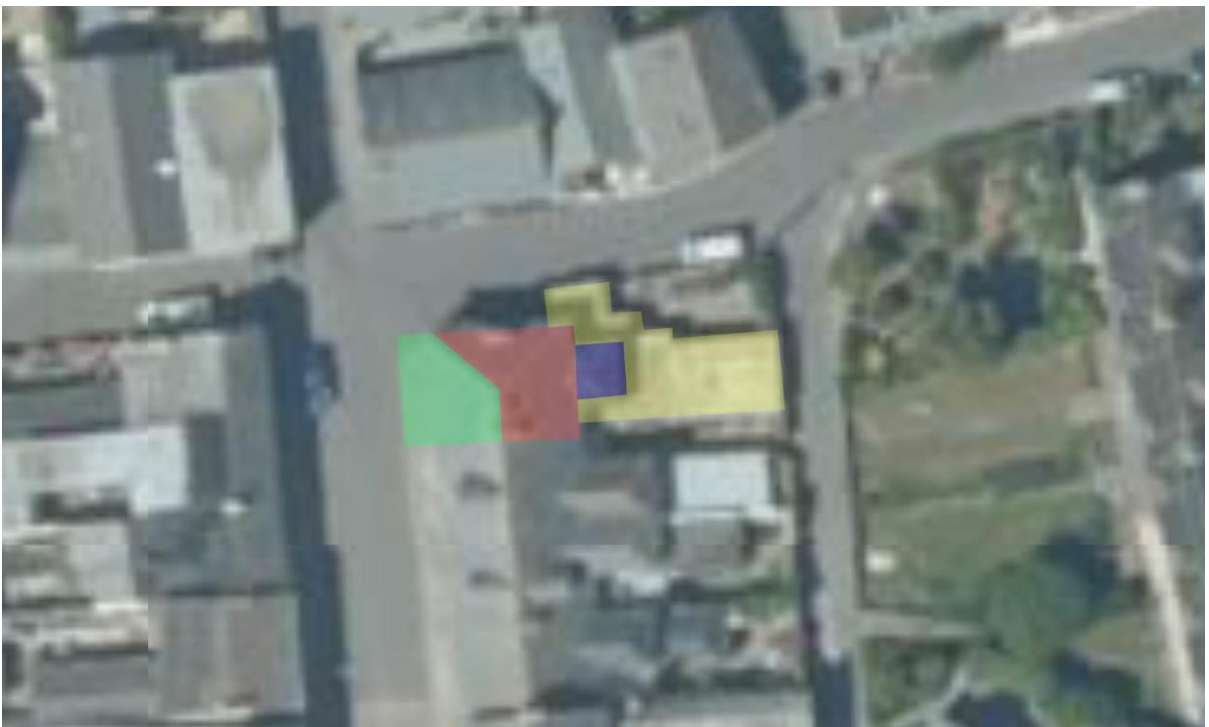
Map 02 – Showing the property within the local environs – the roof sections to be replaced is indicated with the red wash; the retained section of roof is shown in green; the two-storey hipped roof extension is indicated with the blue wash; and the flat-roof single-storey extension is indicated with the yellow wash.

The proposals are restricted to replacement of the existing scantle tile roof on the eastern pitch and northern hipped section; and the removal of the chimney which is situated within the northern hipped section. The focus of this assessment is therefore on these features, and any adjacent structural features which might be directly or indirectly impacted by the proposals.

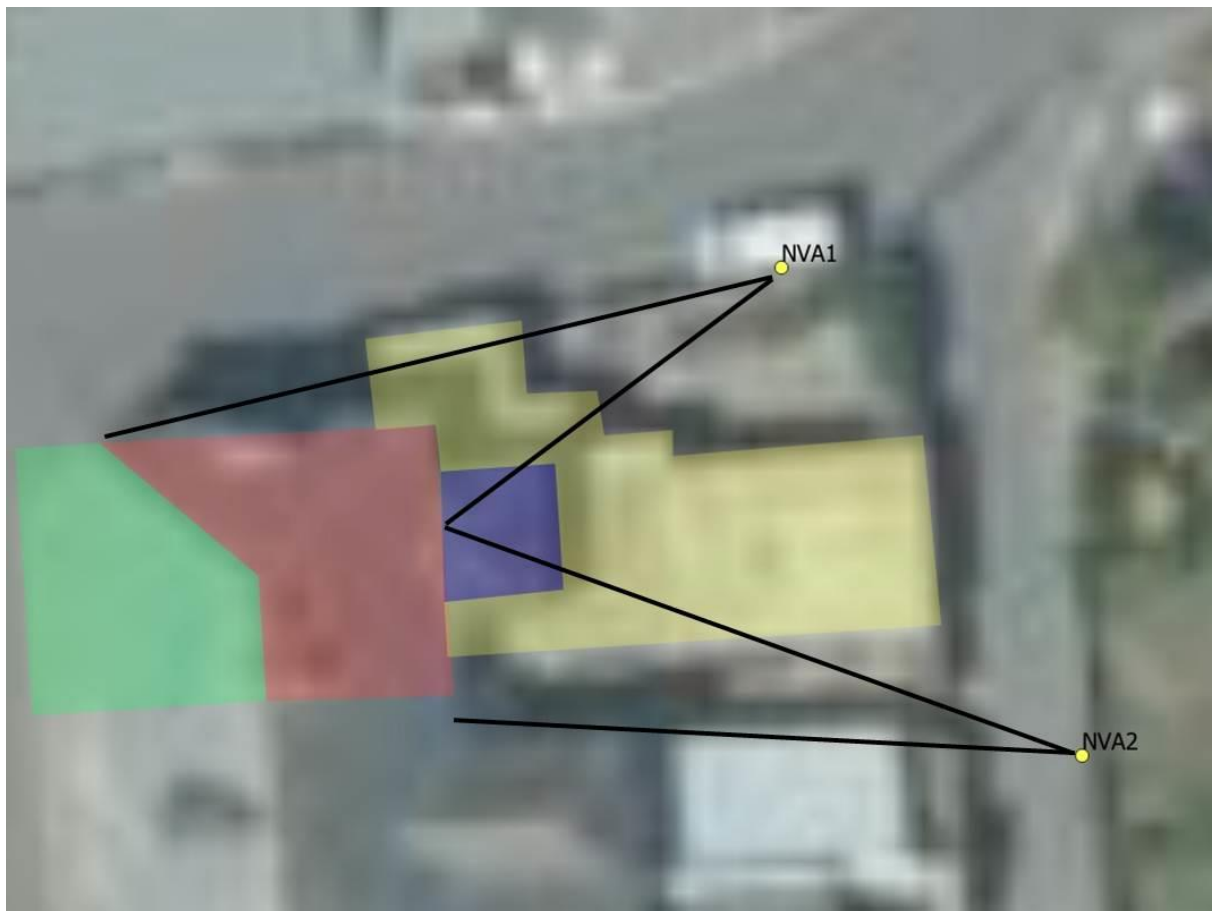
Map 01 – showing two NVA positions with the surveyor positioned adjacent to NVA1. The two-storey hipped roof extension is indicated with the blue wash and the flat-roof single-storey extension is indicated with the yellow wash. These building components are described fully in the PRA report for this property.

In order to ensure that the building received a survey effort of a single bat survey for a Low Potential building (in line with the Best Practice Guidance), one surveyor position and two NVAs were deployed. These are identified in Map 01 below.
