## BAT PRESENCE/ABSENCE SURVEYS (PAS)

GUTHERS,  
ST MARY'S, ISLES OF SCILLY

*Report date: 3<sup>rd</sup> September 2024*

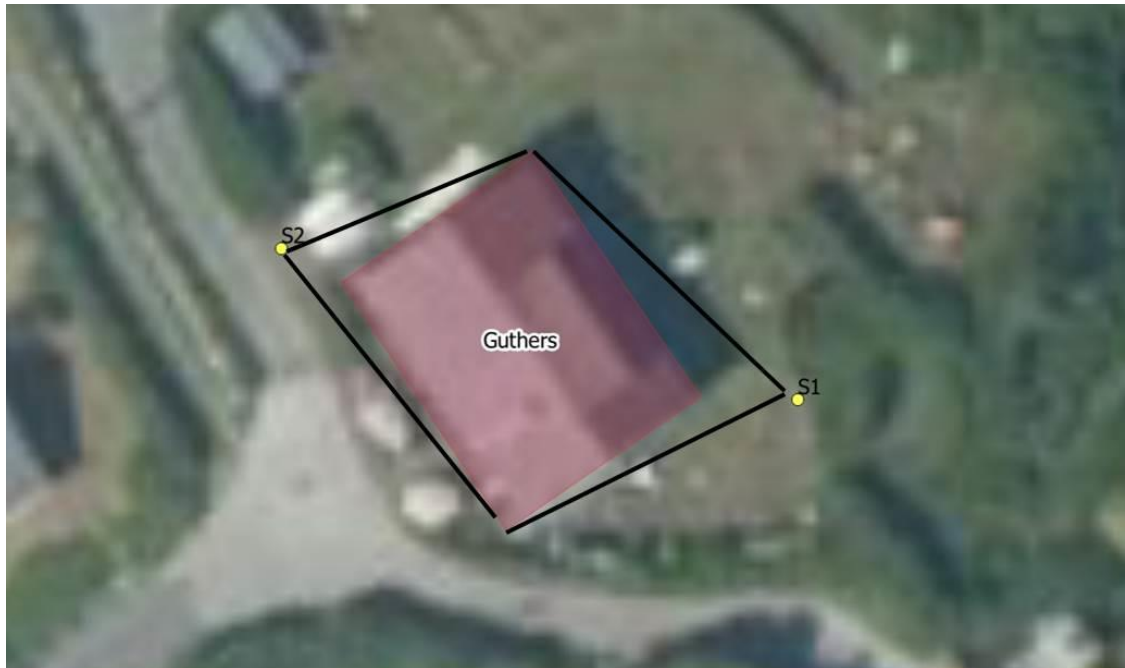
**Map 01** – showing surveyor positions (S1-S2).

In order to ensure that the different elements of the building received a survey effort appropriate to a Moderate Potential building (in line with the Best Practice Guidance), two surveyor positions with associated NVAs were deployed. These are identified in Map 01 below.

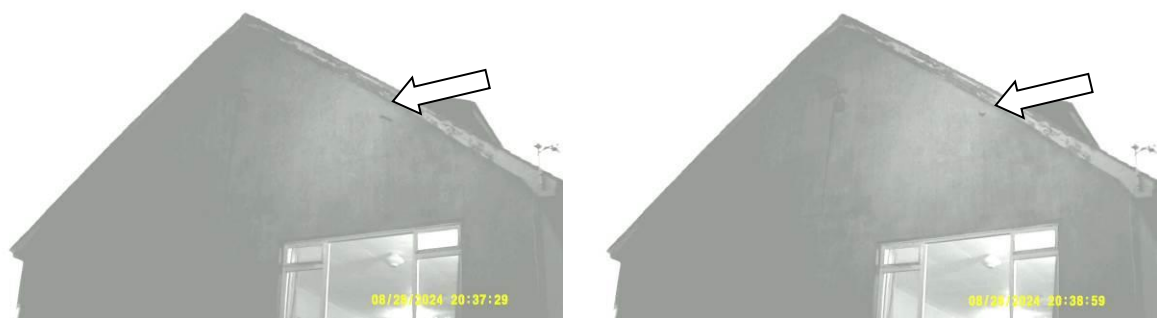
**Photos 01 - 02** – showing the confirmed emergence location (indicated with the arrow) – the emerging bats can be seen just below the emergence point.

Two common pipistrelle bats were recorded emerging from a roost access feature on the overhang of the south-eastern gable of the property in the location indicated in Photos 01 and 02. The emergence was at 8:37pm and 8:38pm, 21 and 22 minutes after sunset respectively.

- Key elements of the works should be undertaken under a 'soft strip' methodology whereby the south-eastern gable structure including overhang, soffits and cedar shingles within 1m of the gable would be removed under the ecological oversight of a Licensed Bat Worker. If bats are identified, they would be captured by hand and moved to a place of safety.

- Once the soft-strip works have been completed, further works to the property can proceed with distance supervision.
- Following completion of the works, a bat box designed for use by common pipistrelle bats would be situated on the south-eastern gable in the location where the confirmed roost was located (see Plan 01). A second bat box would be installed on the north-western gable to provide further enhancement (see Plan 02). The installation of these features would be completed under the direction of the Licensed Bat Worker who would confirm and sign off the installation at the end of works.
