Mike and Karrie Skaife have recently purchased Guthers, a dormer bungalow set back from Church Street in Hugh Town, St.Mary's. They have relocated from another property on St.Mary's, and Guthers will become their new permanent home. The previous owner was an elderly lady who enjoyed living in this impressive location with garden views overlooking Lower Moors, but she was unable to devote time and effort to ongoing maintenance. There is therefore a long list of improvements and alterations the new owners would like to undertake to tailor the house to suit their own needs. The Council have already been consulted on these planned changes and have provided useful feedback in the form of a pre-app report. This advice has helped to inform the current planning application proposals. This document explains to proposed regeneration of Guthers and should be read in conjunction with drawings 2045-P01 to P05 inclusive.

PRELIMINARY ROOST ASSESSMENT (PRA)

GUTHERS,
ST MARY'S, ISLES OF SCILLY

BAT PRESENCE/ABSENCE SURVEYS (PAS)

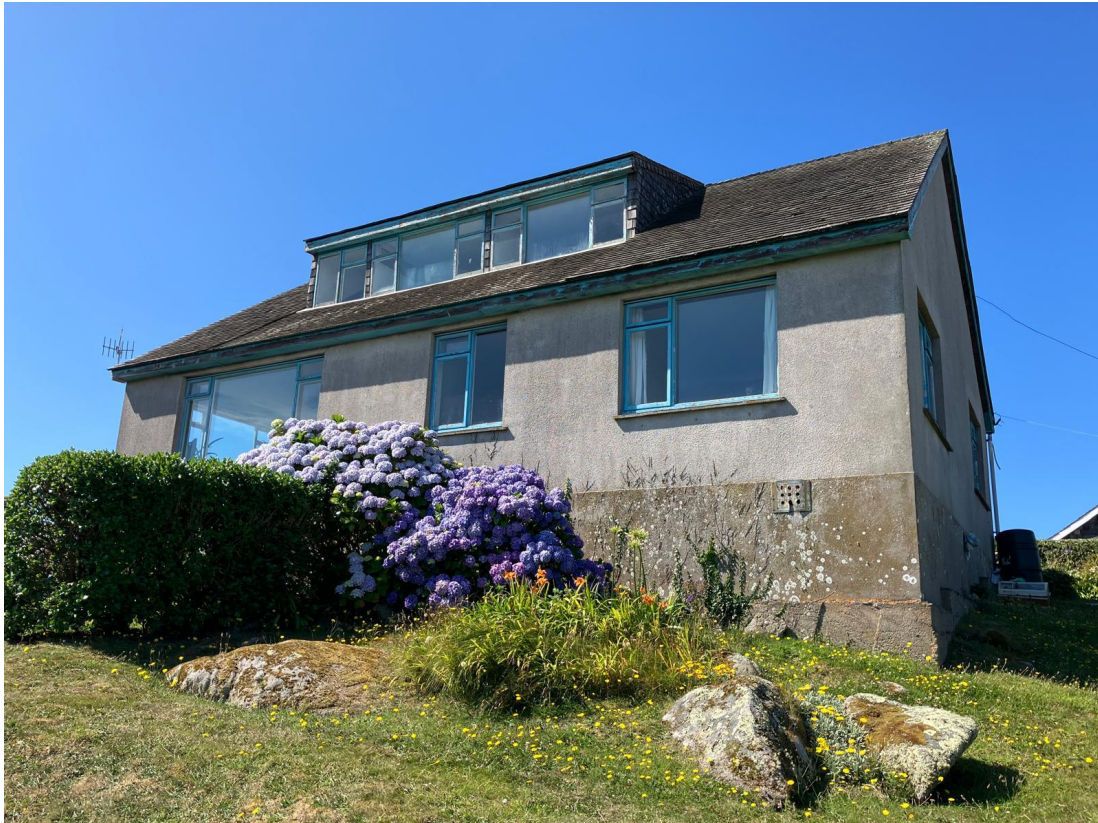
Above: View of Guthers from the private garden on the NE side of the property

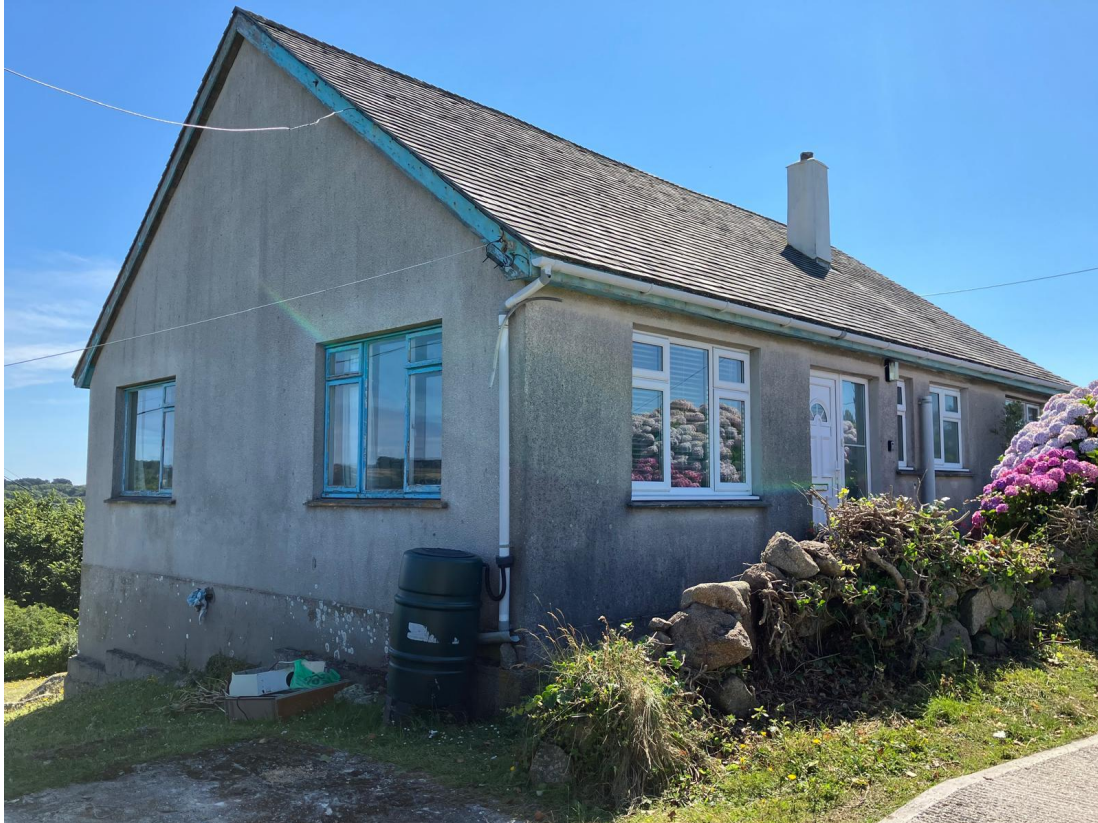
Side view looking back towards Guthers

Guthers is in a prominent location at the end of the access lane but is partly obscured by some established shrubs and a roughly constructed stone hedge (see photo above). It is one of a number of similar properties that appear to have been built around the same time. The most notable is Lowenva on the North side of the drive, more commonly known as Harold Wilson's bungalow. This property is also rather outdated and the owners intend to extend and alter it to meet current expectations and regulations (see planning approval P/23/031/HH). The immediate neighbourhood will therefore hopefully experience something of a regeneration in the near future.

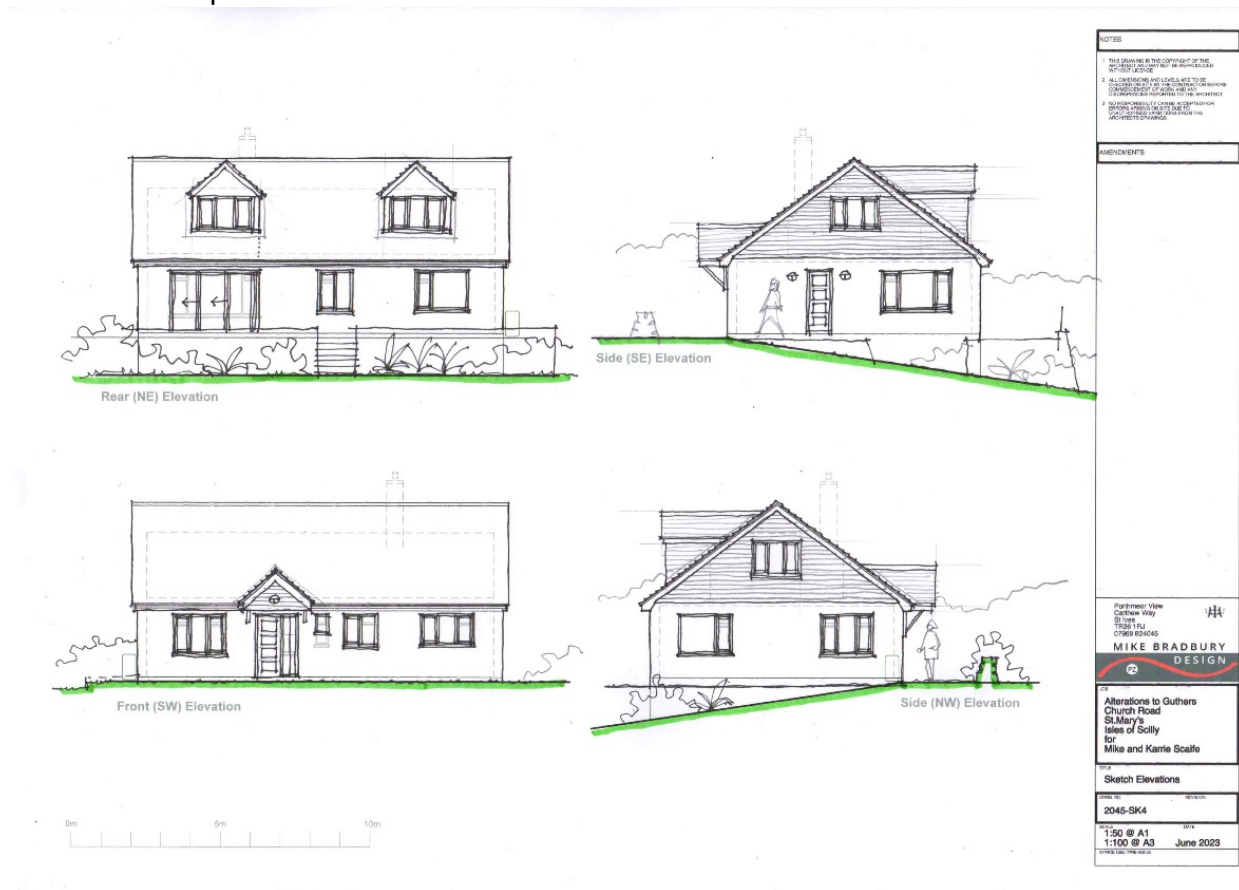
A pre-app enquiry was submitted to the Isles of Scilly Council in June 2024 and was dealt with by Andrew King. The sketch elevations below are one of the drawings submitted. We spoke to Andrew King by phone and a formal response was issued by email on Friday 19 July. The feedback to the sketch designs can be summarised as follows:

- The proposals appear to be acceptable in principle and no major planning problems are envisaged
- New windows and the front door on the SW elevation require planning permission as they face the highway but new windows on the other elevations do not
- The dormer bungalow is not listed and there do not appear to be any restrictive conditions
- The policies in the Isles of Scilly Guide should be taken into account
- New windows should not create overlooking issues
- As there are proposed changes to the roof, a Preliminary Roost Assessment (PRA) is required to assess impact on protected species
- External works require planning permission
- As this will be classed as a 'householder application' it is exempt from Biodiversity Net Gain requirements

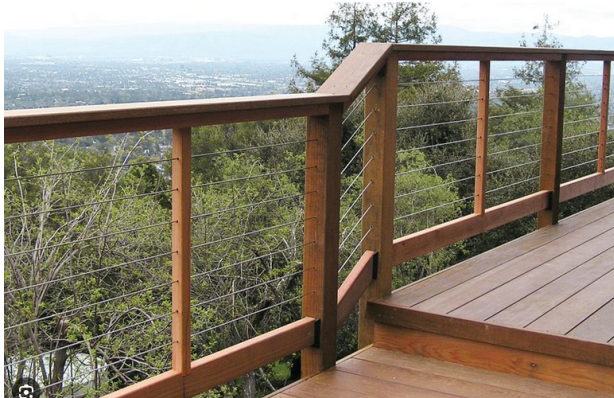
Proposed style of timber balustrading

timber deck at the back of the house extending 2.5m into the garden. This will be one step down from the internal finished floor level and three steps above the garden at the South East end of the terrace. The decking will be constructed in treated non-slip timber to match the timber balustrading. Stainless steel tension cables will be a neat and effective way of making the handrails safe and secure and will preserve the view from the living rooms and terrace.

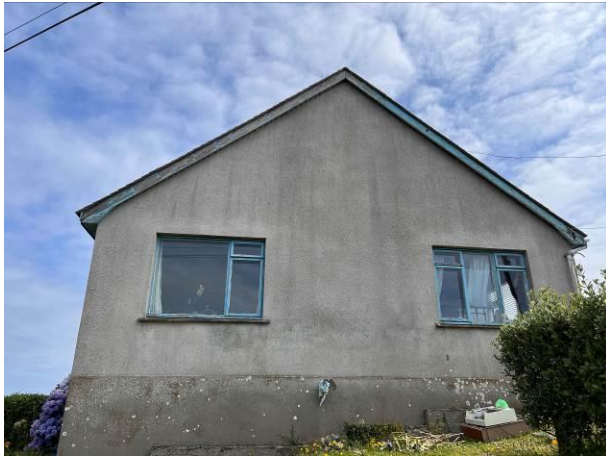
Photograph 1: Showing the southern gable of the property

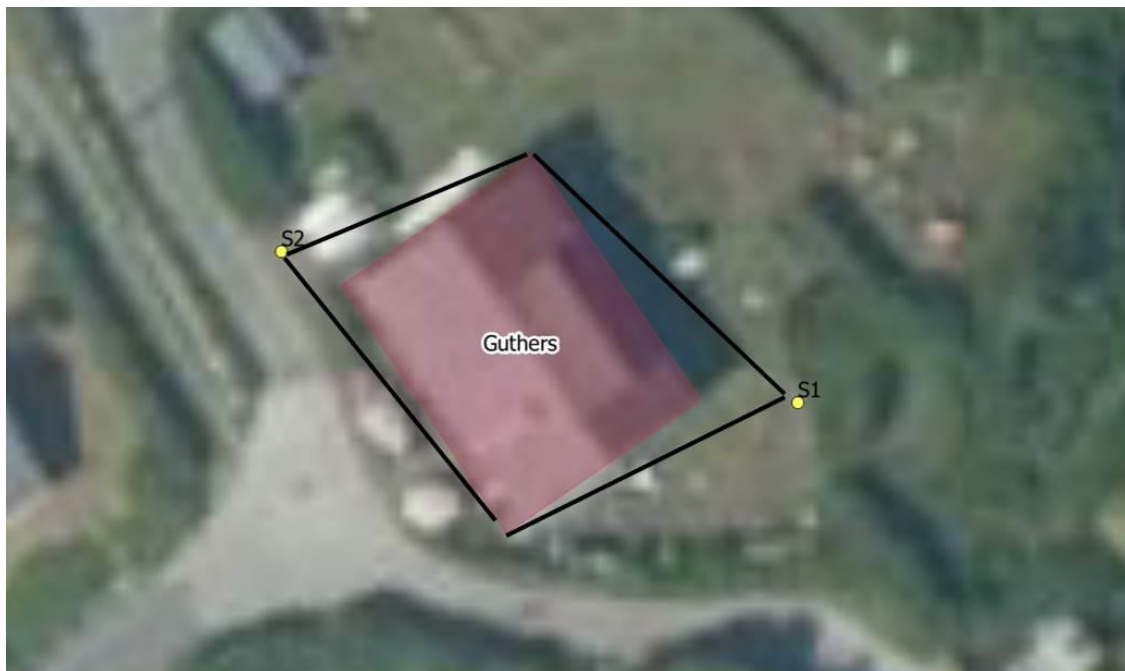
Map 01 – showing surveyor positions (S1-S2).

In order to ensure that the different elements of the building received a survey effort appropriate to a Moderate Potential building (in line with the Best Practice Guidance), two surveyor positions with associated NVAs were deployed. These are identified in Map 01 below.

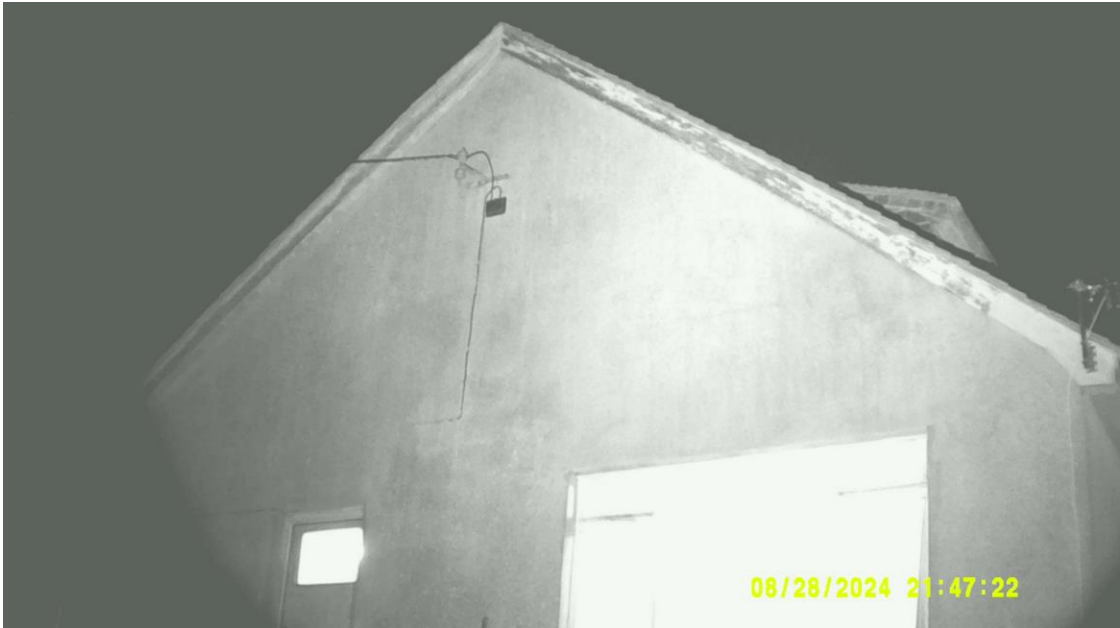
NVA1 – showing footage from the Nightfox Whisker at position S1. This is covering the south-eastern side of the building and includes all identified potential access features on this aspect.

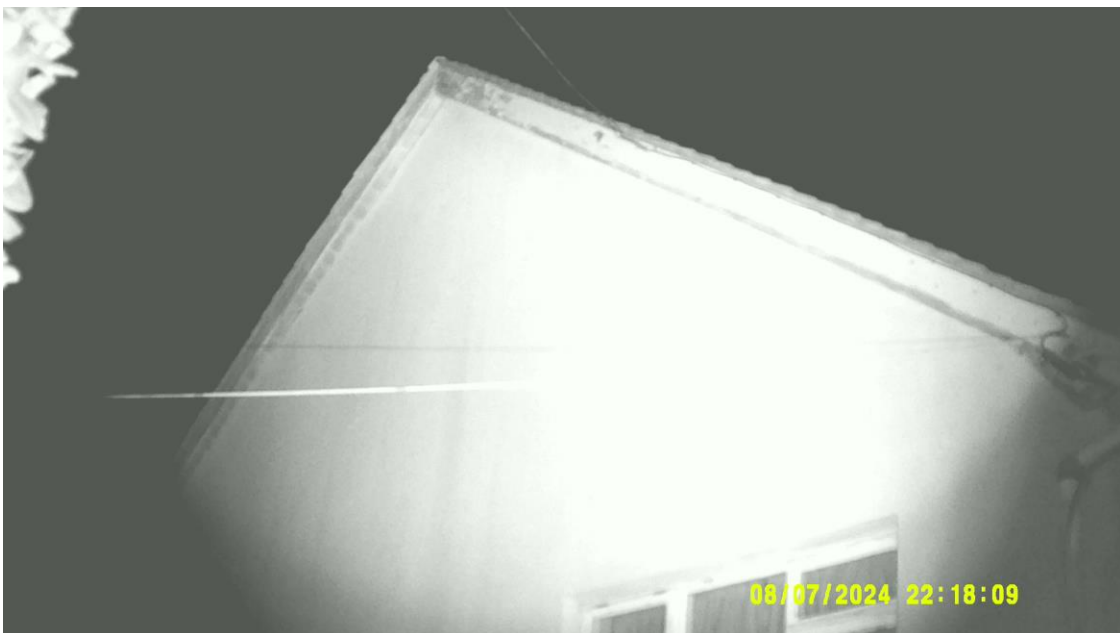
NVA2 – showing footage from the Nightfox Whisker at position S2. This is covering the north-western side of the building and includes all identified potential access features on this aspect.
