BAT PRESENCE/ABSENCE SURVEYS (PAS)

PARKSIDE,
ST MARY'S, ISLES OF SCILLY

Client: NHB Architects

Report date: 11th September 2024

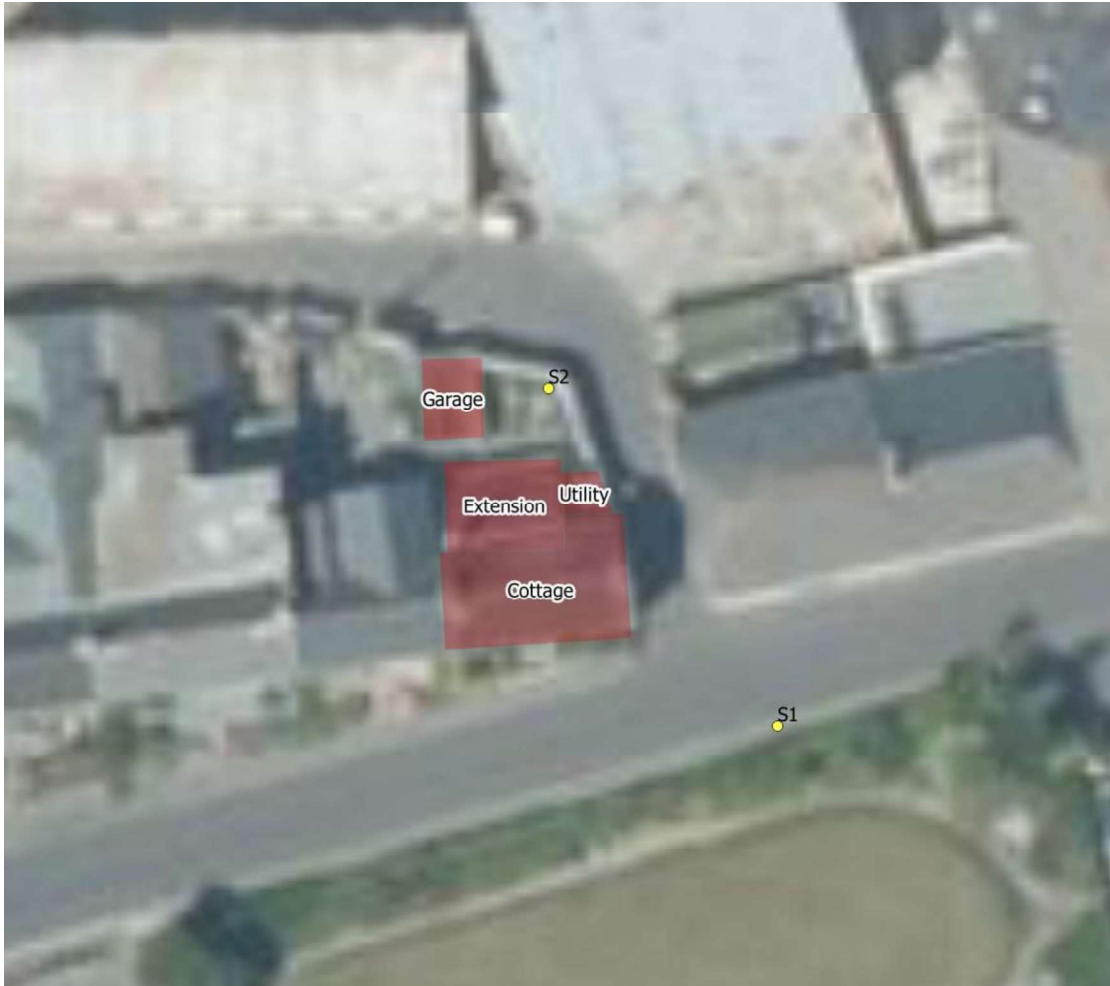
In order to ensure that the different elements of the building were surveyed comprehensively in line with the Best Practice Guidance, a total of two surveyor positions were identified. These are identified in Map 01 below.

Map 01 – showing surveyor positions around the building.

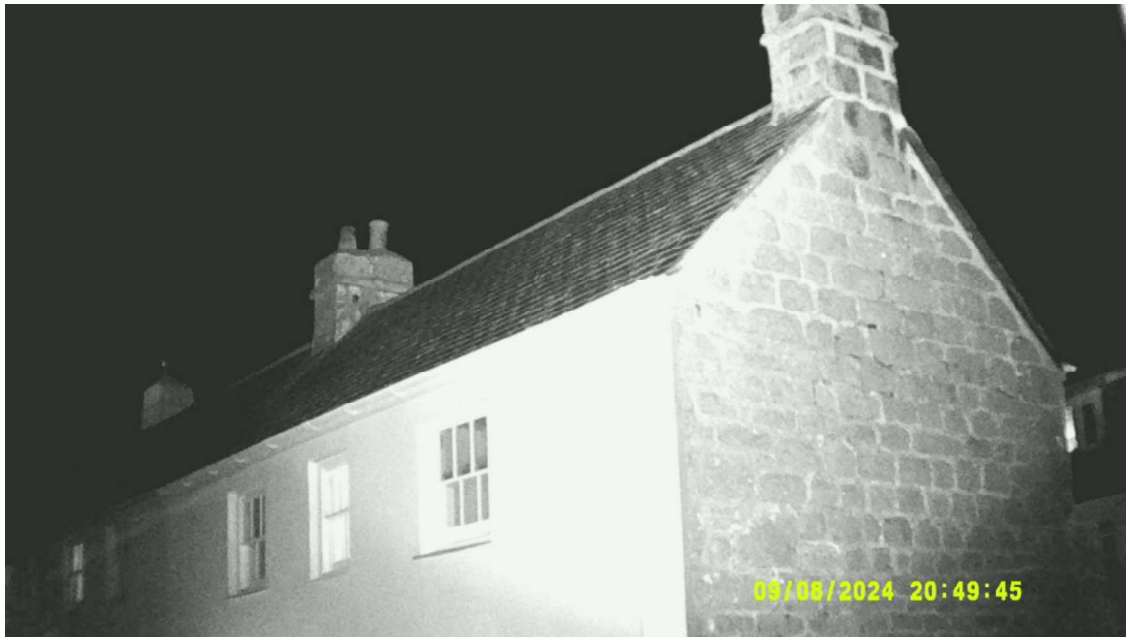
NVA1 – showing footage from the Nightfox Whisker at position S1. This is covering the southern and eastern aspects of the property

The NVA footage covered the vast majority of the areas under consideration and the positioning allowed inference of potential emergence behaviour within any minor gaps in coverage.

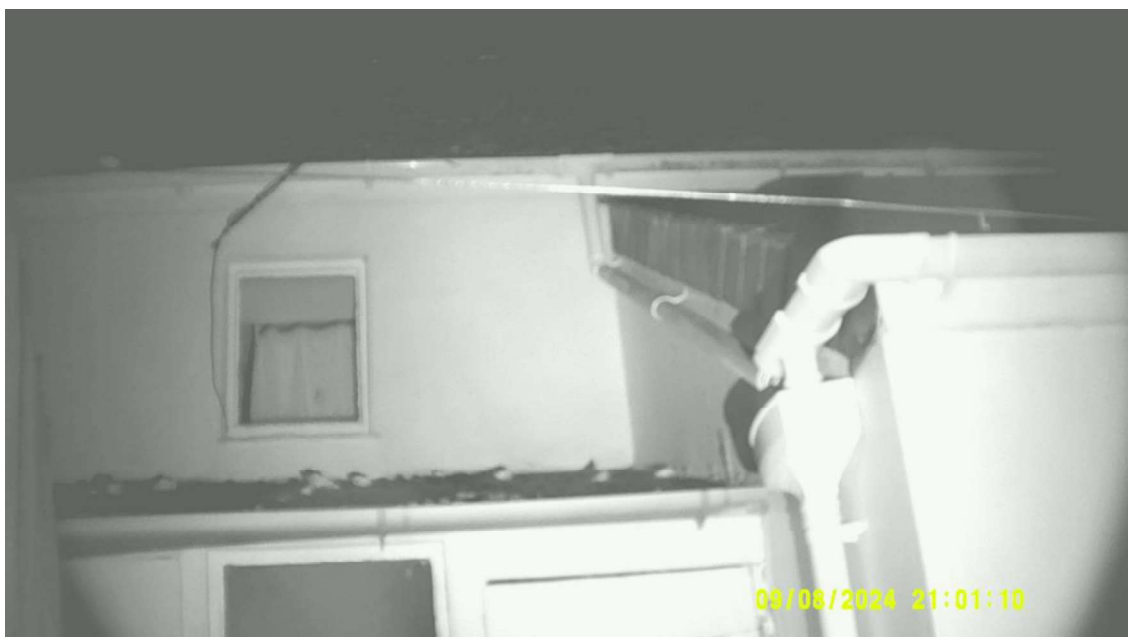
NVA2 – showing footage from the Nightfox Whisker on position S2. This is focussed on the fascias on the northern aspect of the property though the constraints of the site restricted comprehensive FOV in this location.

The NVA used by the surveyor in position S2 was restricted in its FOV by the proximity of the surveyor to the building within a small courtyard garden. The FOV was therefore focussed on the potential features identified associated with the fascias, but did not comprehensively cover this aspect of the property. The excellent vantage visibility afforded by the surveyor however, coupled with very low levels of activity recorded throughout the survey, indicates that this does not represent a constraint to the validity of the survey.
