## BAT PRESENCE/ABSENCE SURVEYS (PAS)

### VERONICA LODGE, ST MARY'S, ISLES OF SCILLY

*Client:* Duchy of Cornwall

*Report date:* 14<sup>th</sup> September 2025

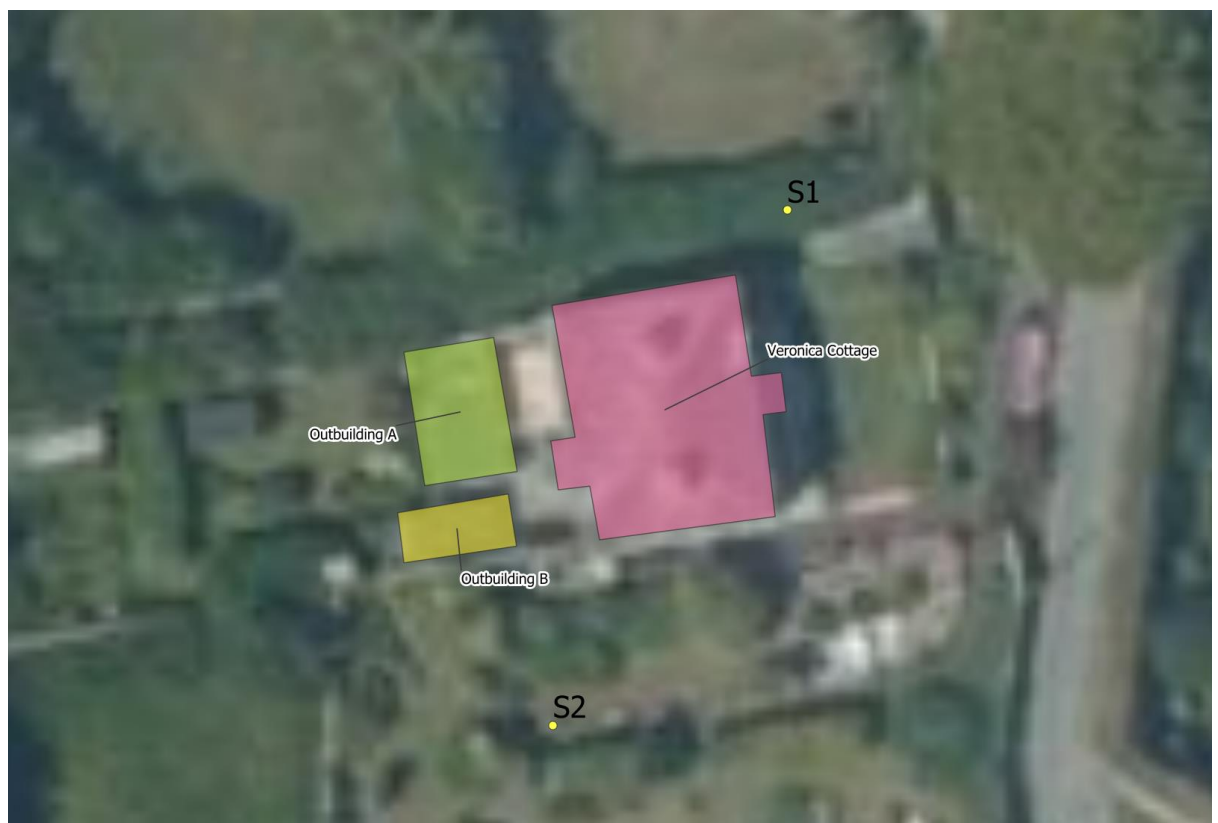
In order to ensure that the building received a survey effort of a single bat survey for a Low Potential building (in line with the Best Practice Guidance), two surveyor positions each with an NVA were deployed. These are identified in Map 01 below.

**Map 01** – showing the surveyor positions (S1 – S2).

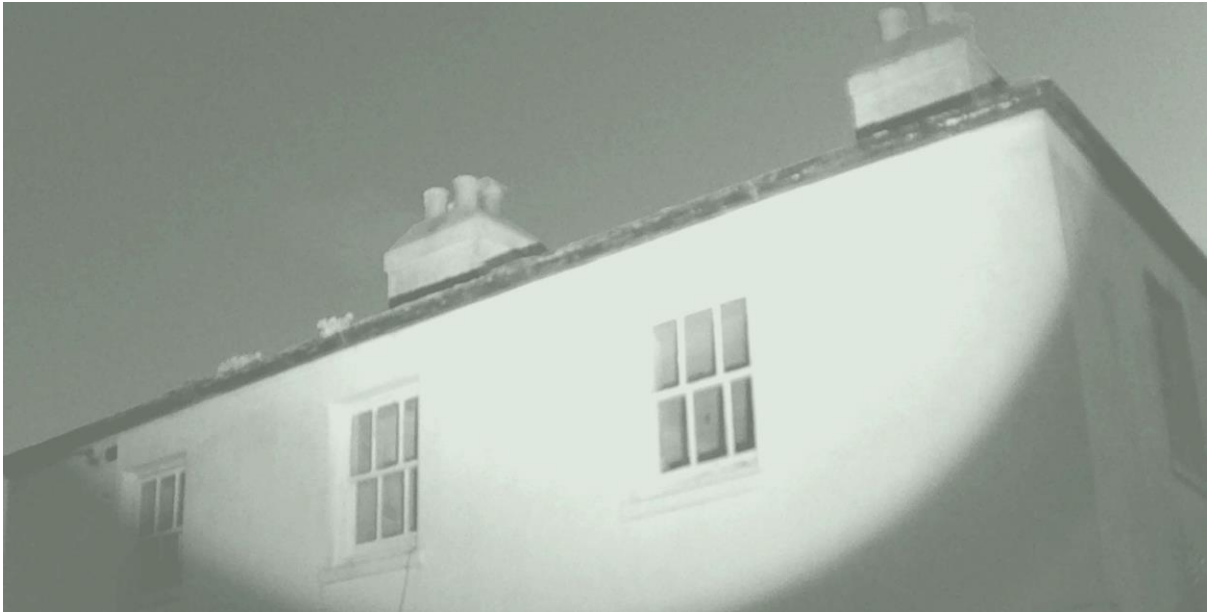
**NVA1** – showing a screenshot from the Nightfox Whisker at position S1 with the front (eastern aspect) of the property and a portion of the northern aspect (RHS) covered by the FOV.

The NV camera Field of View (FOV) covered key areas under survey and allowed cross-reference of records in some instances to confirm the flight paths of bats picked up by both surveyors. Coverage was not comprehensive – this was due to the presence of intervening vegetation and restrictions on access/vantage points which did not affect surveyor visibility but precluded comprehensive FOV for the NVA equipment. The footage obtained is however considered sufficient to confirm the conclusions of the surveyors that no bats emerged from the property during the survey. See Appendix 2 for example screenshots from the footage.

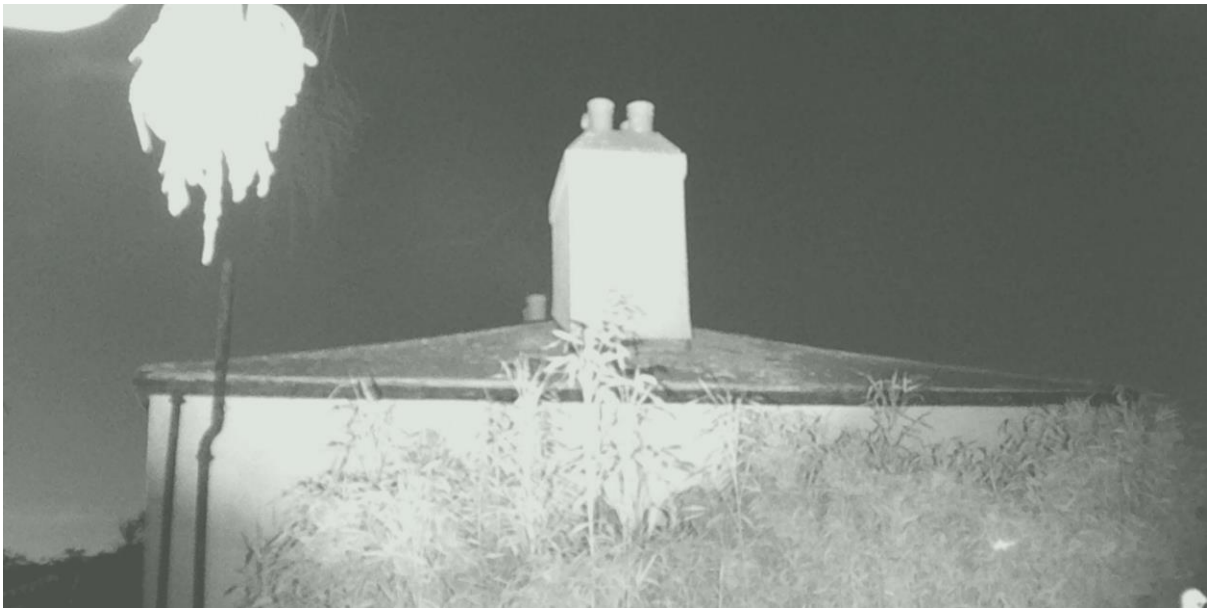
**NVA2** – showing footage from the Nightfox Whisker on position S2 with the southern aspect of the property covered by the FOV. The position along the sightline of the western aspect would allow the identification of bats flying from this location.
