Fig. 7 Photograph of North Farm, St. Martin's, (taken from the south-west) and plan showing the different phases of building.

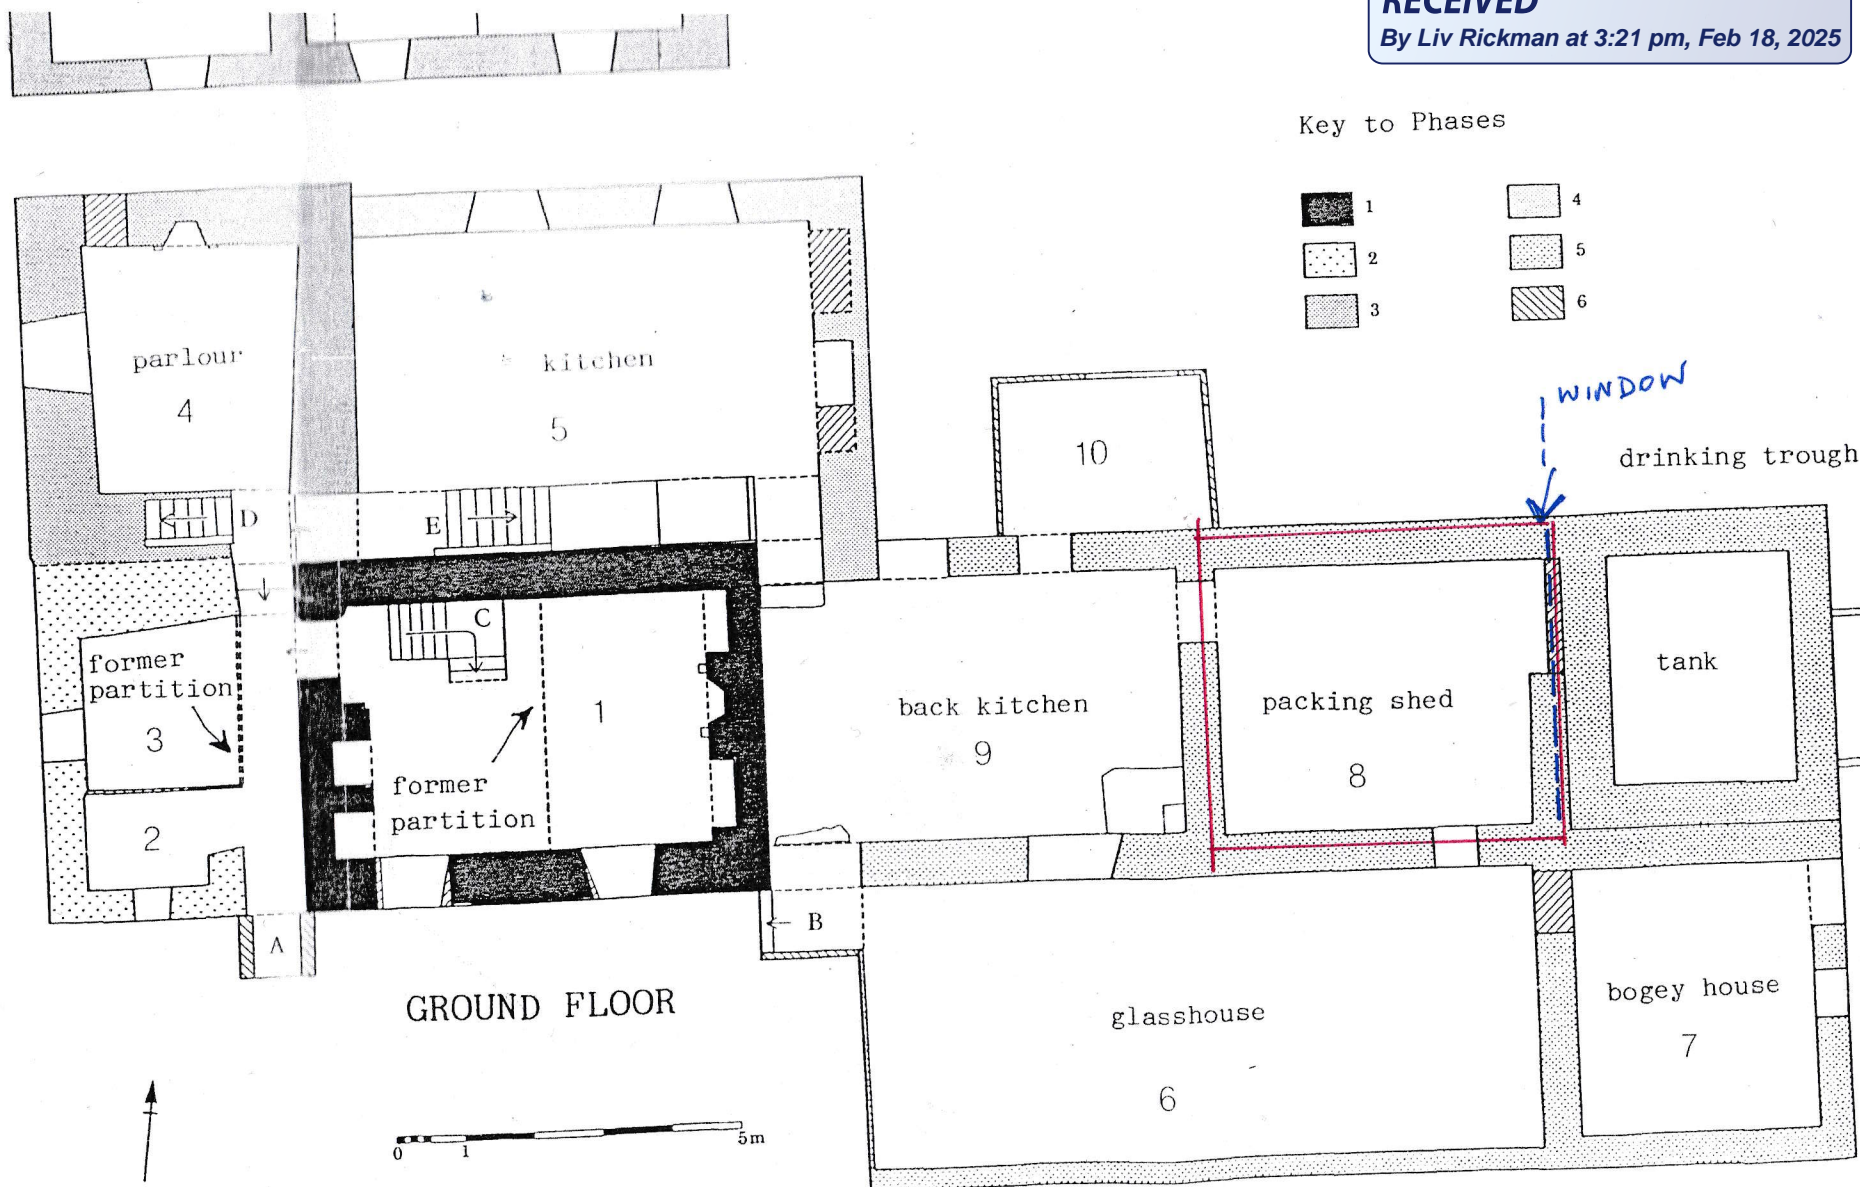
Plan included with Cornwall Archaeological Unit Report  
(Fieldwork in Scilly: September 1989.)
