Preliminary Roost Assessment (PRA) & Nesting Bird Assessment

Watch House, Tresco, Isles of Scilly, UK, TR24 0PW

14th April 2025

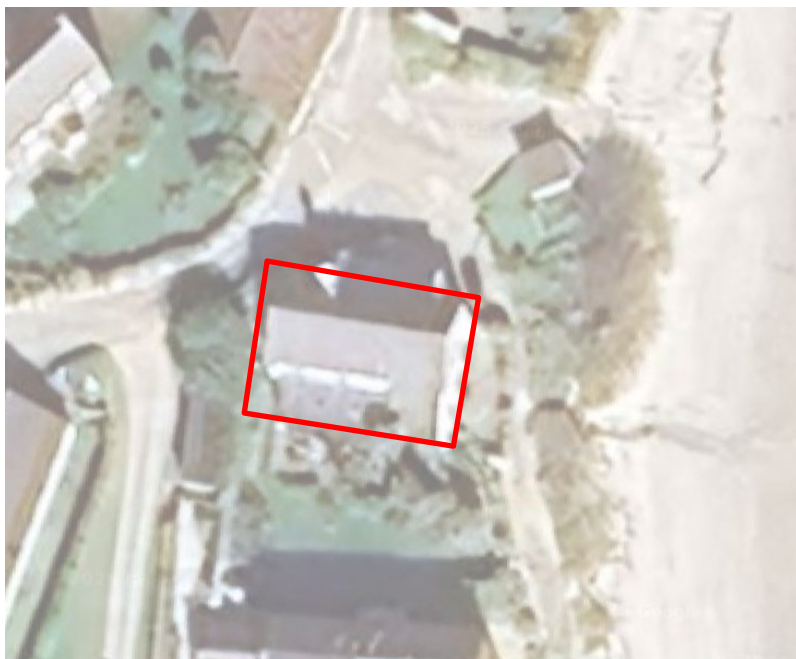
Figure 1: Aerial view of Watch House, Tresco (red outline).

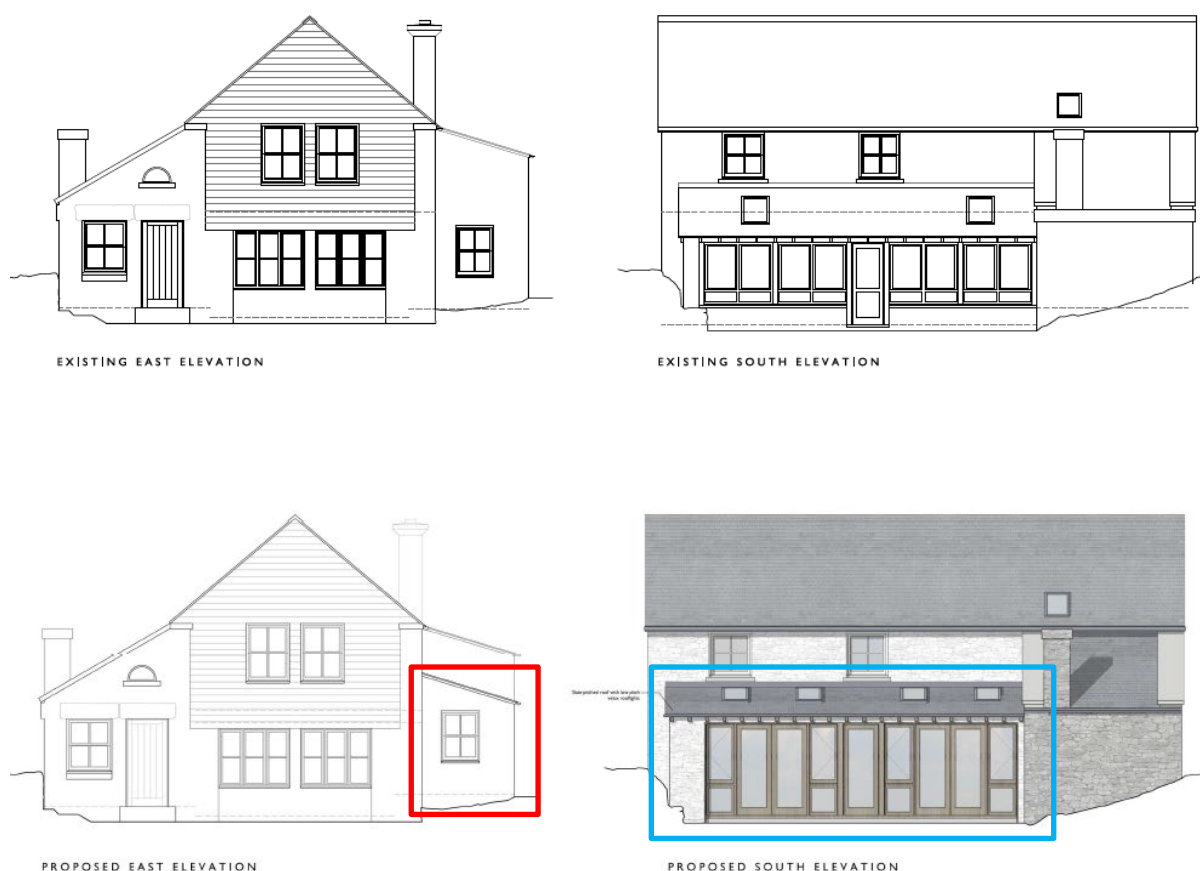
The client proposes to demolish and replace the single-storey glazed sunroom on the southern elevation and construct a single-storey extension on the north elevation. An excerpt of the proposed site plans showing the areas to be impacted are shown in Figure 2, below.

Figure 2: Excerpts from the existing plans (top) and proposed plans (bottom) showing the areas to be impacted by the proposed development. Red outline shows the proposed single-storey extension on the north elevation. Blue outline shows the proposed replacement sunroom on the south elevation.

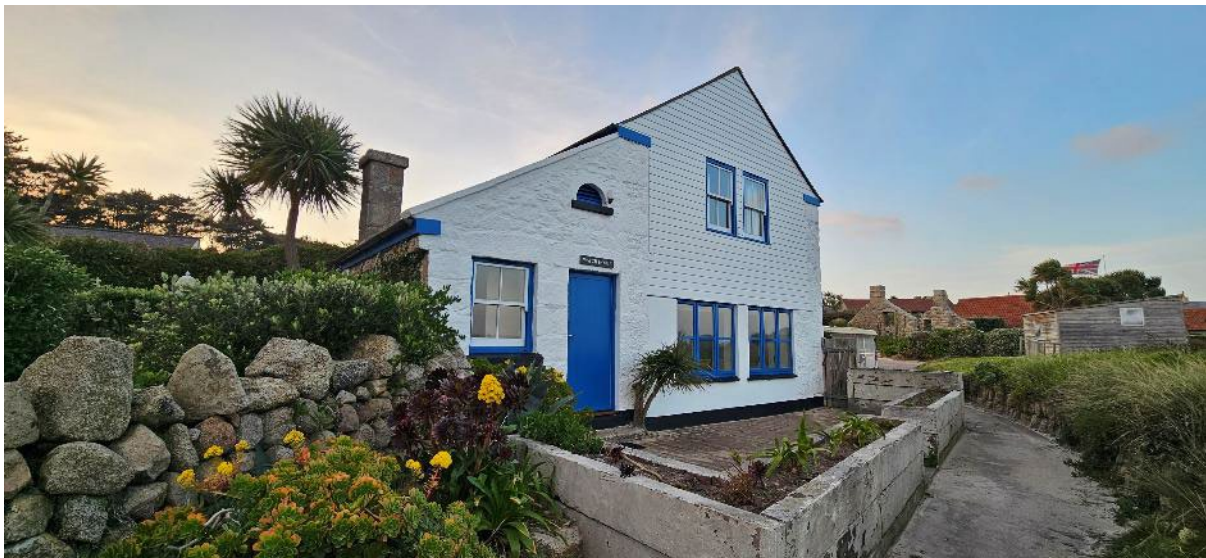
Watch House is a detached stone-built holiday property (Figs. 3-5). A single-storey stone-built projection with slate roof is present on the south elevation (Fig. 3 and 5), together with a glazed, slate roofed sunroom (the latter is proposed for demolition and replacement, Fig. 5). A two-storey stone-built projection with slate roof is present on the north elevation (Fig. 4). All door and window apertures comprise painted timber. Black uPVC rainwater goods are present throughout the building. The main roof is finished in slate with concrete ridge tiles (Fig. 3 – 5).

Externally, the roof and ridge tiles appear to be tight throughout with no potential bat access points or roosting locations (i.e., gaps beneath lifted, broken or slipped tiles). Timber fascia boards are present at first floor level throughout the property (Fig. 3 – 5). All first-floor fascia boards feature gaps with potential to support roosting bats or permit bats access to the first-floor roof void (void 2) (Fig. 3 – 5). A timber slatted vent is present on the east elevation of the stone-built single-storey projection on the south elevation (Fig. 3, 6). The vent provides suitable bat access to void 1; however, no evidence of roosting bats was found within the roof void (void 1); no building works are proposed in this location. There are no potential bat access points within the vicinity of the single-storey sunroom (Fig. 5).

Figure 3: East elevation of Watch House showing the single storey mono-pitched projection off of the southern elevation.

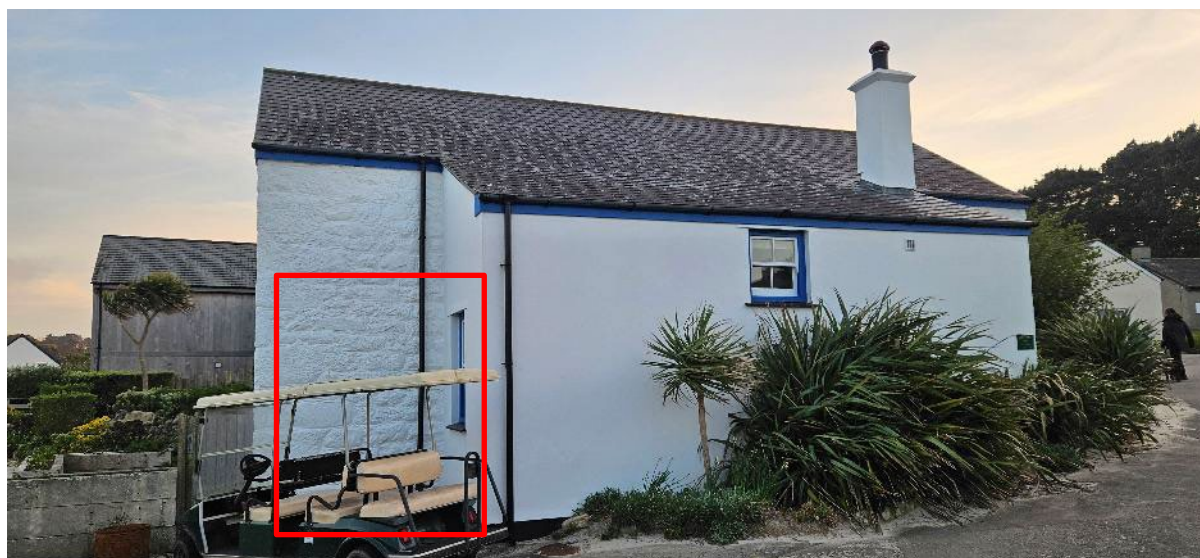
Figure 4: North elevation of Watch House; red open rectangle shows the proposed location of the single storey extension. Blue timber fascia boards above the first-floor height support a 20mm gap beneath but will not be impacted by the proposals.

If the proposed works are altered to include work to the roof void above the first floor (void 2) of the property, or if works to the first-floor fascia boards are required, then it will be necessary to consult the project ecologist in the first instance and likely undertake two bat emergence surveys. In line with the Bat Surveys for Professional Ecologists: Good Practice Guidelines (Collins, 2023), bat emergence surveys can only be undertaken between May and September. Emergence surveys must be spaced at least three weeks apart and at least one of the surveys must be carried out between May and August. The surveys will determine if bats are present and, if so, the species, number of individuals, bat access points and timings of usage.

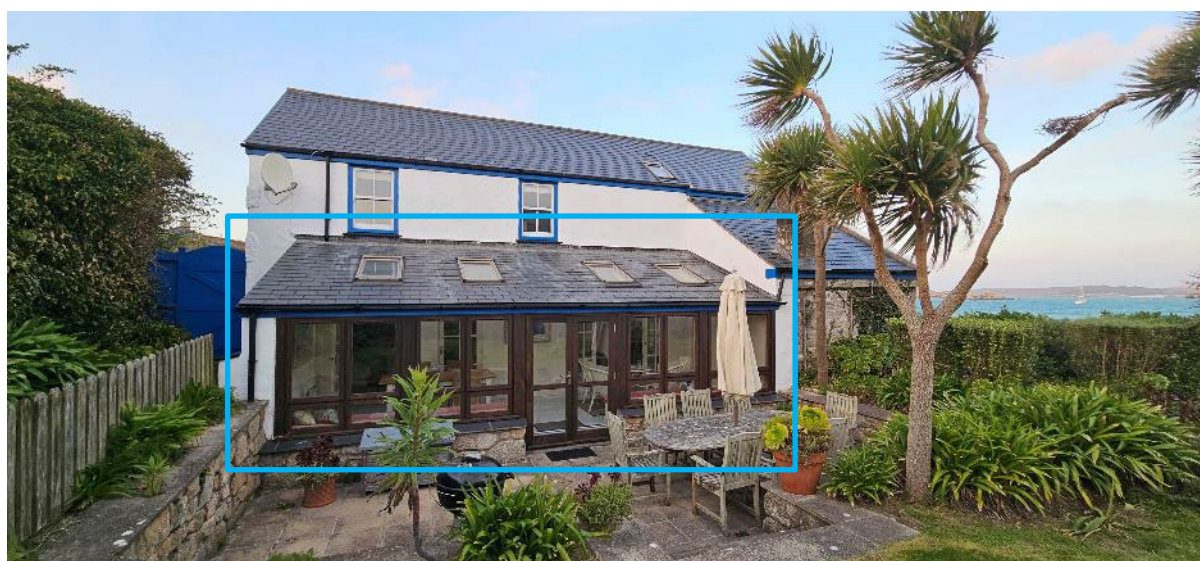
Figure 5: South elevation of Watch House showing the slate roofed sunroom (blue open rectangle) to be demolished and replaced with a replacement sunroom.

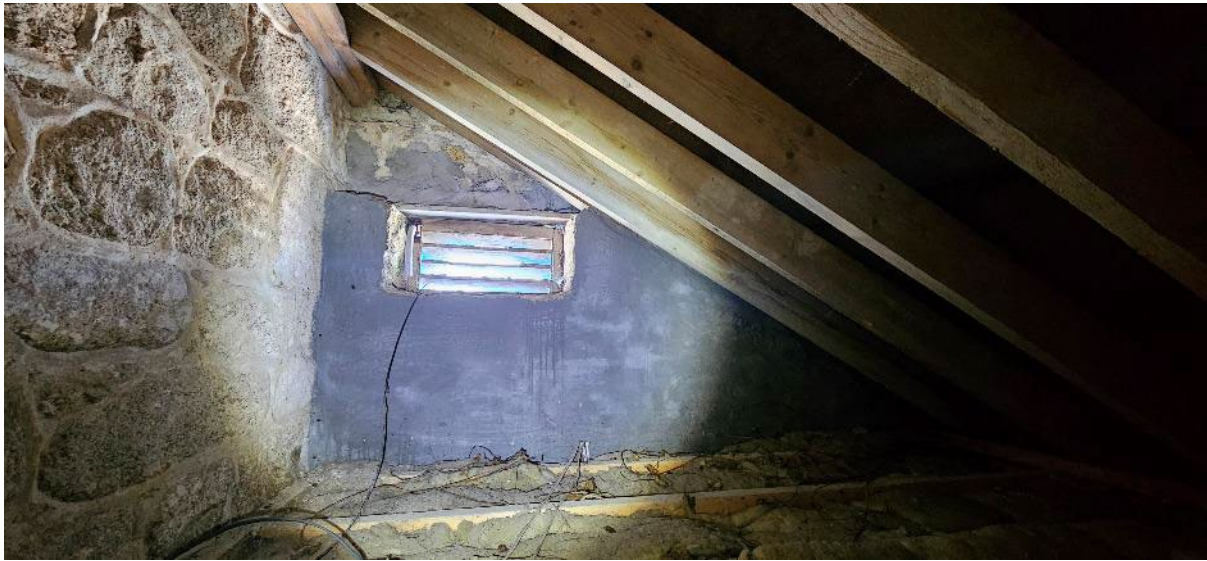
Internally, the property supports a single roof void above the stone-built single-storey projection on the south elevation (void 1) (Fig. 6). Void 1 is lined with bitumen and supports rolled insulation between the joists (Fig. 6). The slatted vent on the east elevation creates a draughty and partially lit internal environment (Fig. 6). No evidence of roosting bats was observed within void 1. The sunroom lacks a roof void. A single large but shallow void runs the length of the property above the first floor (void 2) (Fig. 7). The slate roof tiles are lined with taught bitumen; rolled insulation

Figure 6: Roof void 1 interior showing vent on east elevation.

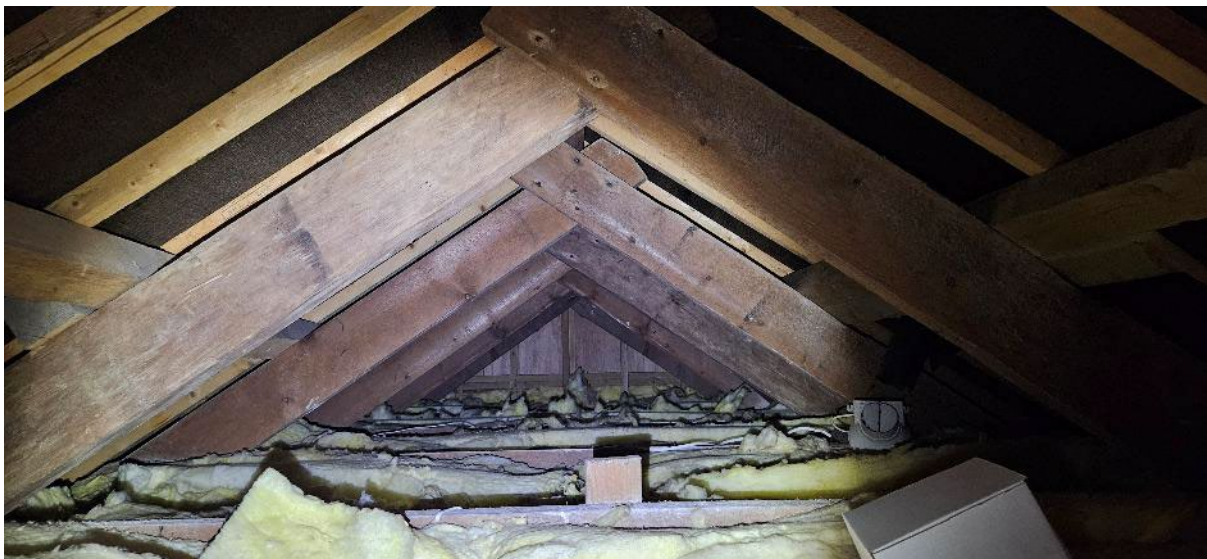
is present between the joists. No evidence of roosting bats was observed within void 2. Access was limited to within 4m² of the loft hatch, but it was possible to inspect the remaining roof void with a torch from a distance.

Figure 7: Roof void 2 interior (view east).
