## BAT PRESENCE/ABSENCE SURVEYS (PAS)

SOUTH HILL,  
SOUTHARD, BRYHER, ISLES OF SCILLY

*Our reference: 25-8-1*

*Report date: 9<sup>th</sup> September 2025*

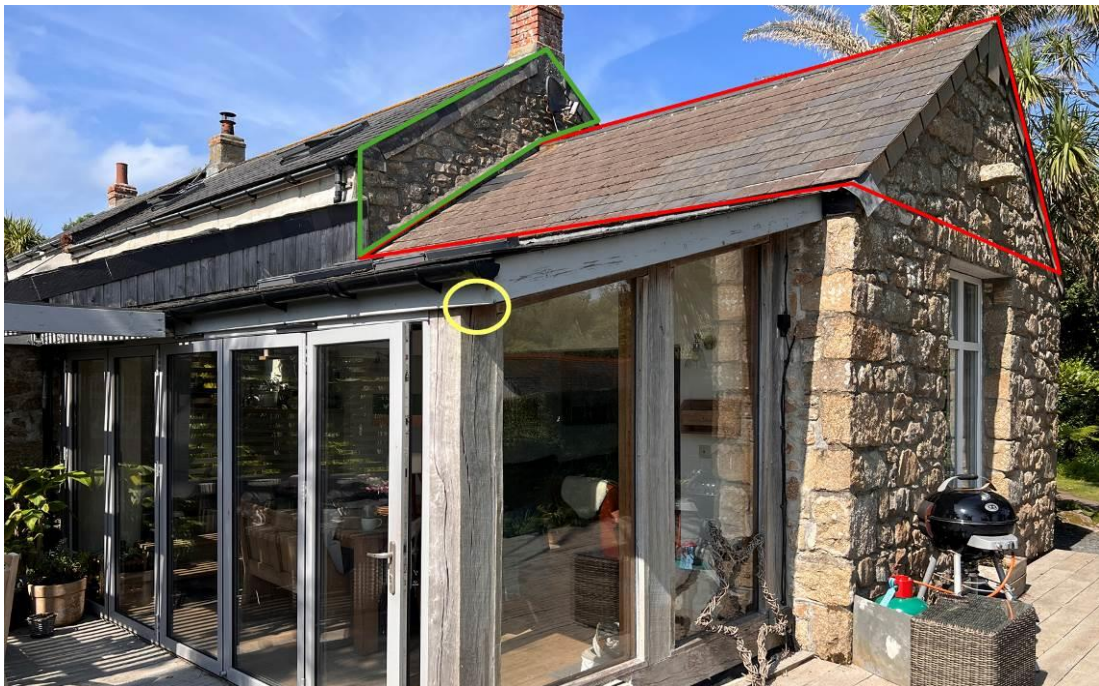
**Photo 05** – Showing the structure with distinct components indicated; the single-storey extension is outlined in red - this roof would be raised to first floor level and tied in with the existing two-storey cottage outlined in green. The confirmed common pipistrelle day roost is located in the mono-pitch extension and indicated by the yellow circle.

The works would not directly impact upon the mono-pitch extension and the confirmed roost is located at the south-western corner, physically separated from the proposed area of works.

The proposed approach to avoid an EPSML is contingent on works being designed and undertaken in a way that the confirmed roost in the mono-pitch extension is not impacted by the proposed works. This would need to be secured through a Precautionary Method of Works (PMW).

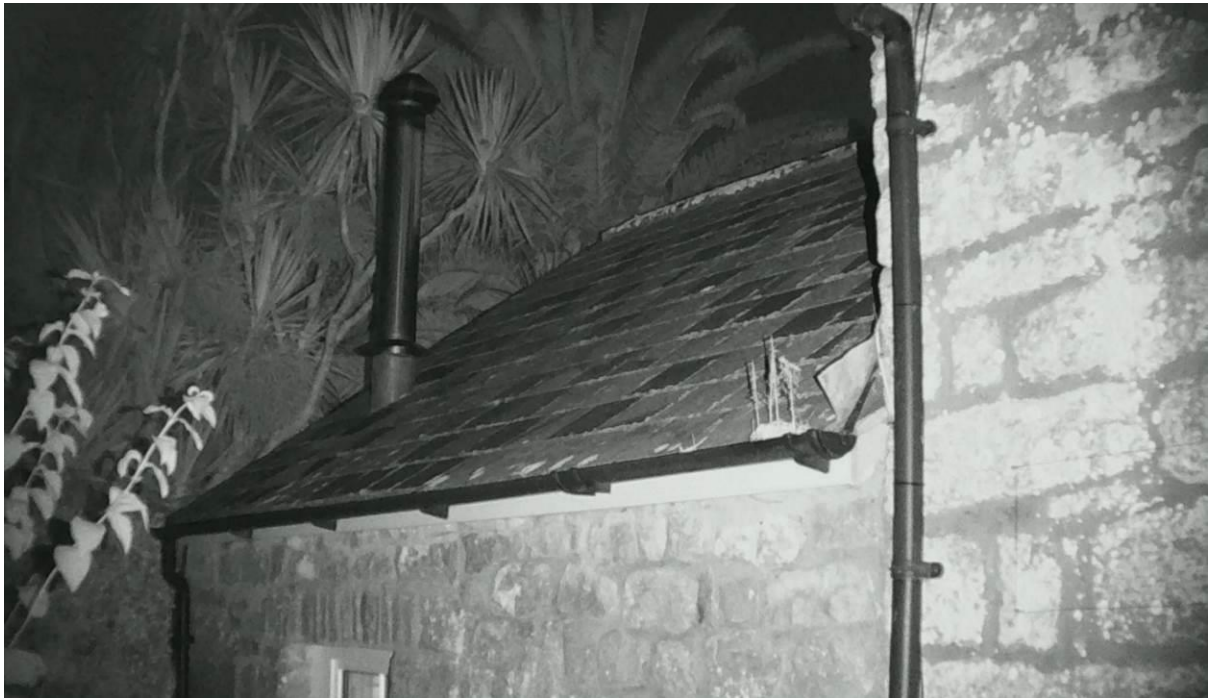
**NVA S1** – showing footage from the Nightfox Whisker at surveyor position S1.

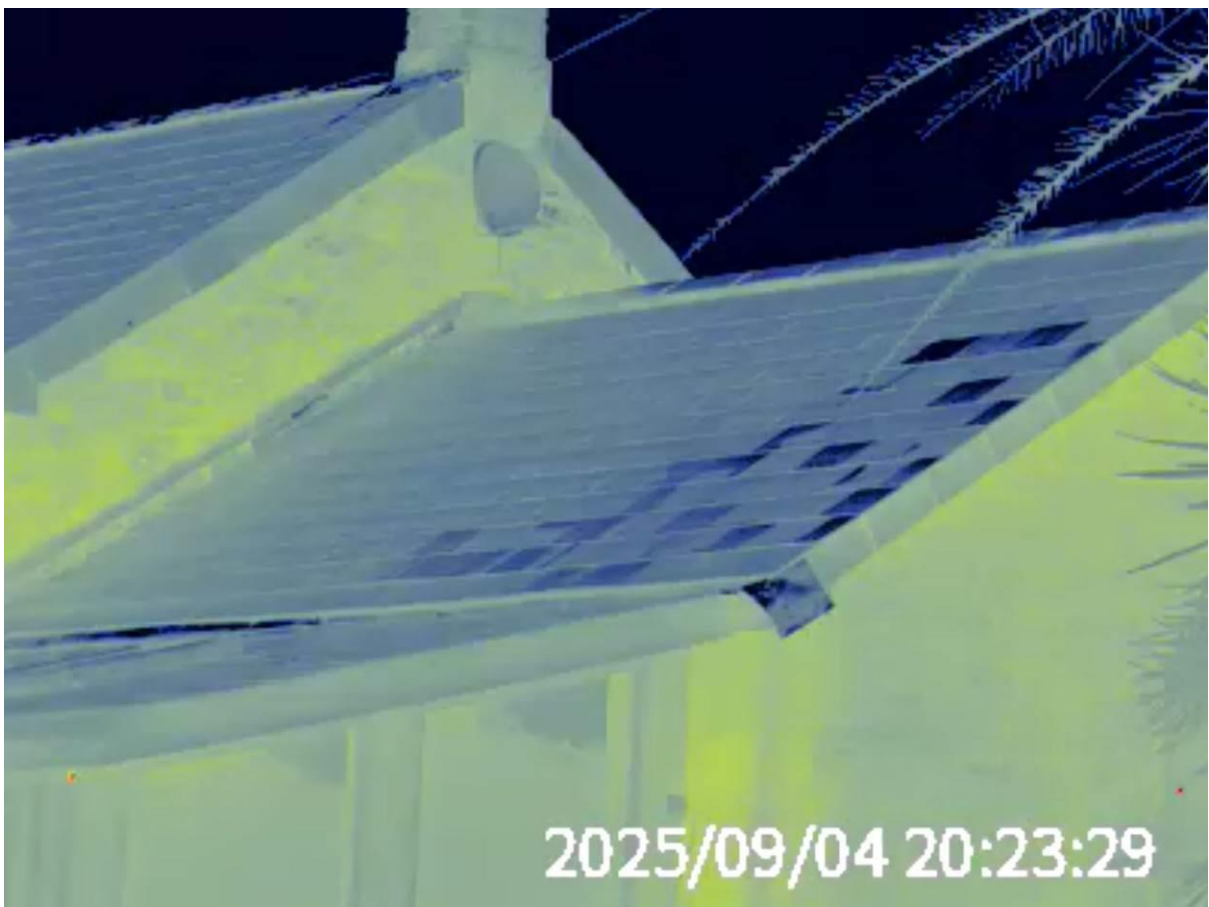
**NVA S2** – showing footage from the Guide Track IR35 at surveyor position S2.
