PRELIMINARY ROOST ASSESSMENT (PRA)

SOUTH HILL, BRYHER, ISLES OF SCILLY

Report date: 4th August 2025

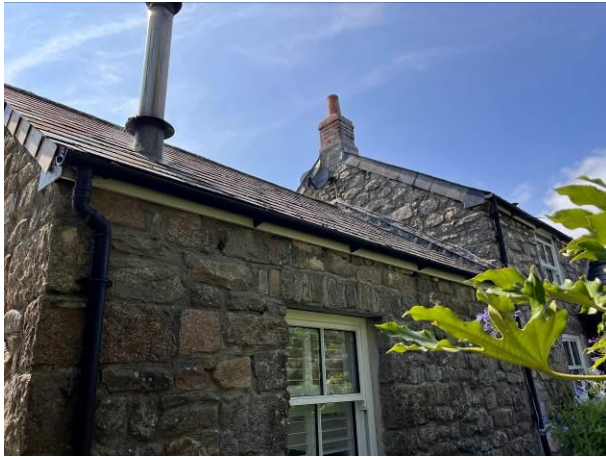
Photograph 1: Showing the view of the property from south-east with the single-storey extension in the foreground and the two-storey cottage in the background

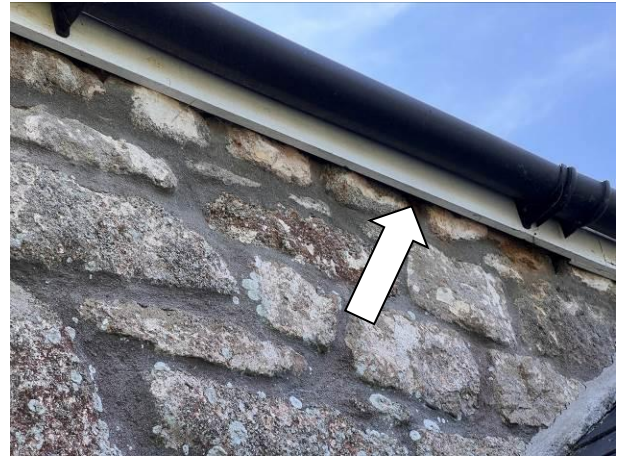
A wooden fascia runs along the eaves on both aspects; the extensions on the western aspect tie in just below this feature which would preclude any direct fly-in access for bats but gaps were noted between the timber and the irregular blockwork of the granite to which it is attached on the eastern aspect. This could potentially provide access to roosting features associated with the wall plate; or provide roosting opportunities in its own right.

Photograph 2: Showing the fascia which runs along the eastern aspect of the two-storey cottage. This feature is present but the fly-in is obstructed on the western aspect.

- 1x Presence/Absence Survey (PAS).

The purpose of the PAS technique is to allow the building to be watched at dusk to observe bats emerging from concealed roosting locations. This uses the predictable emergence behaviour of bats to allow their presence to be detected in roosting locations which cannot be directly visually inspected.

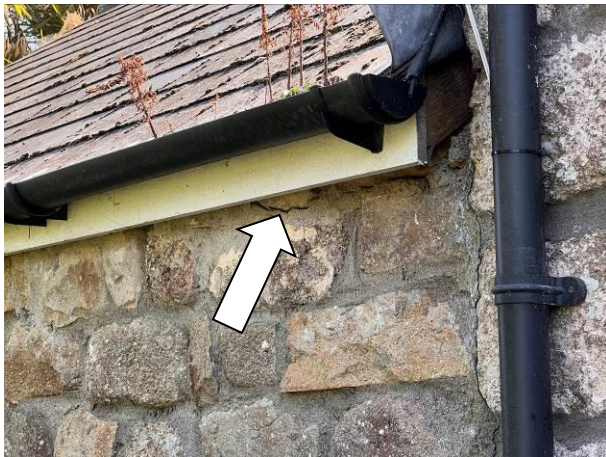
The gaps behind the fascia on the eastern aspect was fully inspected with a video endoscope – these were predominantly sealed or superficial though minor gaps and niches do occur which could potentially support individual roosting bats.

Photograph 3: Showing the fascia which runs along the eastern aspect of the single-storey extension. This feature is present but the fly-in is obstructed on the western aspect.

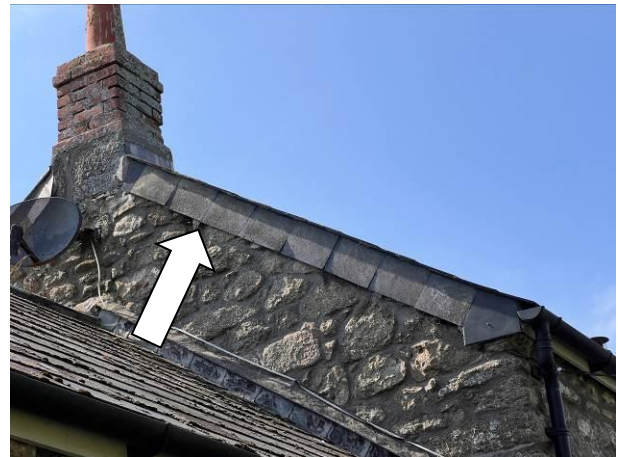
The southern gable of the property has slate drop-tiles along the verge which have gaps behind – these could potentially provide access to roosting features associated with the wall plate; or provide roosting opportunities in their own right.

Photograph 4: Showing the drop tiles present on the southern gable of the two-storey cottage above the roofline of the single-storey extension

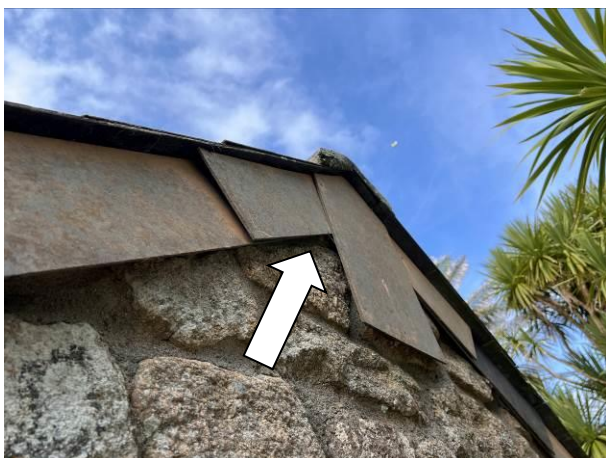
Gaps behind the drop tiles on the southern gable were inspected with a video endoscope – these did not provide access to the fabric of the building where larger roosts might be supported; however the gaps between the tiles and the wall itself would provide suitable roosting niches

Photograph 5: Showing the drop tiles present on the southern aspect of the single-storey extension.

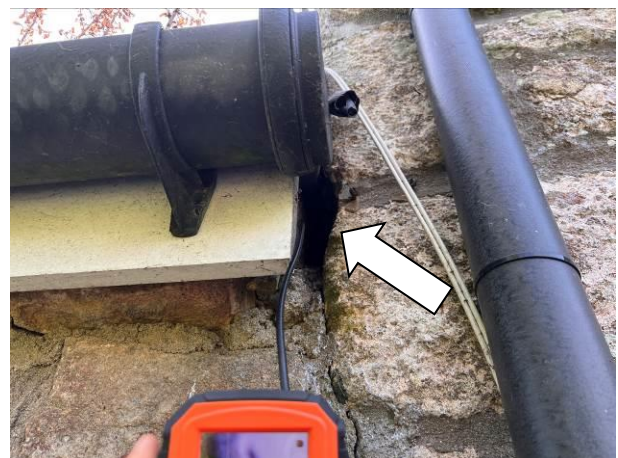
There is a gap between the two-storey and the single-storey structures at the roofline of the single-storey component which is accessible at the eaves and extends beyond the reach of the video endoscope to inspect – the dimensions and fly-in access to this feature on the eastern aspect would provide a suitable roosting opportunity for bats. On the western aspect, the potential fly-in for this feature is obstructed by the roofline of the mono-pitch roof which ties in just below it; however there appears to be nesting material indicating likely use by breeding birds.

Photograph 6: Showing the gap which extends along the roofline between the single-storey extension and the two-storey cottage.

Works affecting the roof should be undertaken outside of the breeding season which runs from March – September inclusive, where practicable. This would provide the most robust means of avoiding risk of impact to nesting birds.

If the recommended timing of works is not possible, then contractors should visually inspect the work area internally and externally before they are affected by the works, in order to confirm that no nests are present. In the event that a bird nest is present, it must be left undisturbed until chicks have fledged the nest, at which point works can proceed.

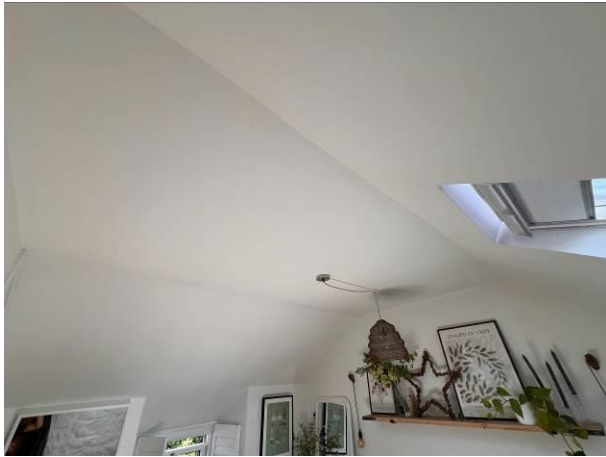
There is no loft space associated with the roof; the upper floor accommodation is built largely into the roof space although a small sealed void occurs at the apex of the roof.

There is no loft space associated with this roof with the accommodation built largely into the roof space; however a small sealed void occurs at the apex of the roof.

Photograph 7: Showing the interior room with the minor sealed void visible at the apex.

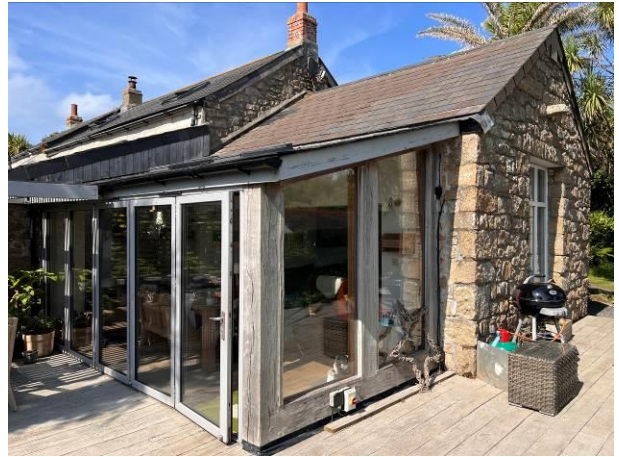
The extensions on the western aspect of the property as well as the porch on the eastern aspect were inspected. Whilst features suitable to support roosting bats were noted in these structures, these were restricted to features at the eaves or were otherwise situated in a way which, due to their physical separation from the proposed area of works, would not be directly or indirectly impacted by the proposals. These are not therefore given further consideration in this report.

Photograph 8: Showing the property from the south-western aspect – the mono-pitch extensions are visible in the foreground.
