PERMISSION FOR DEVELOPMENT

Application No:	P/25/061/HH	Date Application Registered:	12 August 2025
Applicant:	Mr Phillip Spence South Hill Green Bay Road Southard Bryher Isles of Scilly TR23 0PR	Agent:	Mr Jonathan Arnold Arnold Planning Ltd 5B Riverway Auckley Doncaster DN9 3LA

Site address: South Hill Southard Bryher Isles of Scilly TR23 0PR
Proposal: Extension to the first floor of South Hill to create an additional bedroom (Amended Plans)

SOUTH HILL, BRYHER, ISLES OF SCILLY

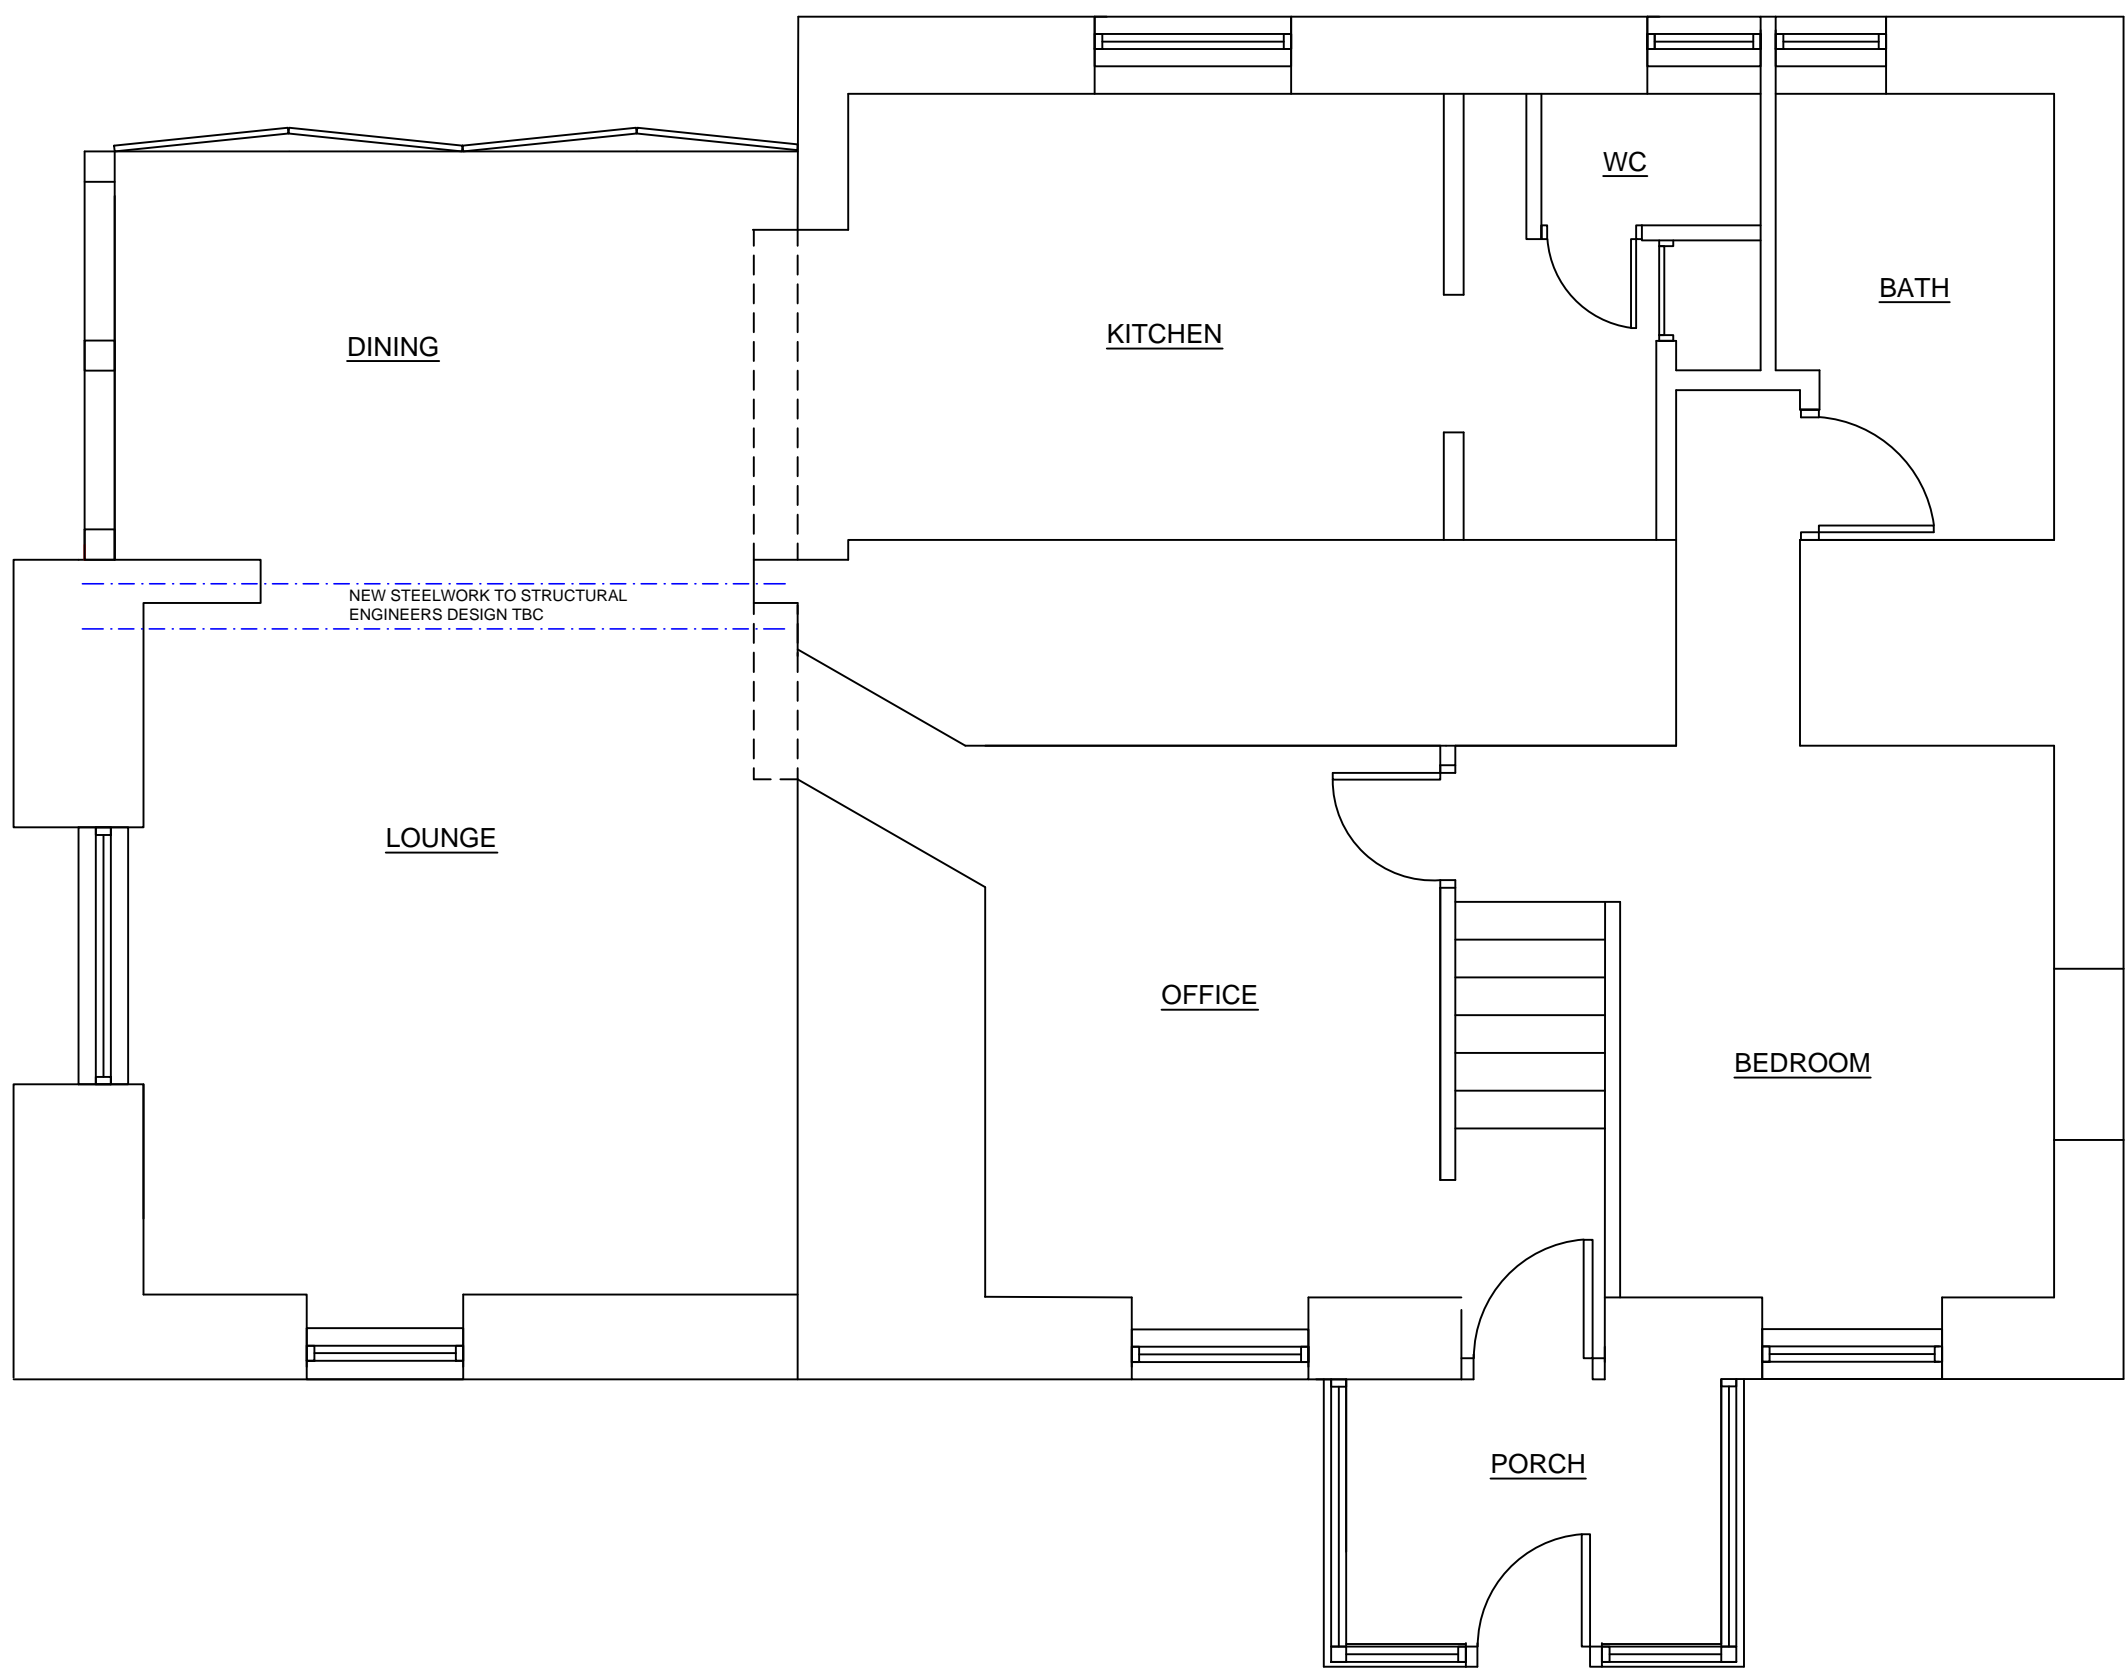
Proposed Ground Floor Plan Scale 1:50

KEY	
	EXISTING WALLS
	PROPOSED 300MM CAVITY WALL
	DASHED LINES = TO BE REMOVED
	NEW TIMBER / METAL STUD WALLS
	PROPOSED STEELWORK TO SE DESIGN - TBC

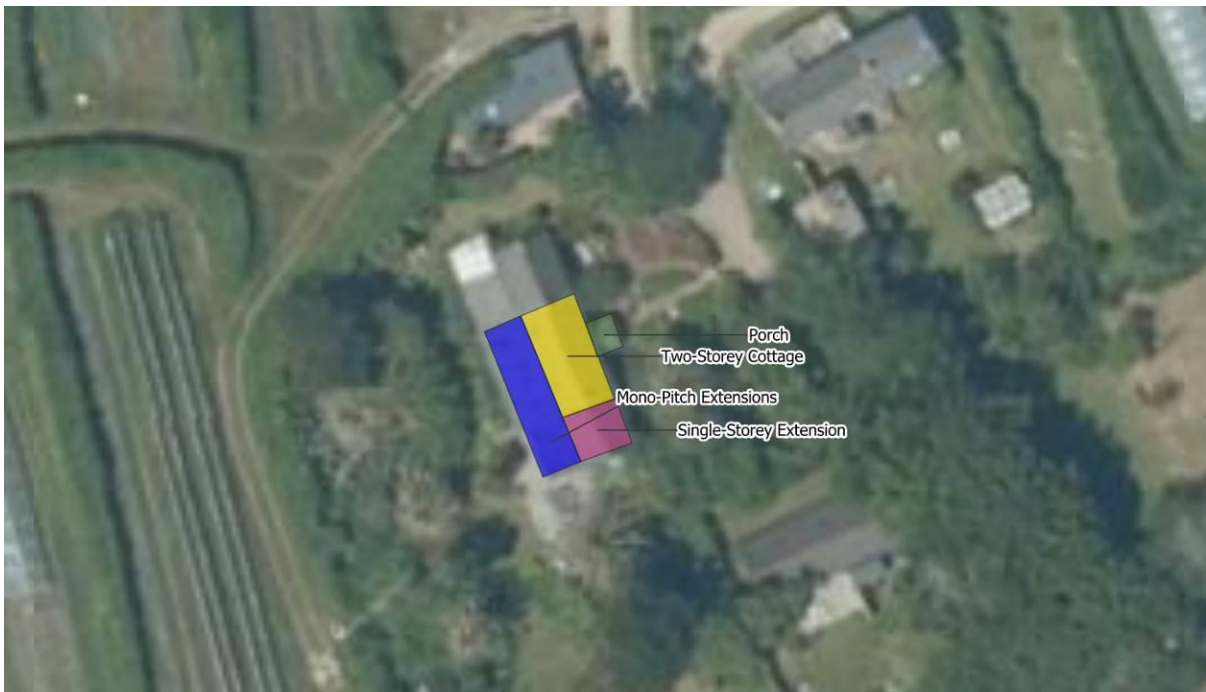
Map 02 – Showing the South Hill building – the semi-detached property to the north is visible but not identified.

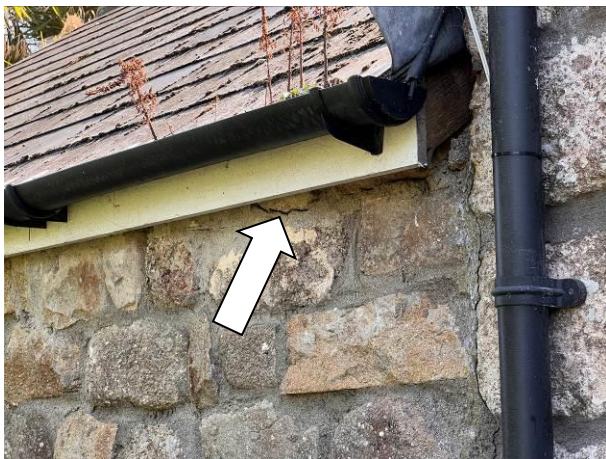
Photograph 3: Showing the fascia which runs along the eastern aspect of the single-storey extension. This feature is present but the fly-in is obstructed on the western aspect.

A wooden fascia runs along the eaves on both aspects; the extensions on the western aspect tie in just below this feature which would preclude any direct fly-in access for bats but gaps were noted between the timber and the irregular blockwork of the granite to which it is attached on the eastern aspect. This could potentially provide access to roosting features associated with the wall plate; or provide roosting opportunities in its own right.

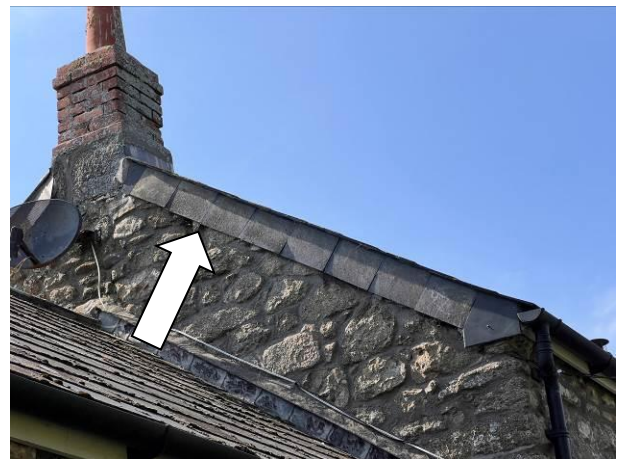
Photograph 4: Showing the drop tiles present on the southern gable of the two-storey cottage above the roofline of the single-storey extension

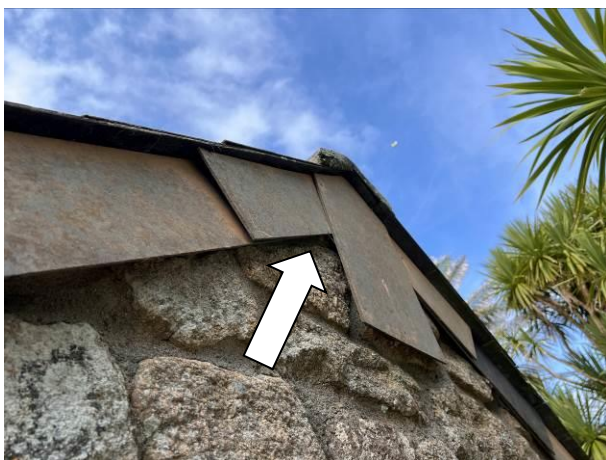
Photograph 5: Showing the drop tiles present on the southern aspect of the single-storey extension.

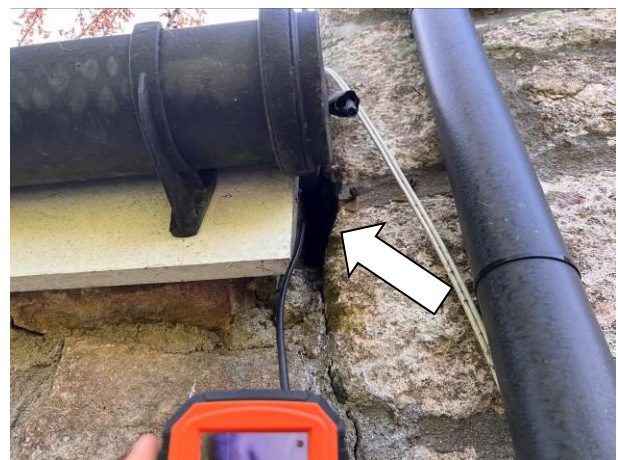
Photograph 6: Showing the gap which extends along the roofline between the single-storey extension and the two-storey cottage.

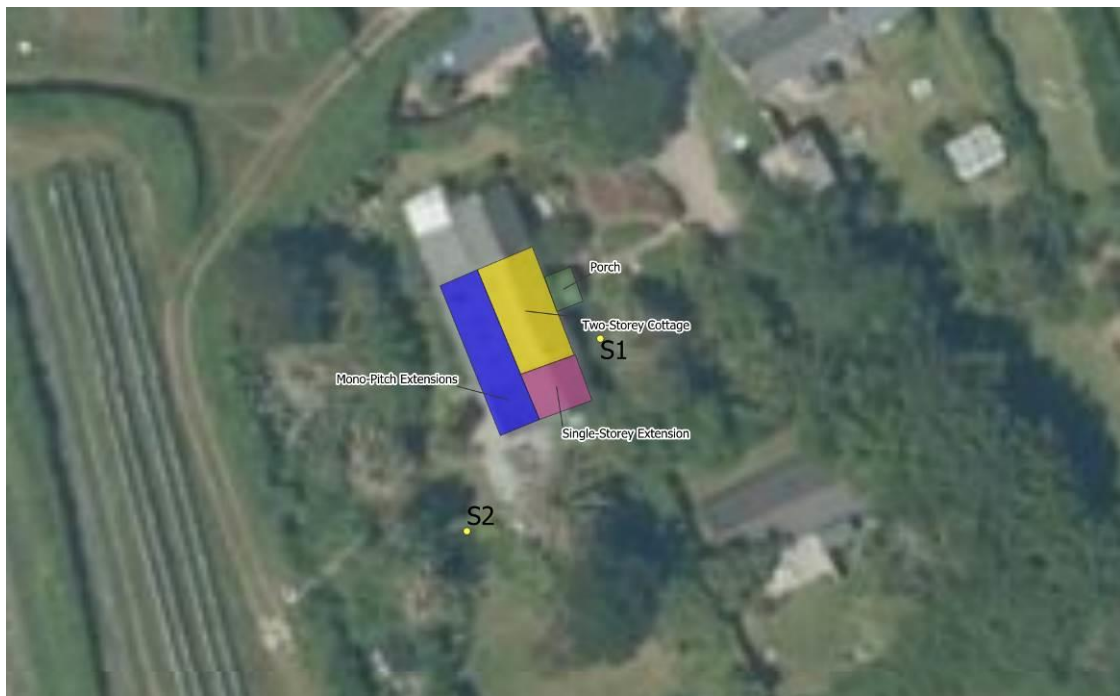
Map 01 – showing the NVA positions in relation to the property.

In order to ensure that the building received a survey effort in line with the Best Practice Guidance appropriate to its potential (as identified in the PRA survey) there were two surveyor positions to the north-east and south-west of the building as shown in Map 01 below.

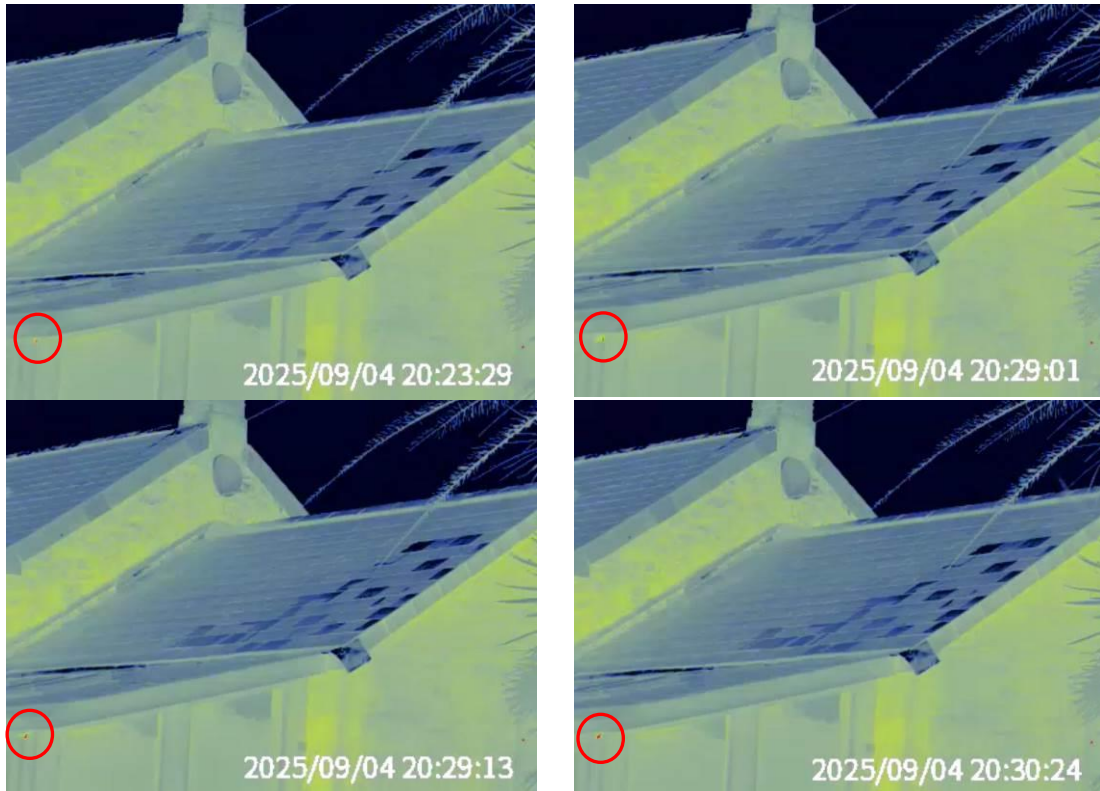
Photos 01 - 04 – screenshots from the video files showing the confirmed emergence from the south-western corner of the mono-pitch extension.

Four common pipistrelle bats were confirmed emerging from a roost in the south-western corner of the Mono-Pitch Extension. This is a later addition to the building and is structurally distinct both in terms of design and materials. The first bat was confirmed emerging at 8:23pm – 18 minutes after sunset – with a further three bats emerging between 8:29pm and 8:30pm.

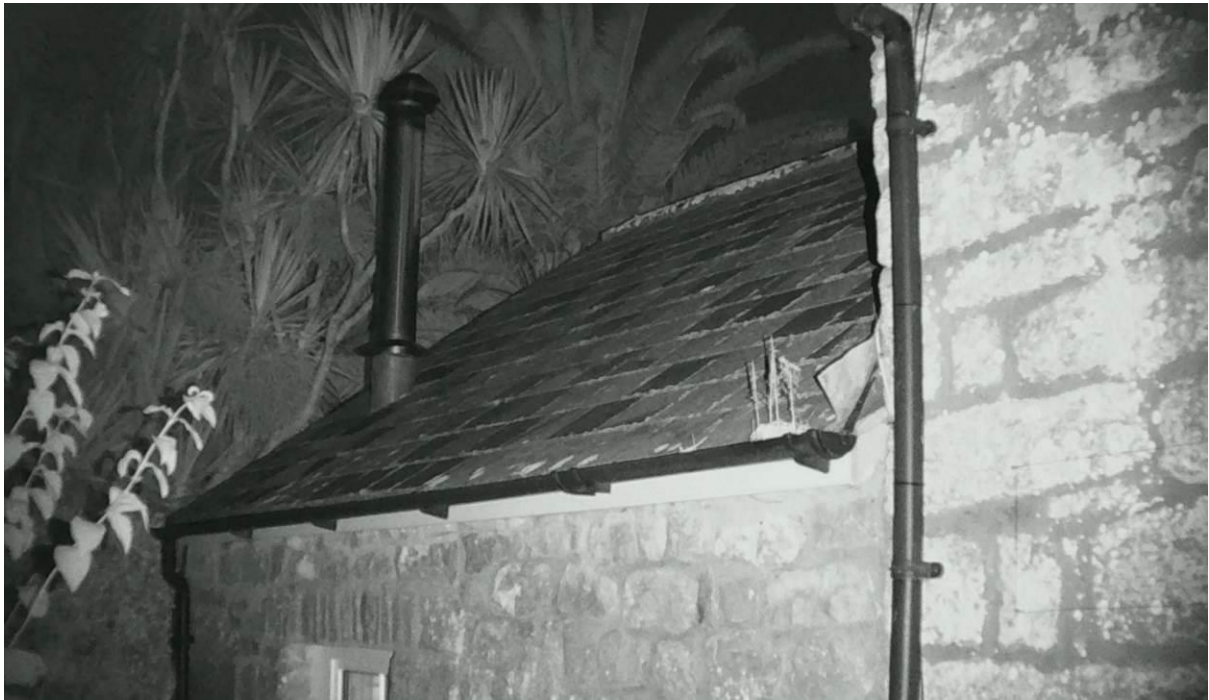
NVA S1 – showing footage from the Nightfox Whisker at surveyor position S1.

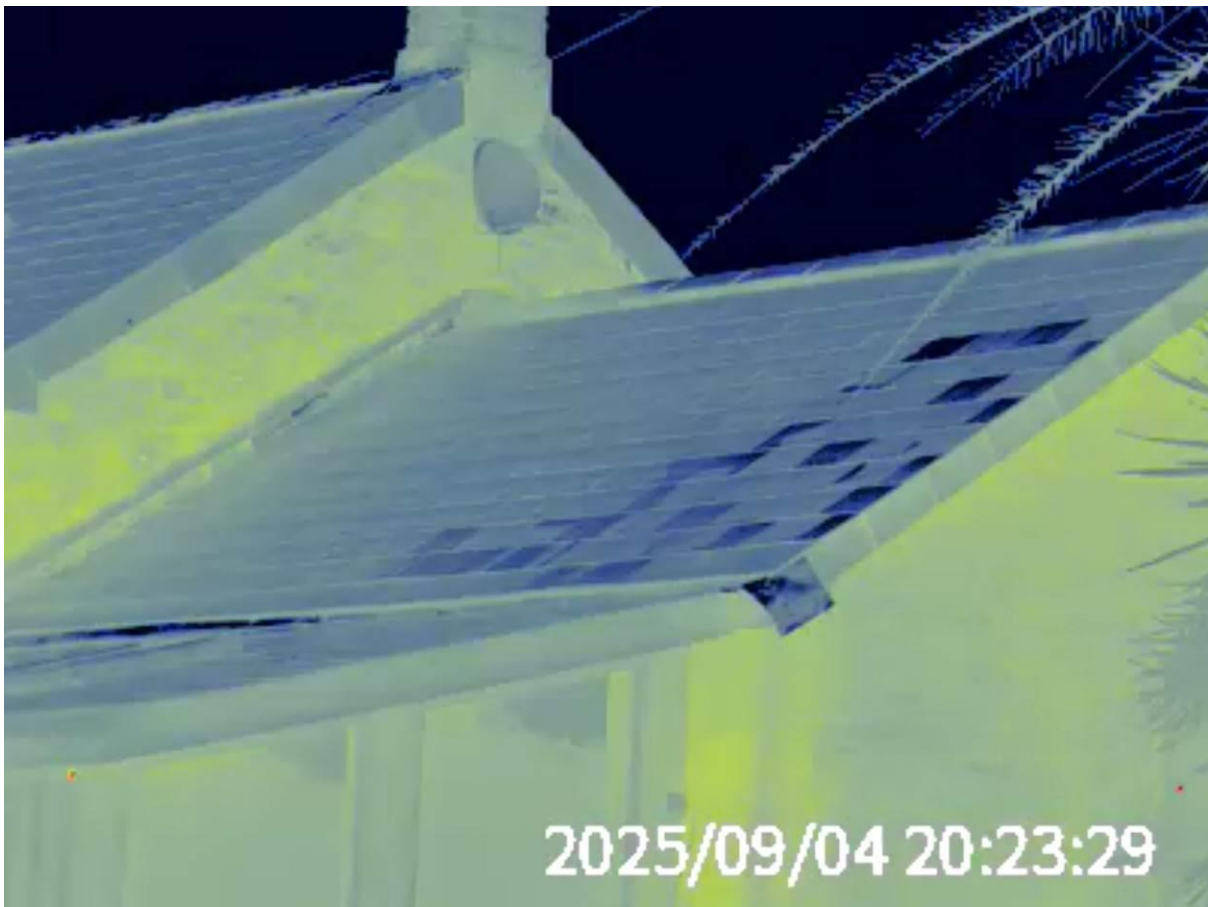
NVA S2 – showing footage from the Guide Track IR35 at surveyor position S2.
