NORTH ELEVATION

DRAWING / REF No: NH/10516/ELEV-NTH/01

SITE ADDRESS: NEWMAN HOUSE, THE GARRISON, ST MARYS, TR21 0LS

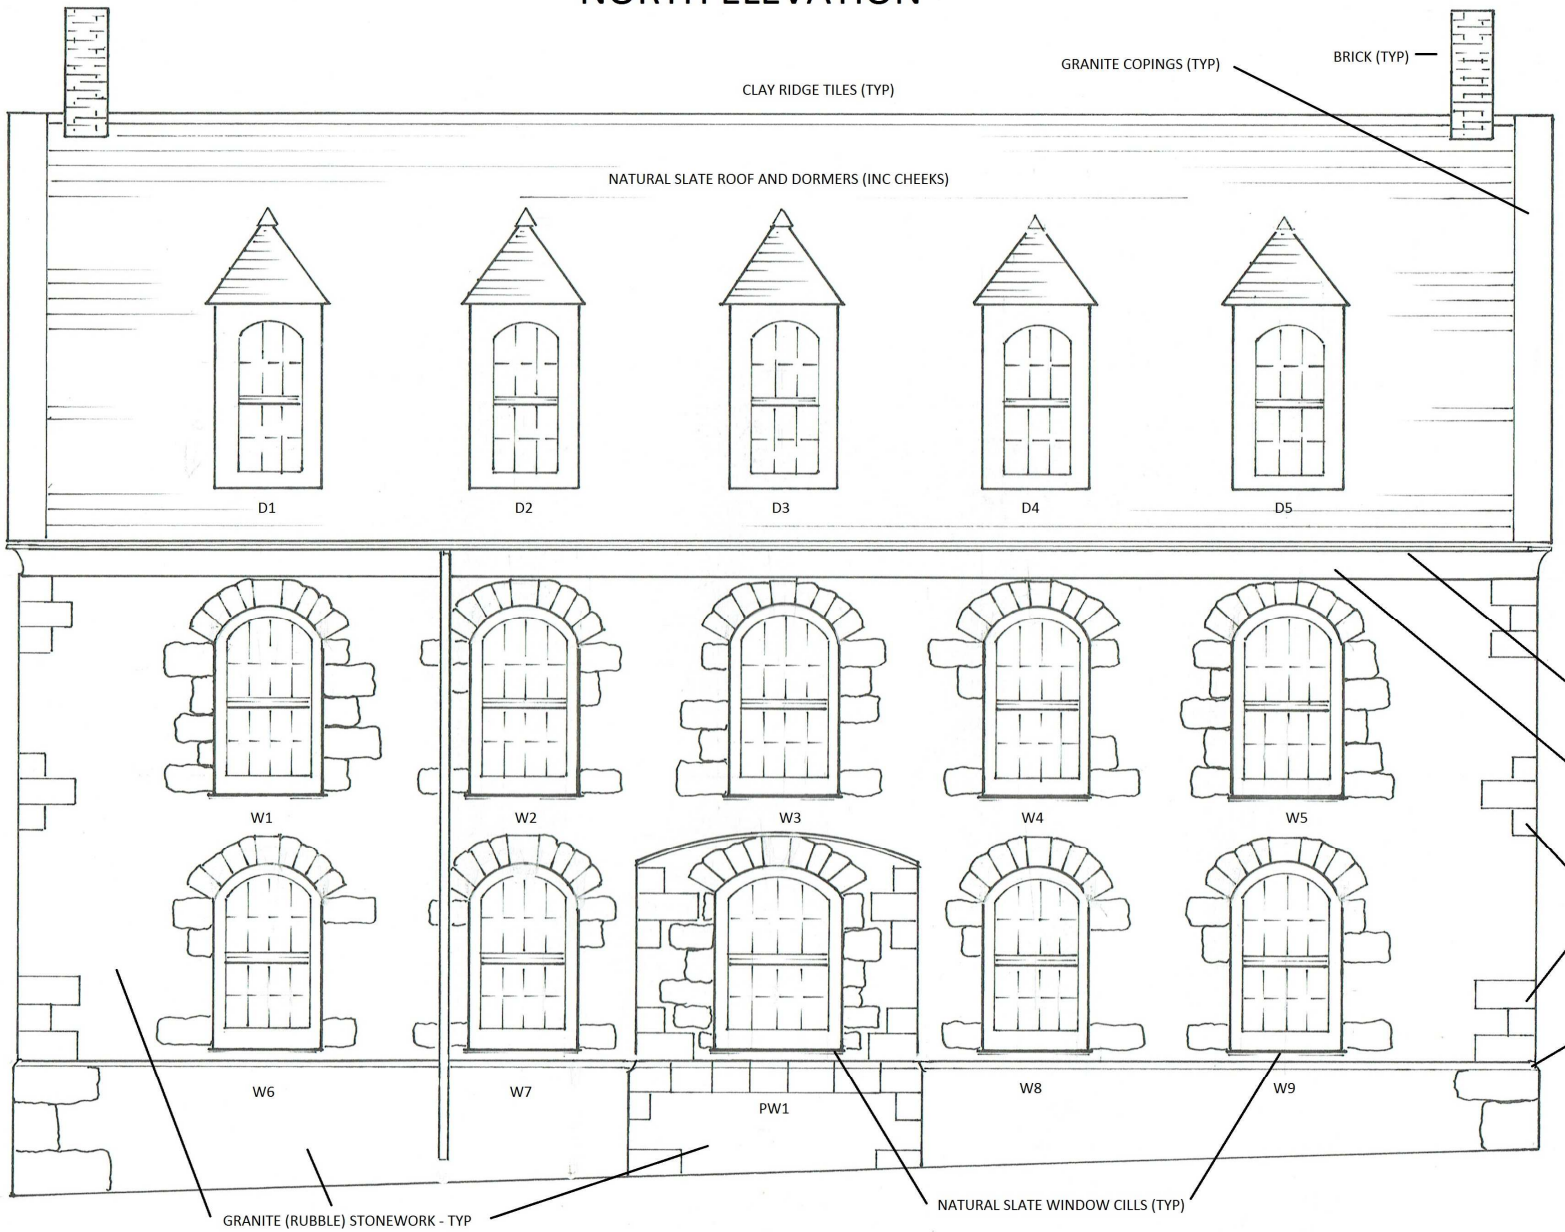
1. Existing jointing applications [to all stonework] is cementitious
2. All weather flashings to be inspected - inc parapet copings and ridge
3. Cast-iron rainwater systems to be cleaned and inspected
4. D1 - D5 Insitu restoration/decoration to sashes and frames
5. D1 - D5 Hipped Dormers-Inspection of slates,valleys & ridges
6. W1 - W9 (as Item 4)
7. PW1 (as Item 4)
8.
9.
10.
11.
12.
